Closure Report
Devon Energy Production Company, LP
Blue Krait 23 Central Tank Battery 2
Unit Letter M, Section 23, T24S, R33E
Lea County, New Mexico
(32.198582, -103.549863)

GHD Services Inc. (GHD), on behalf of Devon Energy Production Company, LP (Devon Energy), has prepared this *Closure Report* to document Site assessment activities at the Blue Krait 23 Central Tank Battery 2 (Site). The purpose of the assessment was to determine the presence or absence of impacts to soil following a release of produced water within a lined containment at the Site. Based on field observations, Devon Energy is submitting this *Closure Report*, describing Site assessment activities that have occurred and requesting closure for Incident Number nAPP2508557417.

Devon Energy Production Company, LP
Blue Krait 23 CTB 2
Incident No. nAPP2508557417
Lea County, New Mexico

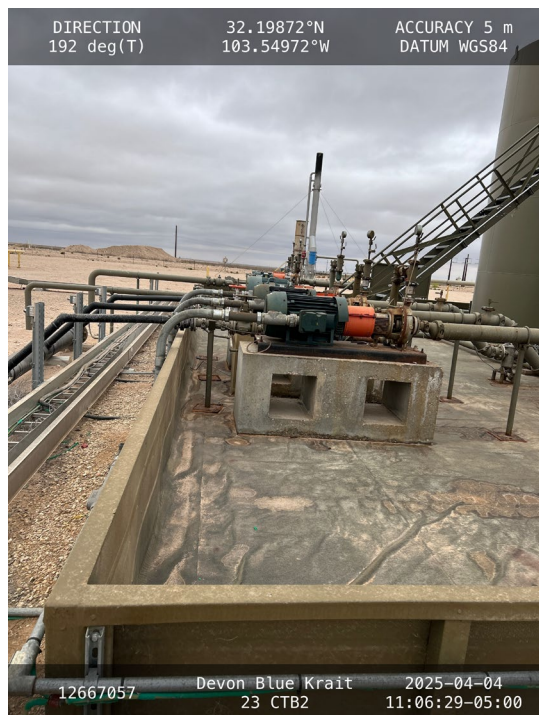
Photo 1 View of east side secondary containment facing south.

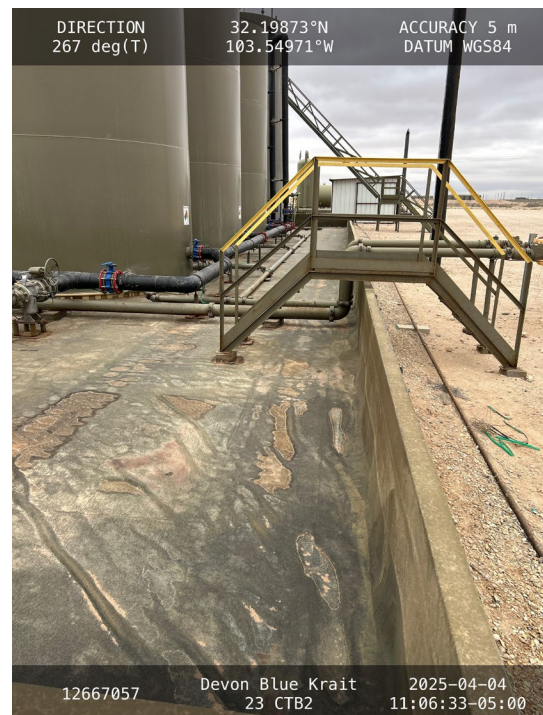
Photo 2 View of north side of secondary containment facing west.

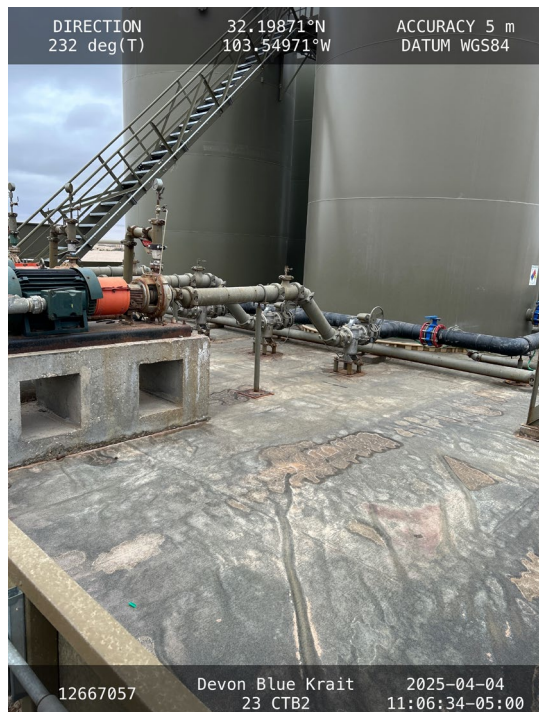
Photo 3 View of central portion of secondary containment facing southwest.

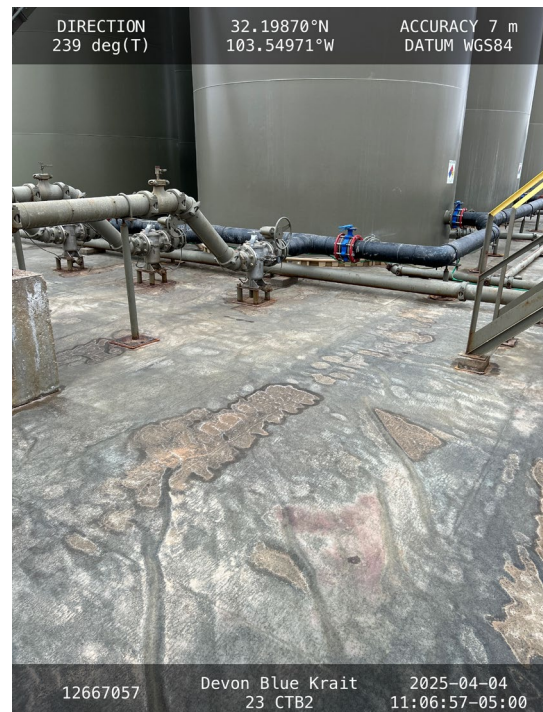
Photo 4 View of central portion of secondary containment facing southwest.

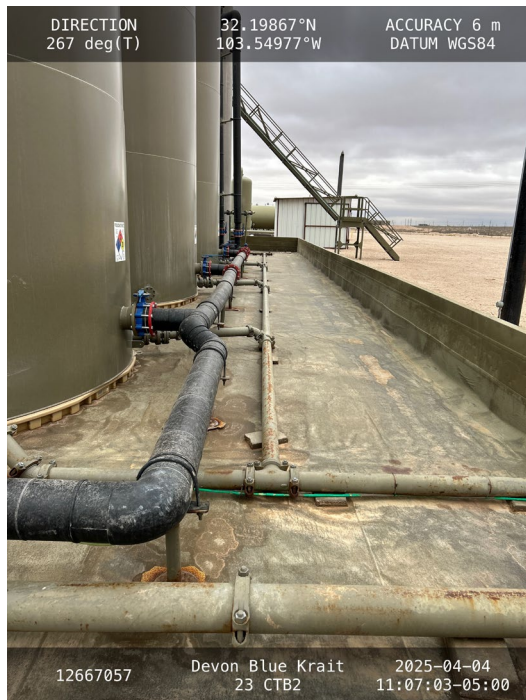
Photo 5 View of north side secondary containment facing west.

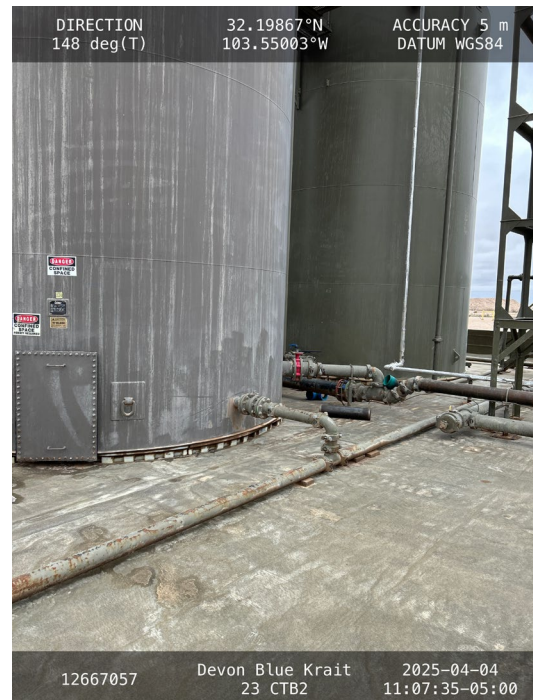
Photo 6 View of central portion of secondary containment.

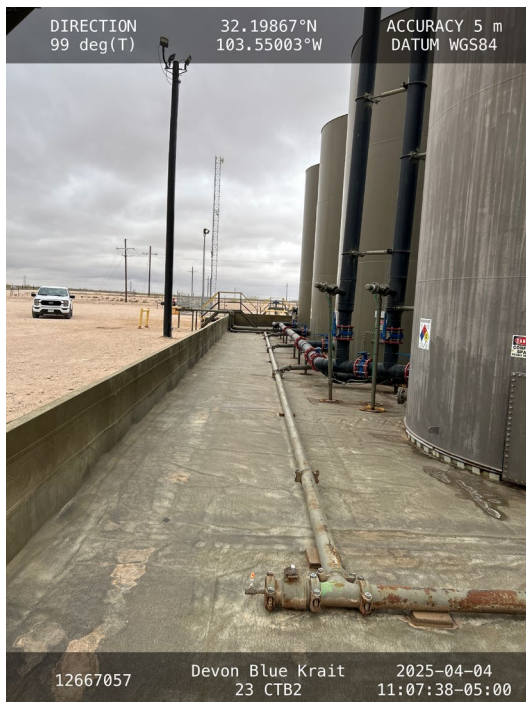
Photo 7 View of north side secondary containment facing east.

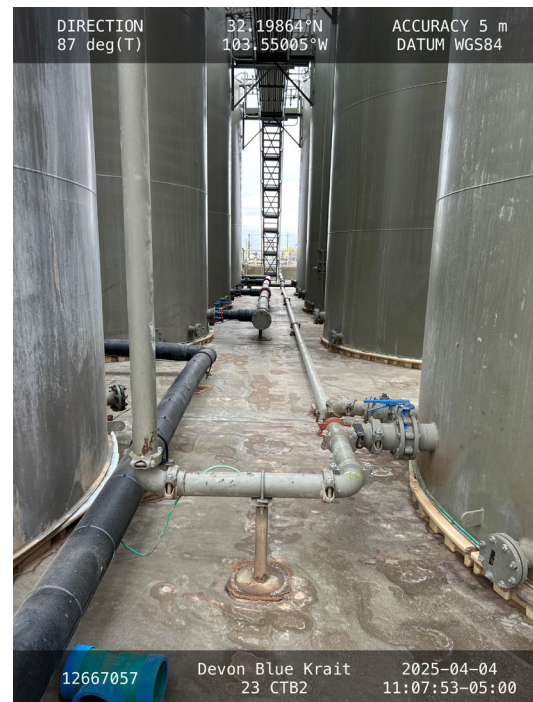
Photo 8 View of central portion of secondary containment facing west.

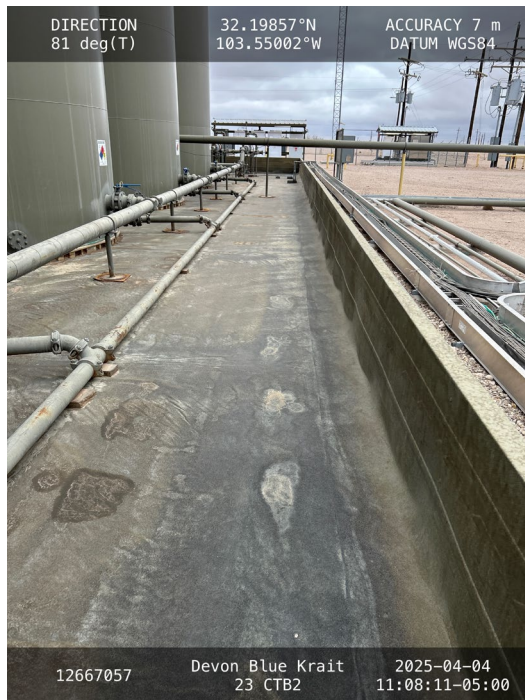
Photo 9 View of south side secondary containment facing east.

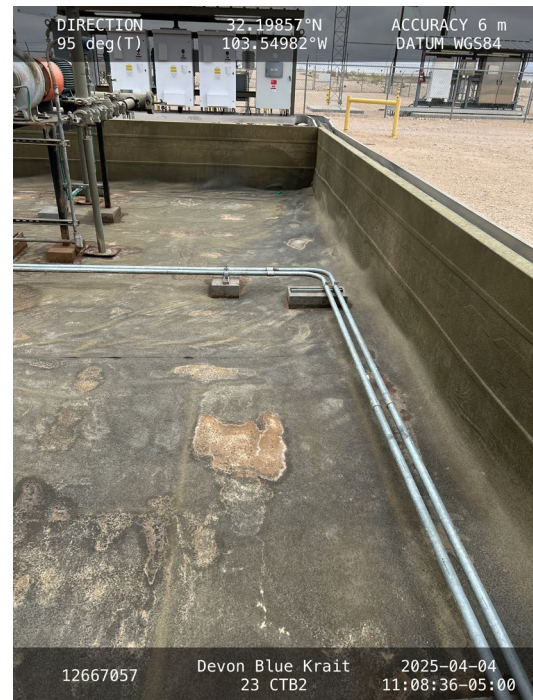
Photo 10 View of southeastern corner of secondary containment.

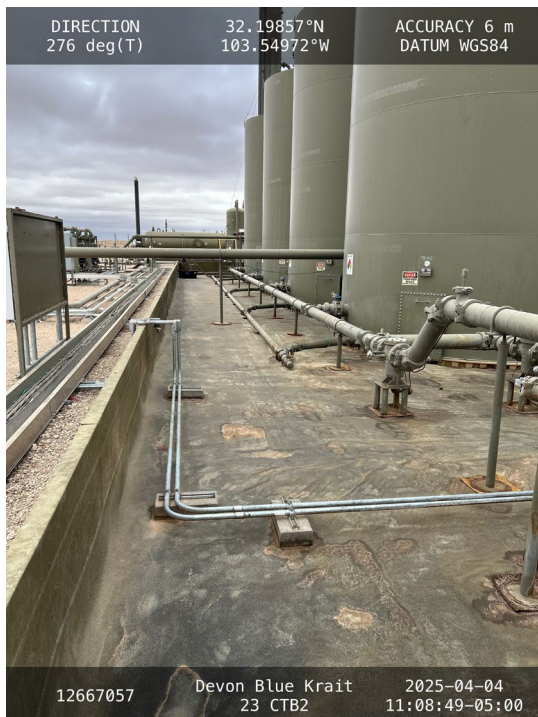
Photo 11 View of south side of secondary containment facing west.

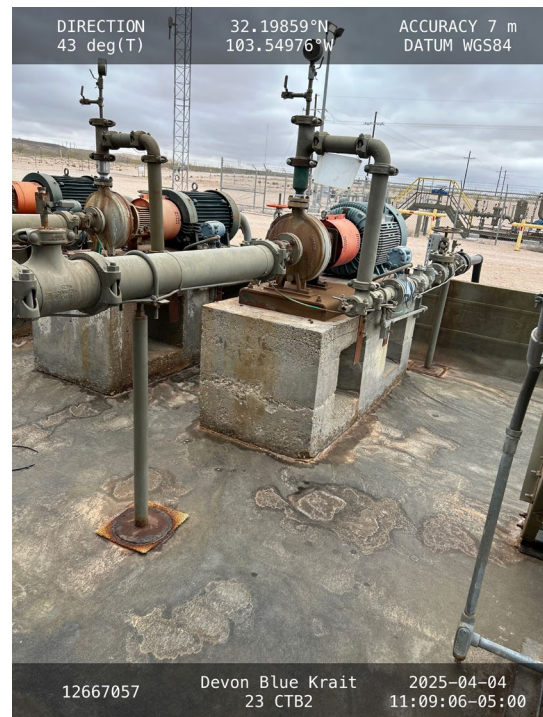
Photo 12 View of east side of secondary containment.
