Our Ref.: 12664976-NMOCD-1

May 20, 2025

Closure Report
Devon Energy Production Company, LP
Tomb Raider 12-1 CTB 1
Unit Letter N, Section 13, T23S, R31E
Eddy County, New Mexico
(32.30914, -103.72744)

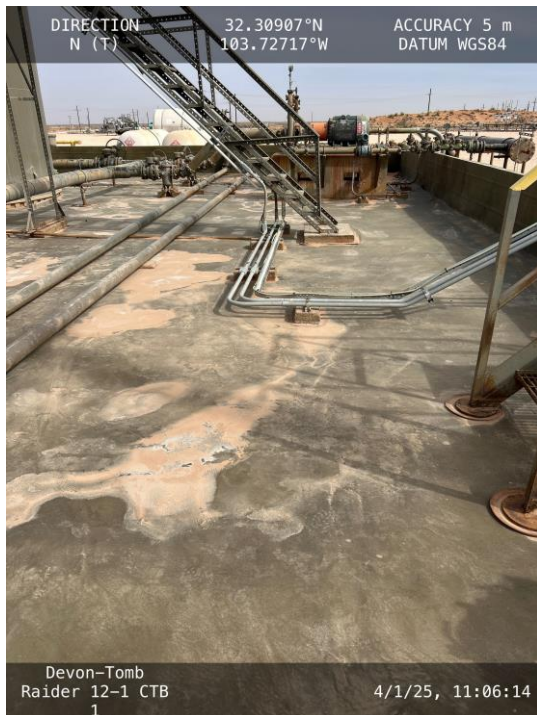
The liner inspection notice was provided on March 26, 2025. A liner integrity inspection was conducted on April 1, 2025. The liner was visually inspected and no rips, tears, holes, or damage in the liner was observed. The liner was determined to be intact with no integrity issues. Photographic documentation of the liner inspection is presented in **Attachment C**.

Photo 1 View of east side of secondary containment facing north.

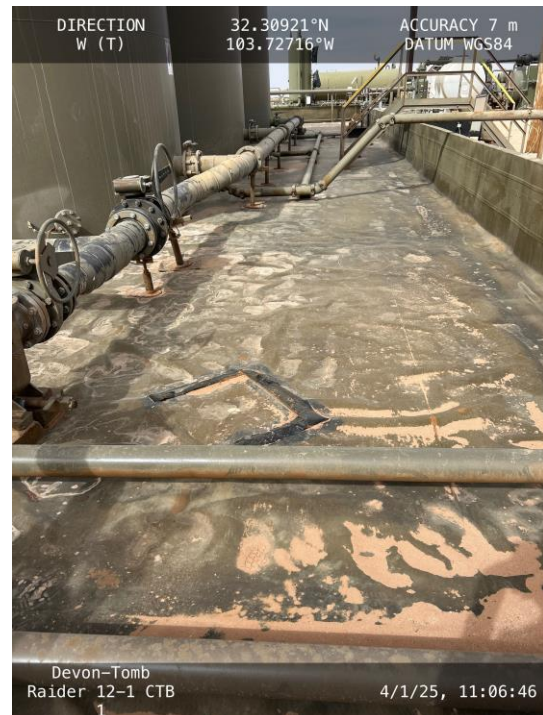
Photo 2 View of north side of secondary containment towards west.

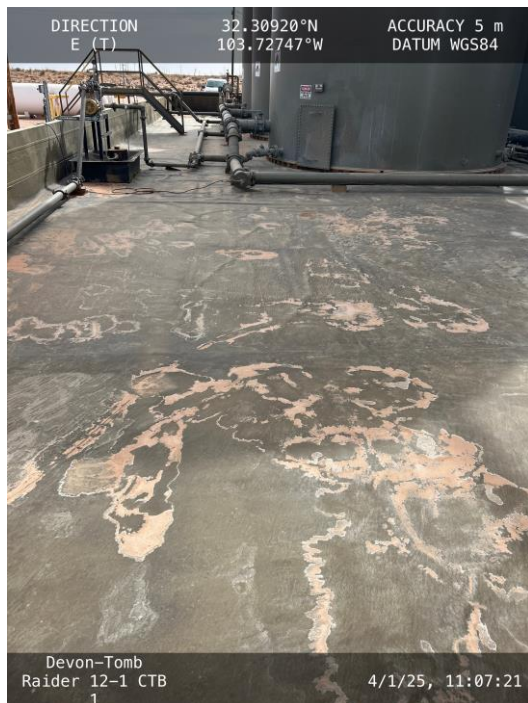
Photo 3 View of northwest corner of secondary containment.

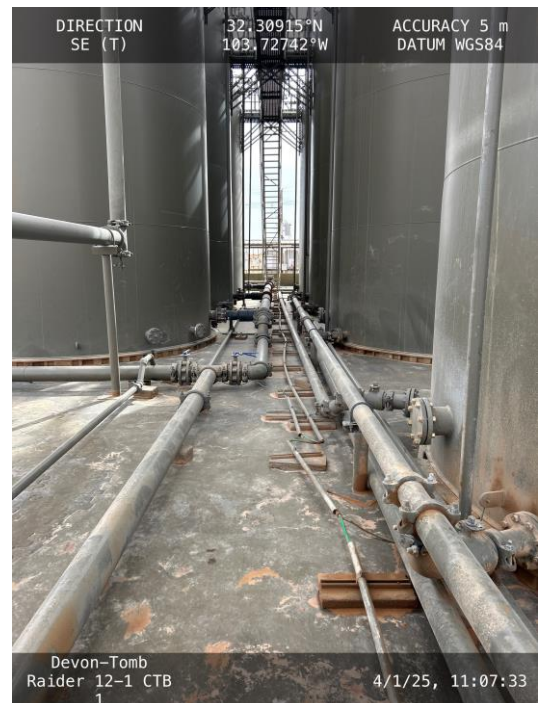
Photo 4 View of central portion of secondary containment.

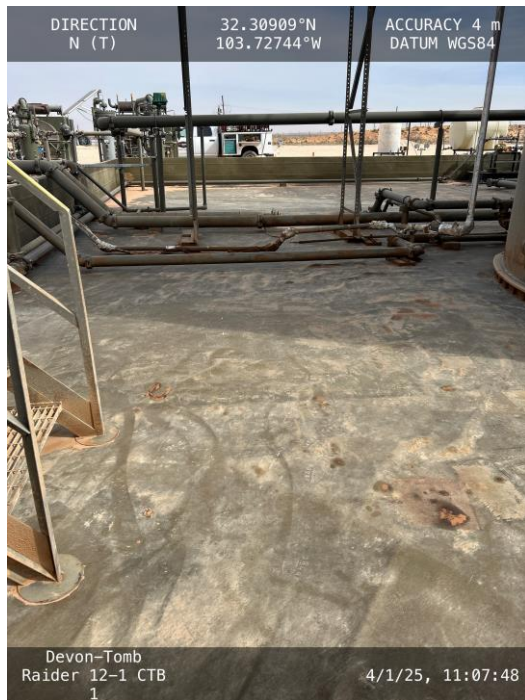
Photo 5 View of west side secondary containment facing north.

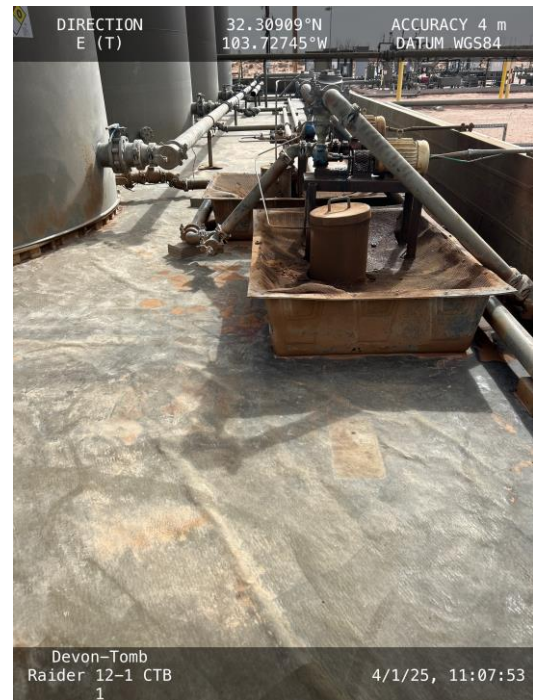
Photo 6 View of south side secondary containment facing east.

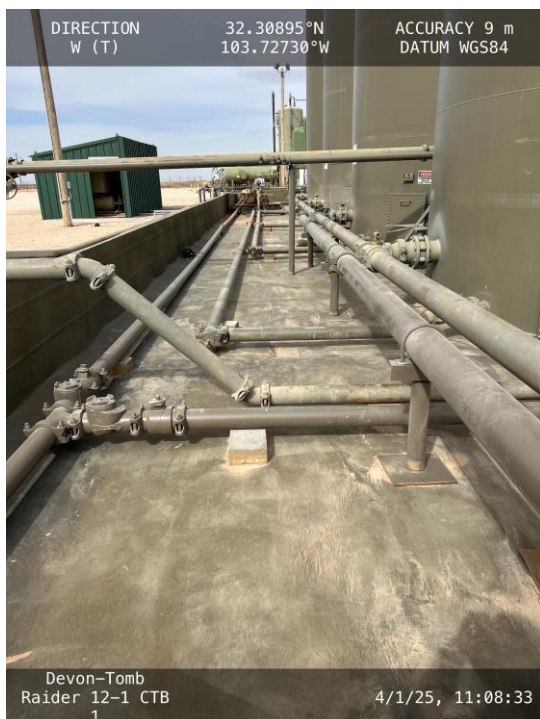
Photo 7 View of south side secondary containment facing west.

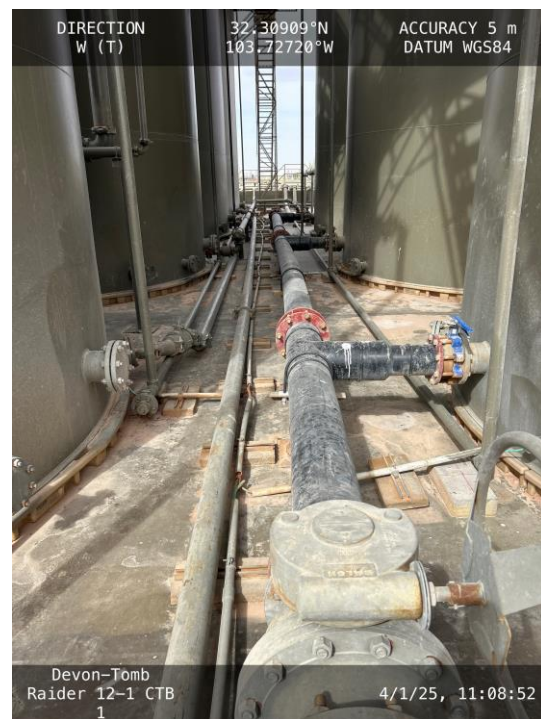
Photo 8 View of central portion of secondary containment.
