Re: Incident Closure Report

Devon Energy Production Company, LP

Marwari 28 CTB 2

Incident ID: nAPP2417749853

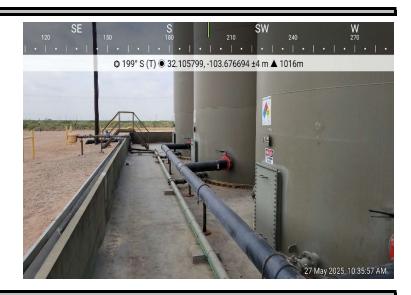
Photograph No. 1

Description: View of Liner

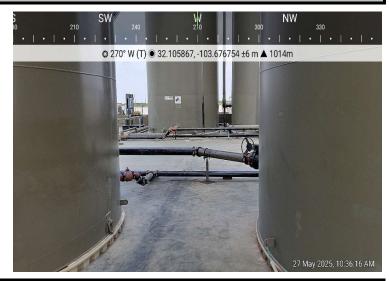
Photograph No. 2

Description: View of Liner

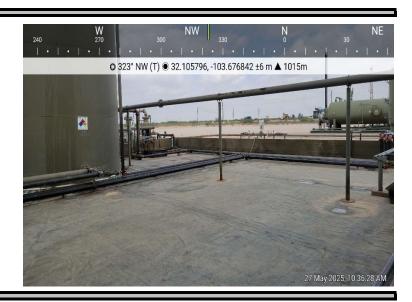
Photograph No. 4

Description: View of Liner

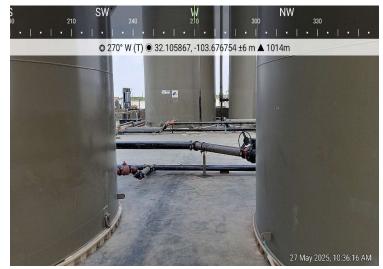
Photograph No. 5

Description: View of Liner

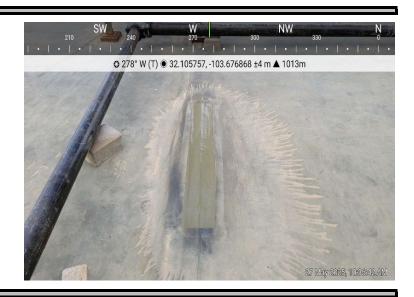
Photograph No. 7

Description: View

of Liner

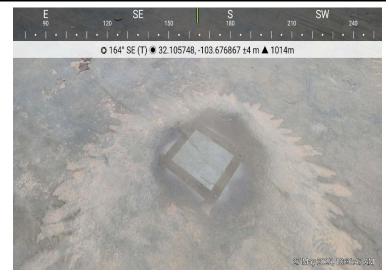
Photograph No. 8

Description: View

of Liner

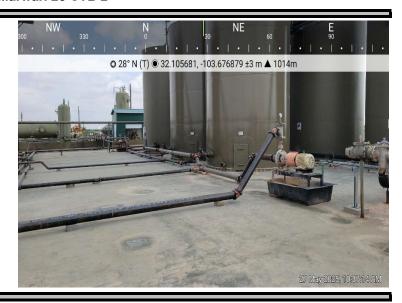
Photograph No. 10

Description: View of Liner

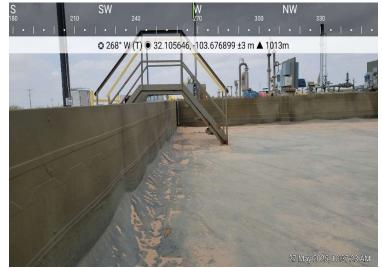
Photograph No. 11

Description: View of Liner Wall
