Our Ref: 12670742–NMOCD–2

August 25, 2025

Closure Report  
Devon Energy Production Company, LP  
Serpentine 2 Facility 1  
Unit Letter O, Section 2, T23S, R33E  
GPS: 32.3296895, -103.5396478  
Lea County, New Mexico

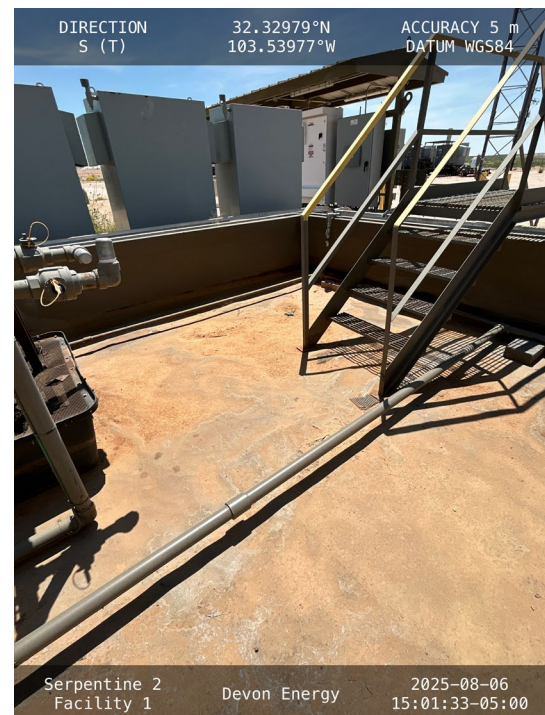
Photo 2 View of southeast corner of secondary containment.

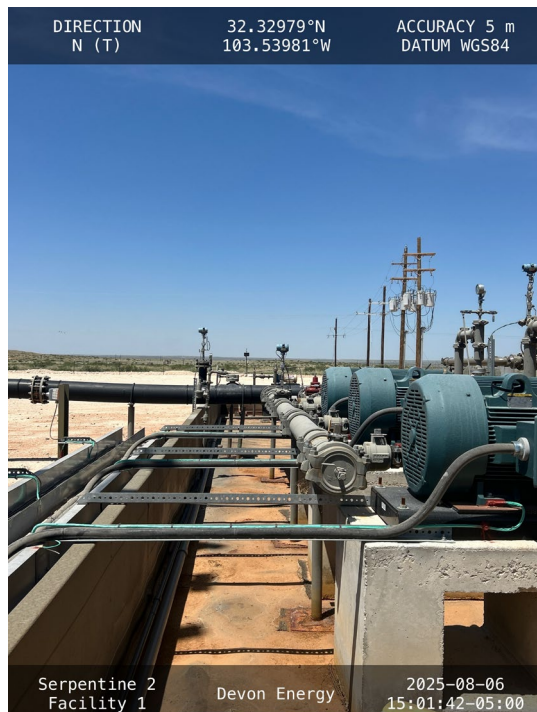
Photo 3 View of western portion of secondary containment facing north.

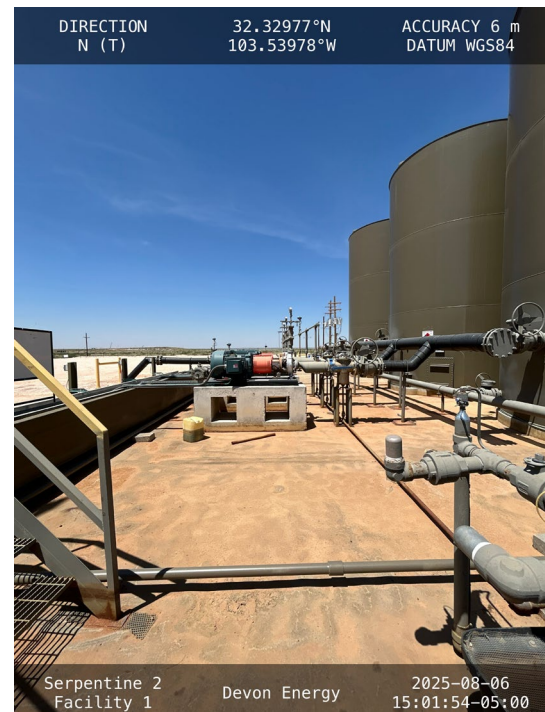
Photo 4 View of western portion of secondary containment facing north.

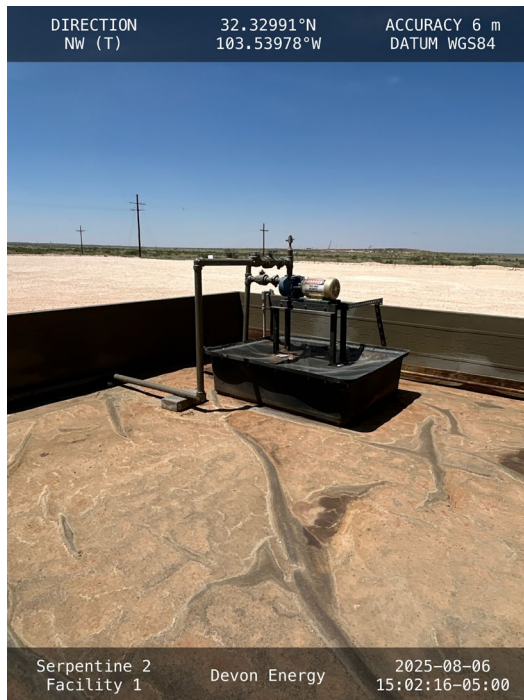
**Photo 5** View of northwest corner of secondary containment.

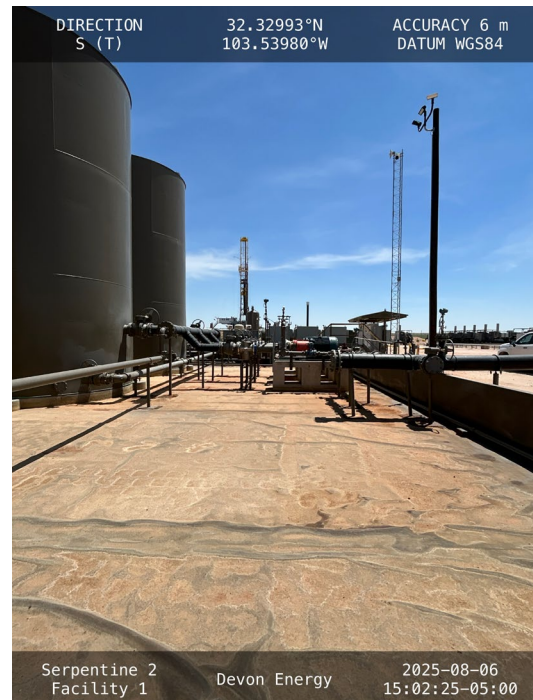
**Photo 6** View of western portion of secondary containment facing south.

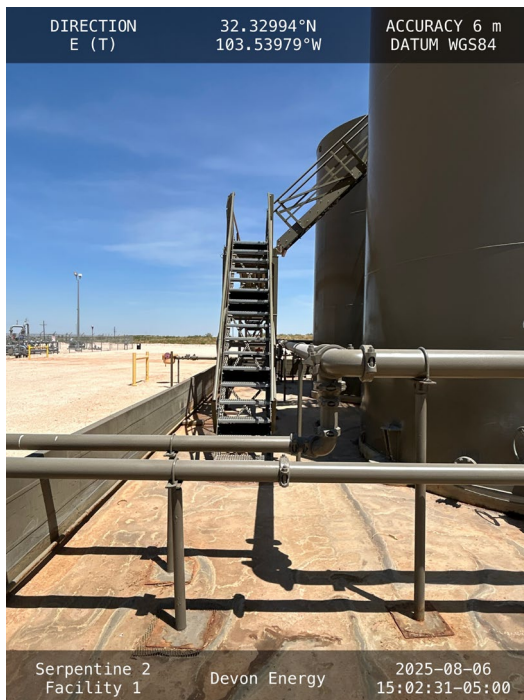
**Photo 7** View of northern portion of secondary containment facing east.

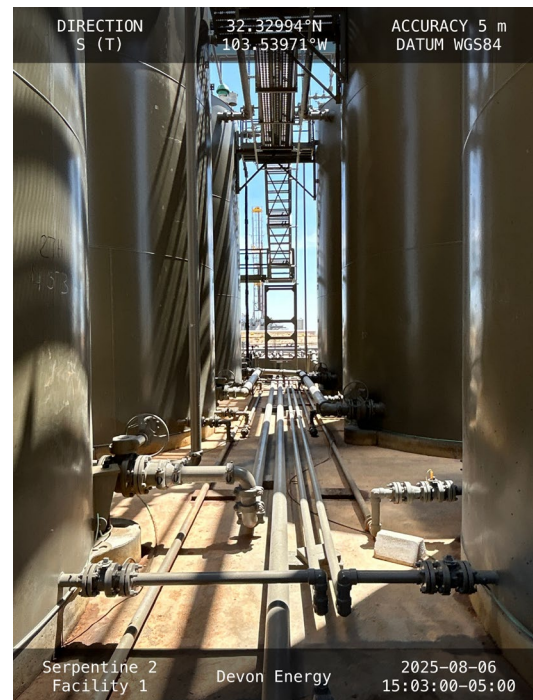
**Photo 8** View of central portion of secondary containment facing south.

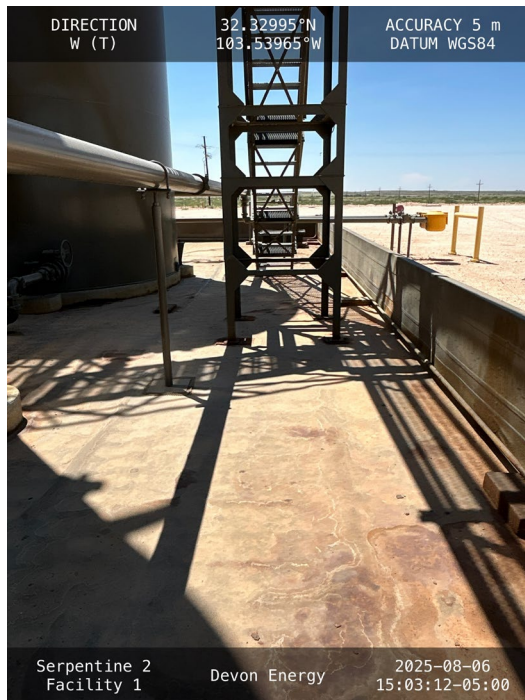
**Photo 9** View of northern portion of secondary containment facing west.

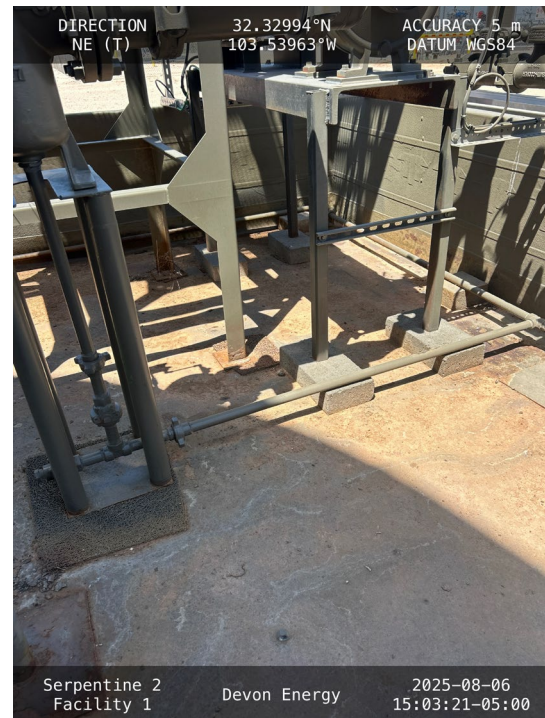
**Photo 10** View of northeast corner of secondary containment.

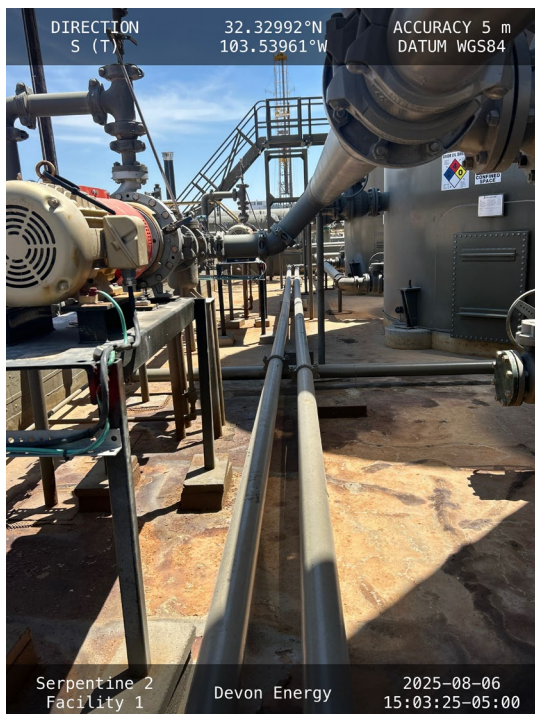
**Photo 11** View of eastern portion of secondary containment facing south.

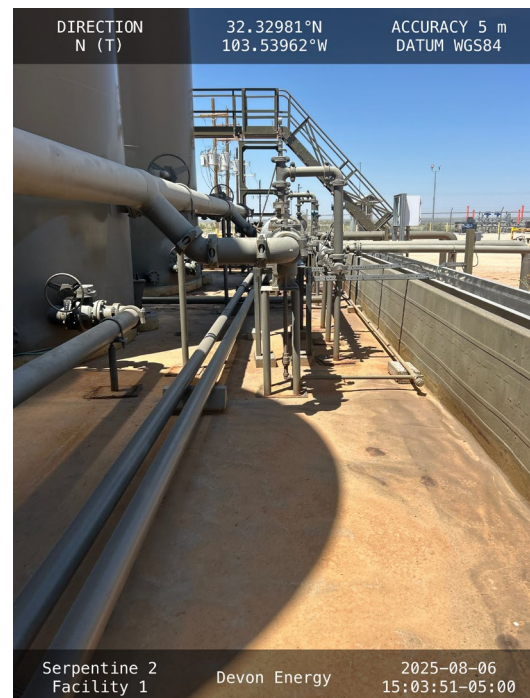
**Photo 12** View of eastern portion of secondary containment facing north.

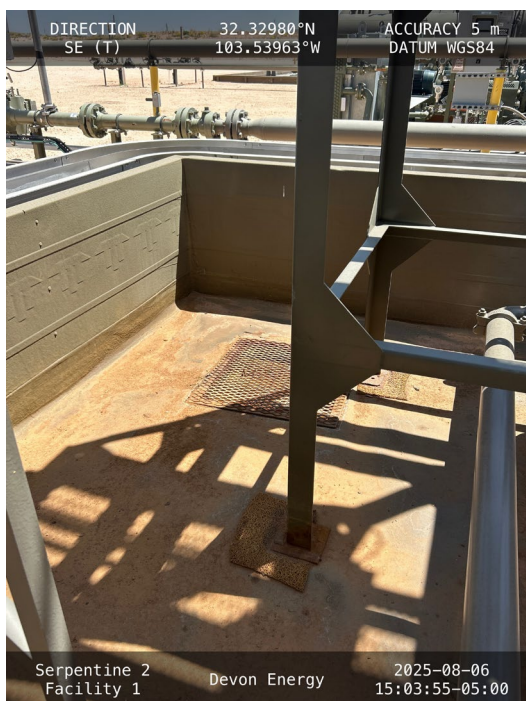
**Photo 13** View of southeast corner of secondary containment.

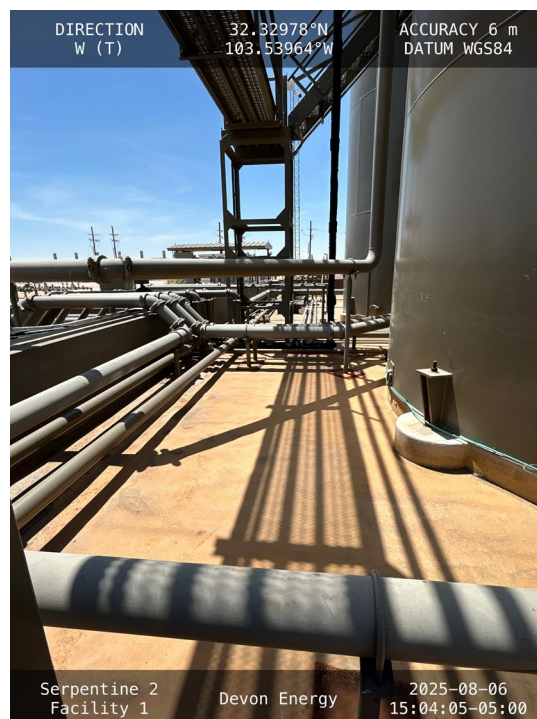
**Photo 14** View of southern portion of secondary containment facing west.
