# CLOSURE REQUEST REPORT

*Devon Energy Production Company, LP*

**Flagler 8 CTB 1**

**Incident Number nAPP2517871293**

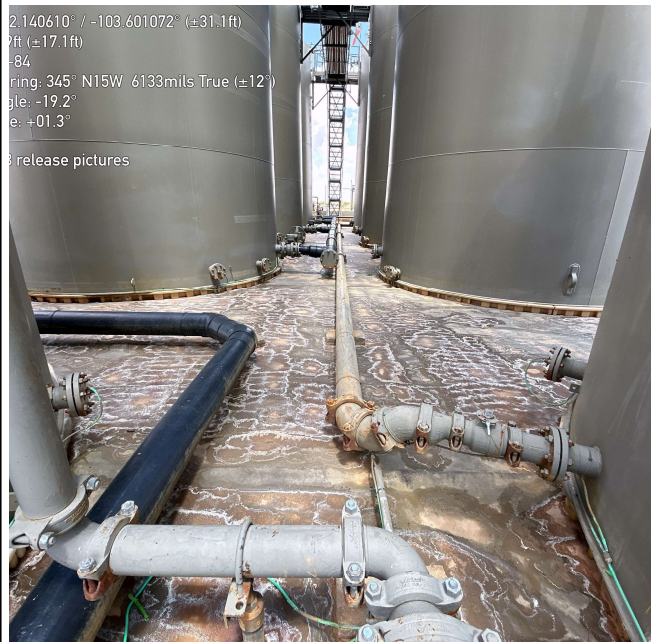
**Photograph 1** Date: 08/15/2025  
 Description: Northern view of tank battery liner.

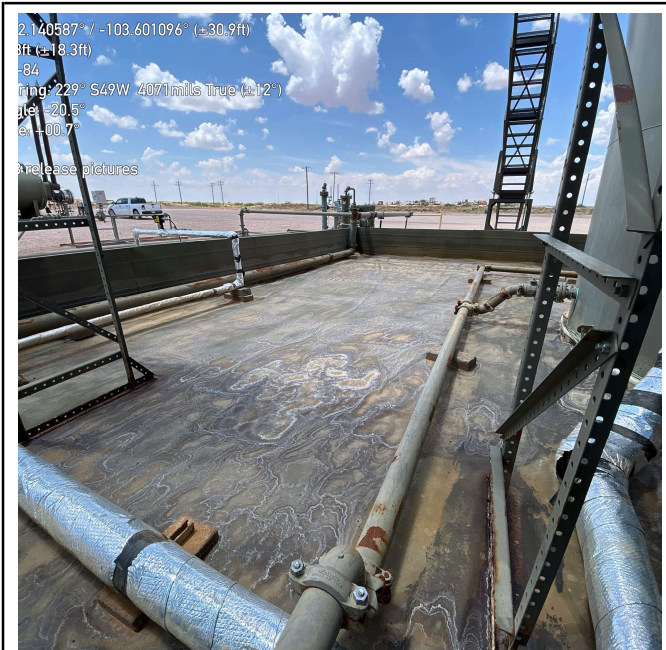
**Photograph 2** Date: 08/15/2025  
 Description: Southwestern view of tank battery liner.

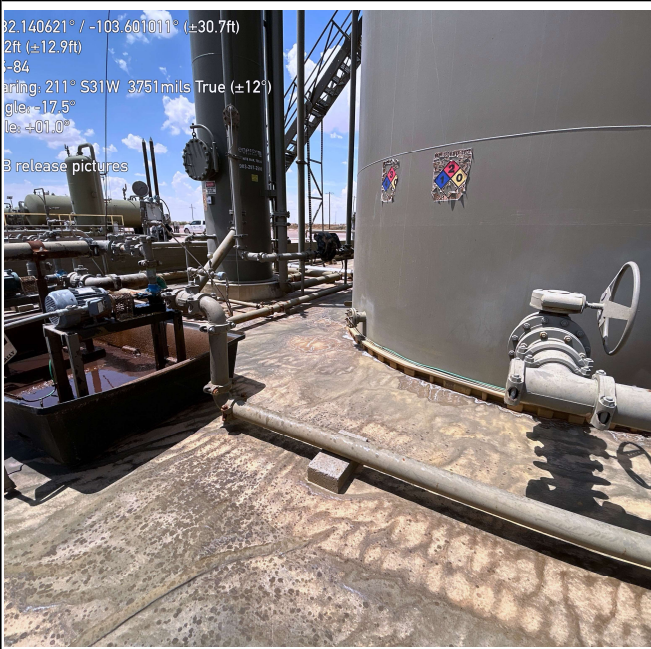
**Photograph 3** Date: 08/15/2025  
 Description: Southwestern view of liner during inspection.

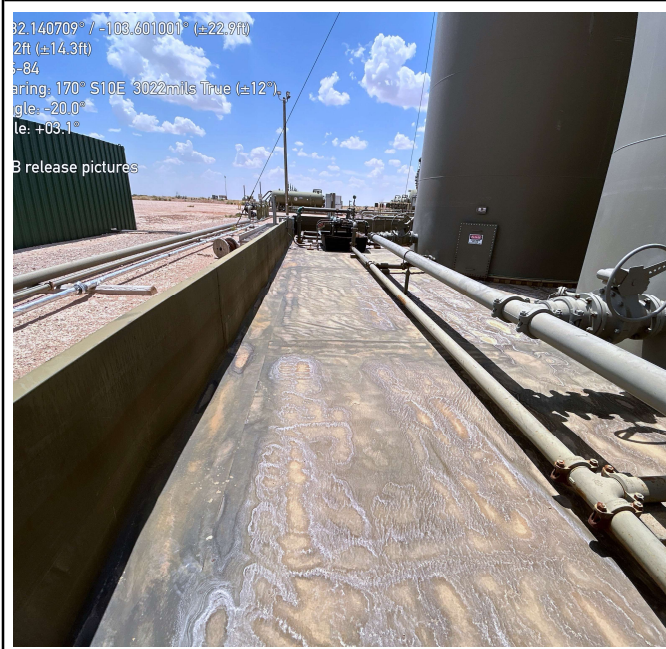
**Photograph 4** Date: 08/15/2025  
 Description: Southern view of liner during inspection.
