SUBJECT: Liner Inspection and Closure Report for Mimosa 18 CTB 1 – July 18, 2025 Site Visit

Incident ID: nAPP2518246083  
Facility ID (Name): fAPP2405030777 (MIMOSA 18 CTB 1)  
Facility Location: Unit F of Section 18, Township 20 South, Range 30 East, New Mexico  
Facility GPS Coordinates: 32.57435467, -104.0141241  
Eddy County, New Mexico

# Environmental Liner Inspection

## Field Notes & Photolog Report

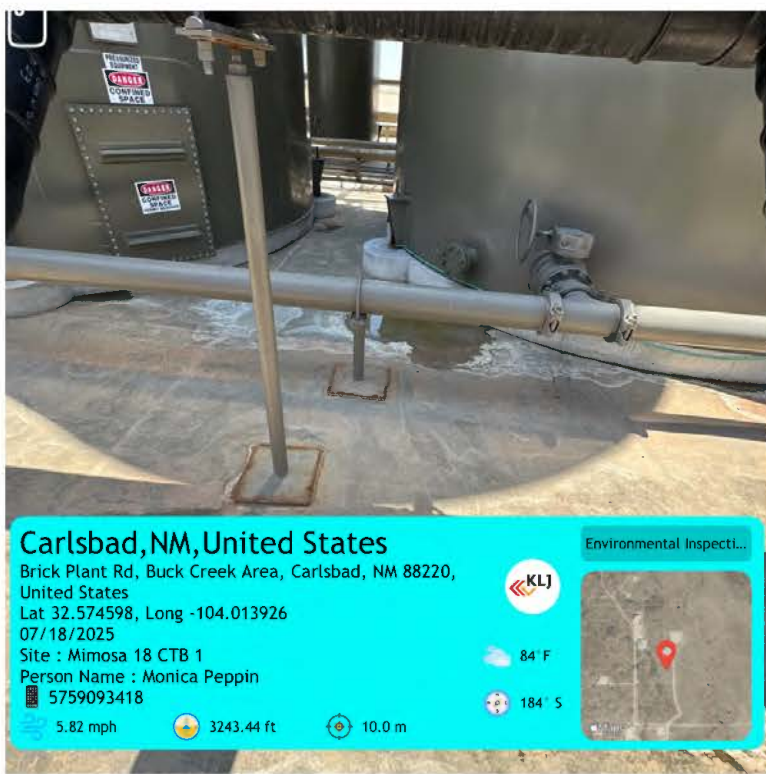
Liner facing south from north side.

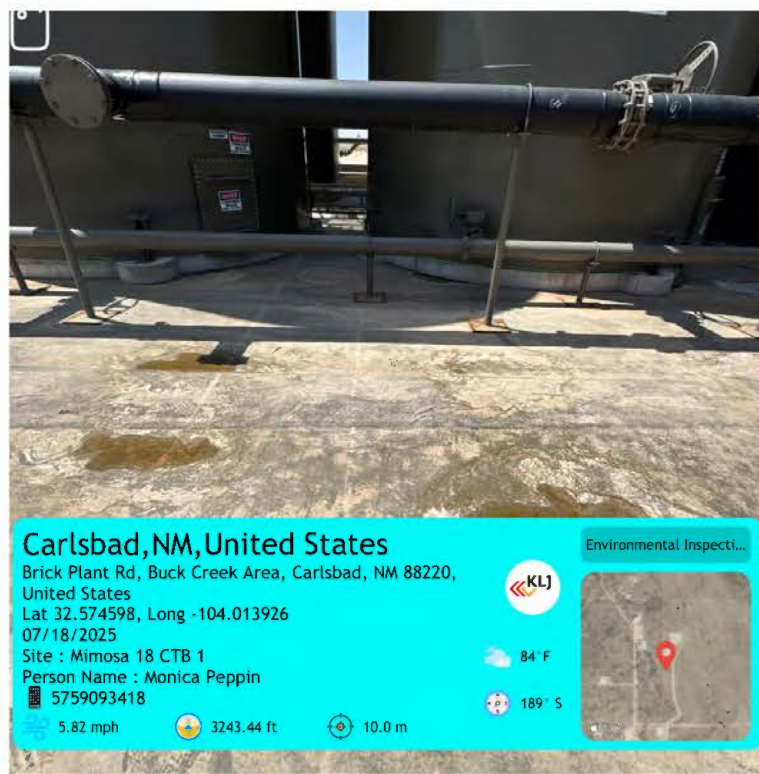
South view of liner between tanks.

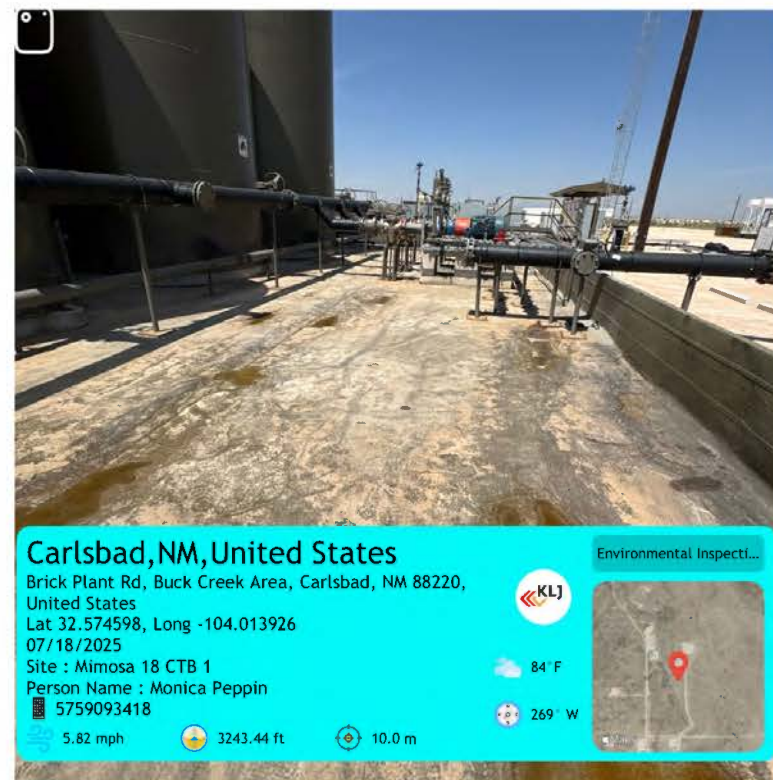
Liner on north end of containment from east corner facing west.

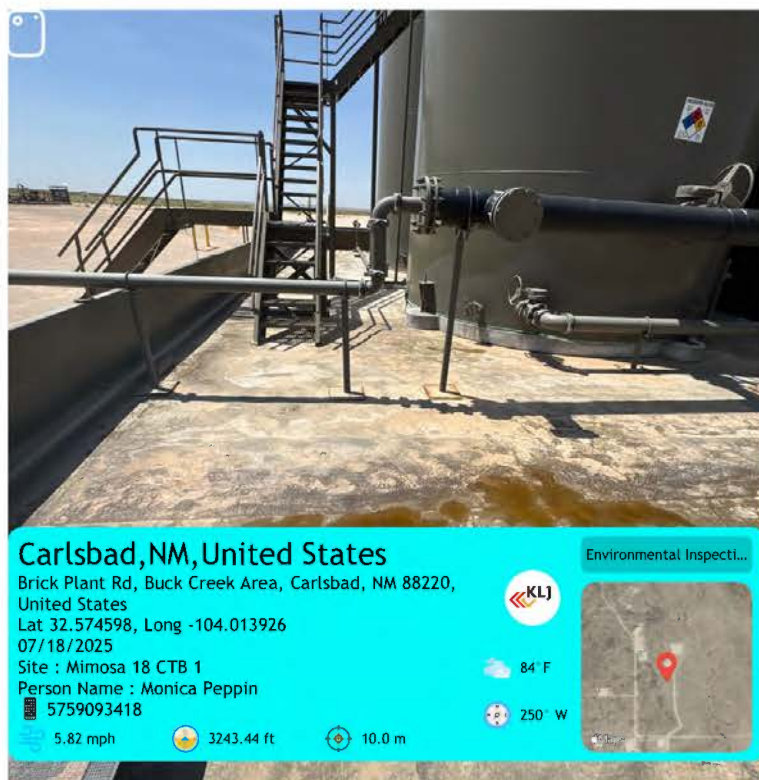
South end of containment view facing west from east corner.

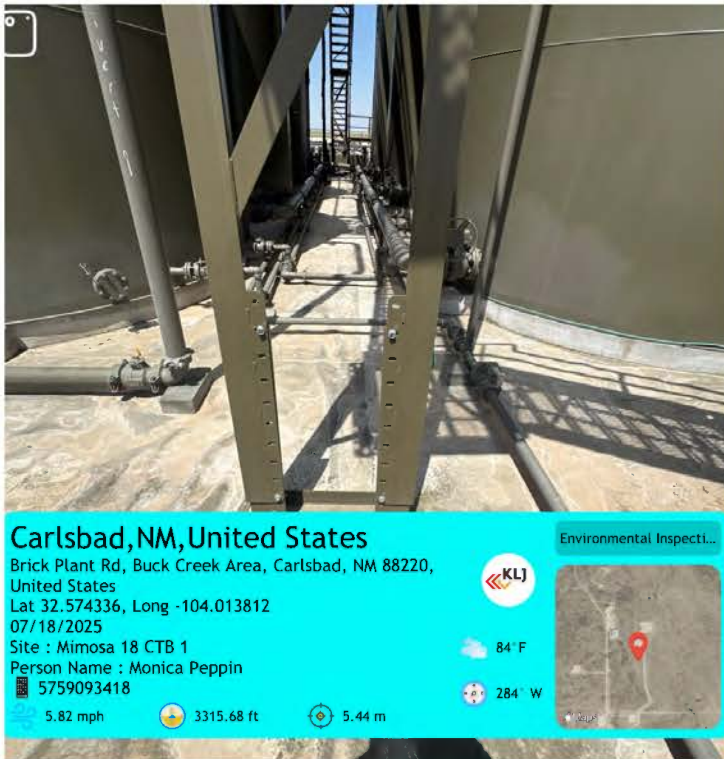
West view of liner from east side  
between tanks.

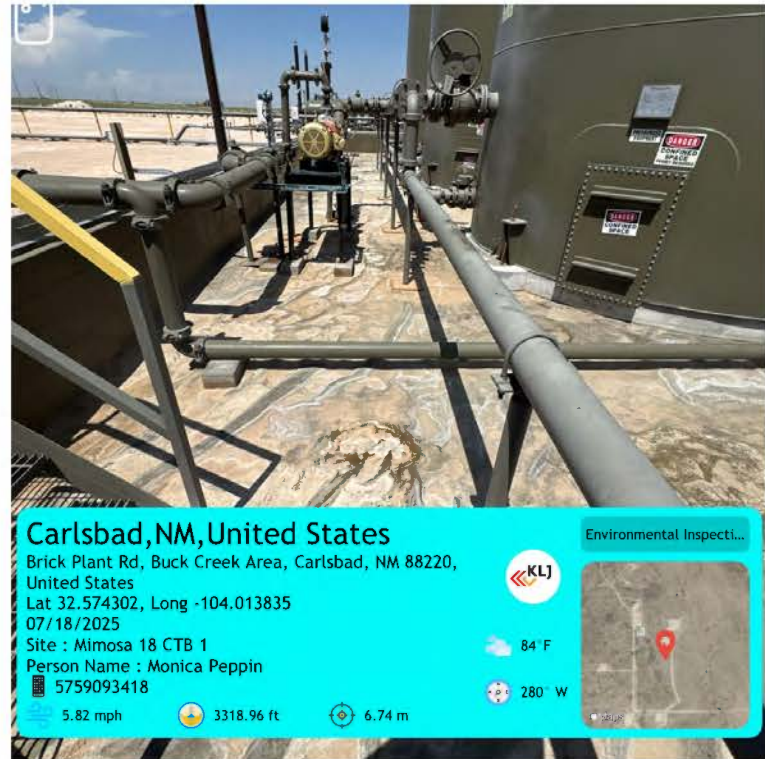
South end of containment facing west

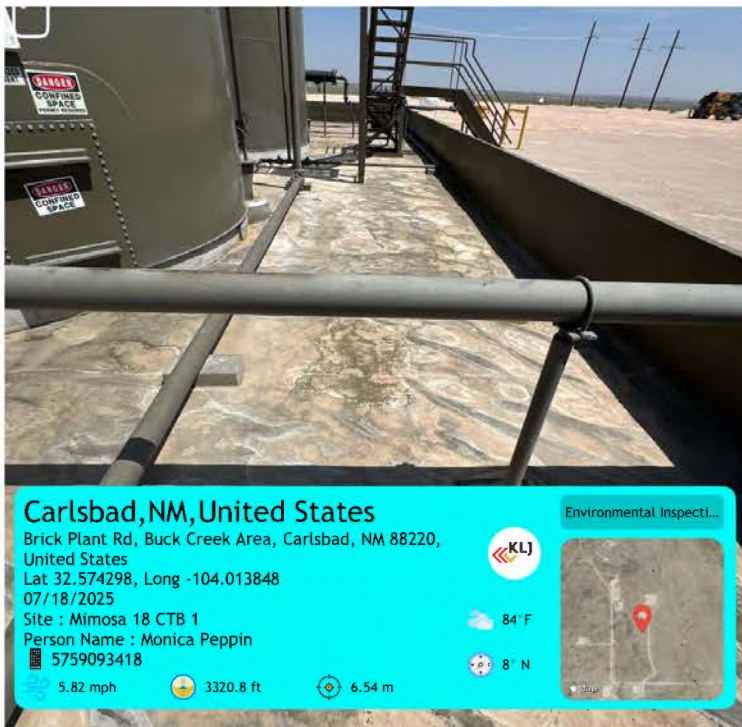
Liner on east end facing north from  
southeast corner.

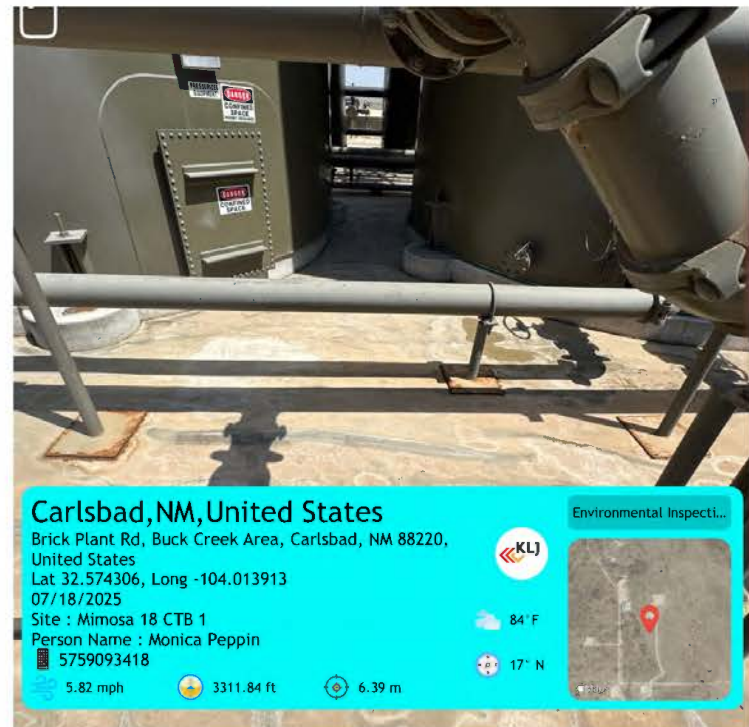
Facing north viewing liner between tanks  
from south side.

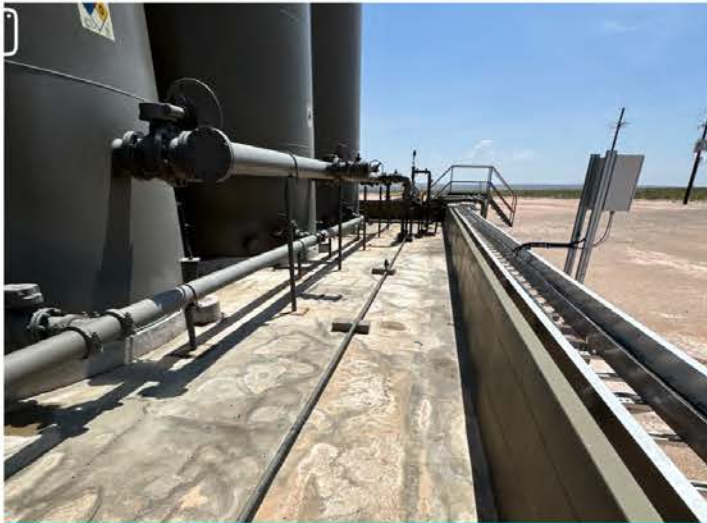
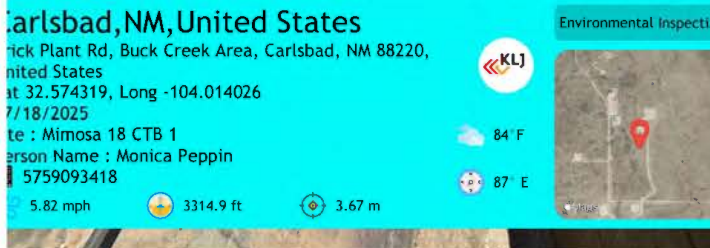
Facing east from northwest corner of south wall.

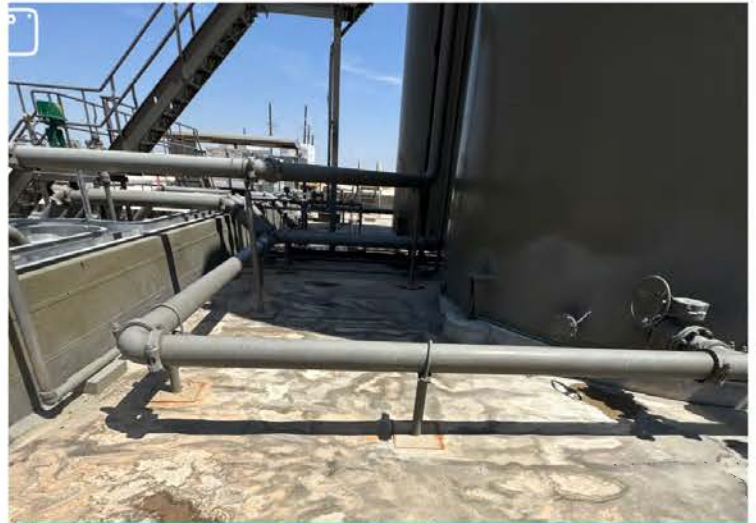
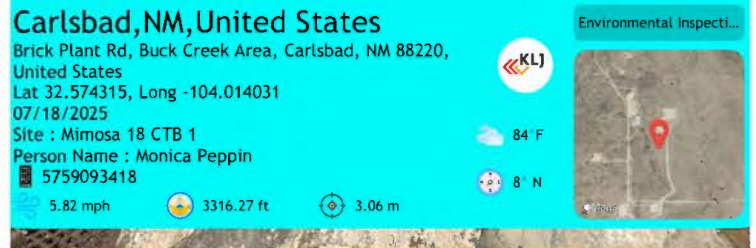
Facing north viewing west wall.

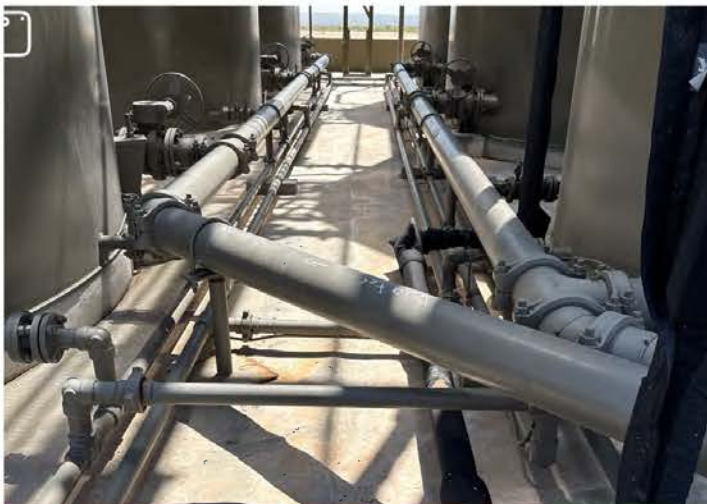
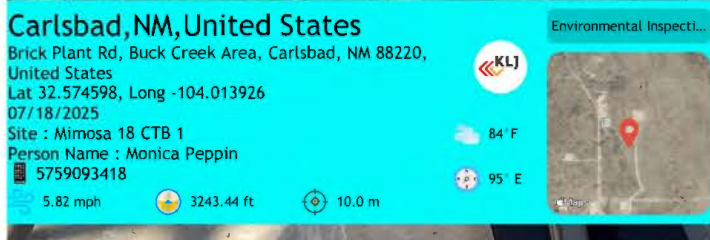
Liner between tanks facing east from west end.

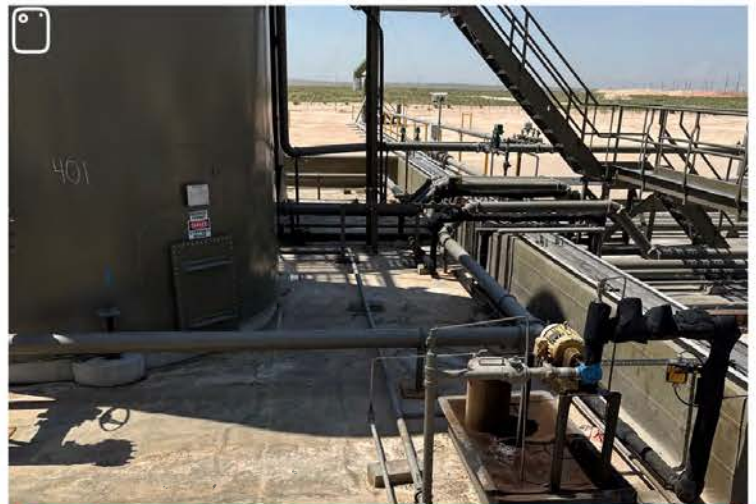
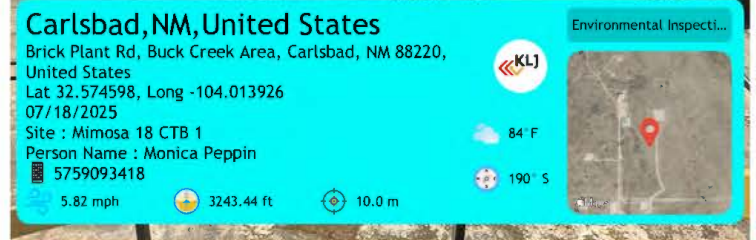
Liner on west side from northwest corner.

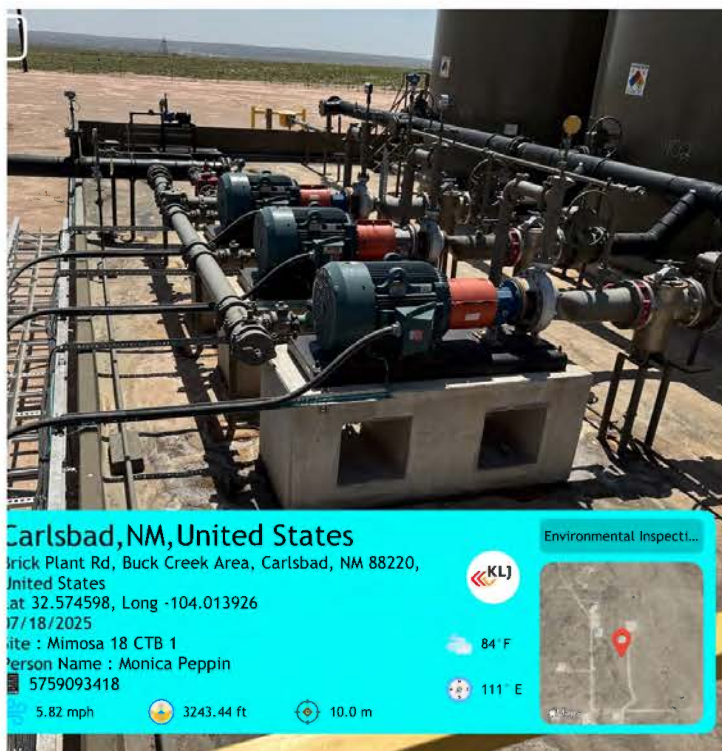
North end of containment facing west near transfer pumps.

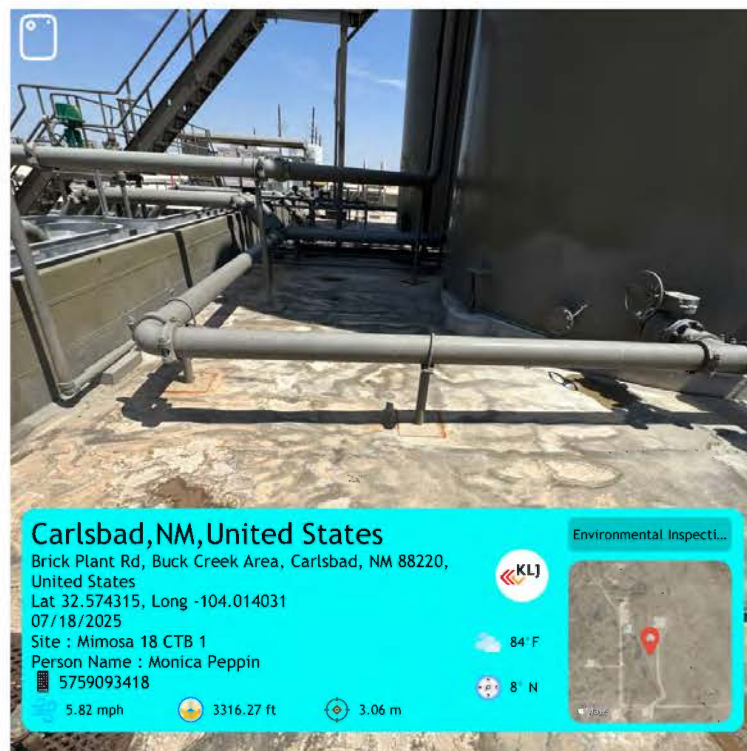
Facing north view of west wall from southwest corner.

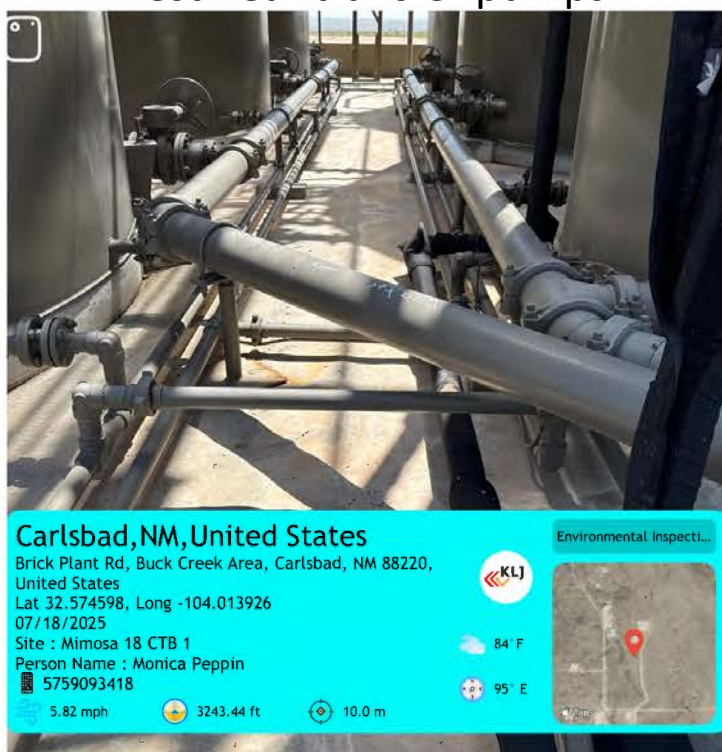
Liner between tanks from south end facing north.

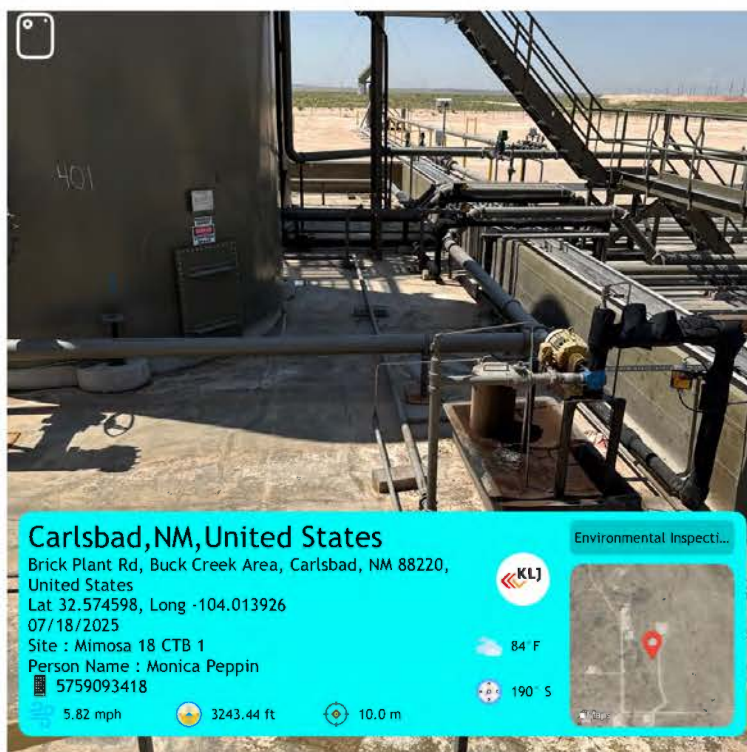
Liner from outside containment facing north.
