**Re: Site Assessment and Closure Report**  
**BKU 13A Battery**  
**API No. 30-015-02971**  
**GPS: Latitude 32.83649 Longitude -104.02642**  
**UL "G", Sec. 13, T17S, R29E**  
**Eddy County, NM**  
**NMOCD Ref. No. NAPP2513335730**

Paragon Environmental, LLC (Paragon) has been contracted by Spur Energy Partners (Spur) to perform a spill assessment, conduct remediation activities and write a closure report for the release site known as the BKU 13A Battery (BKU). Details of the release are summarized below:

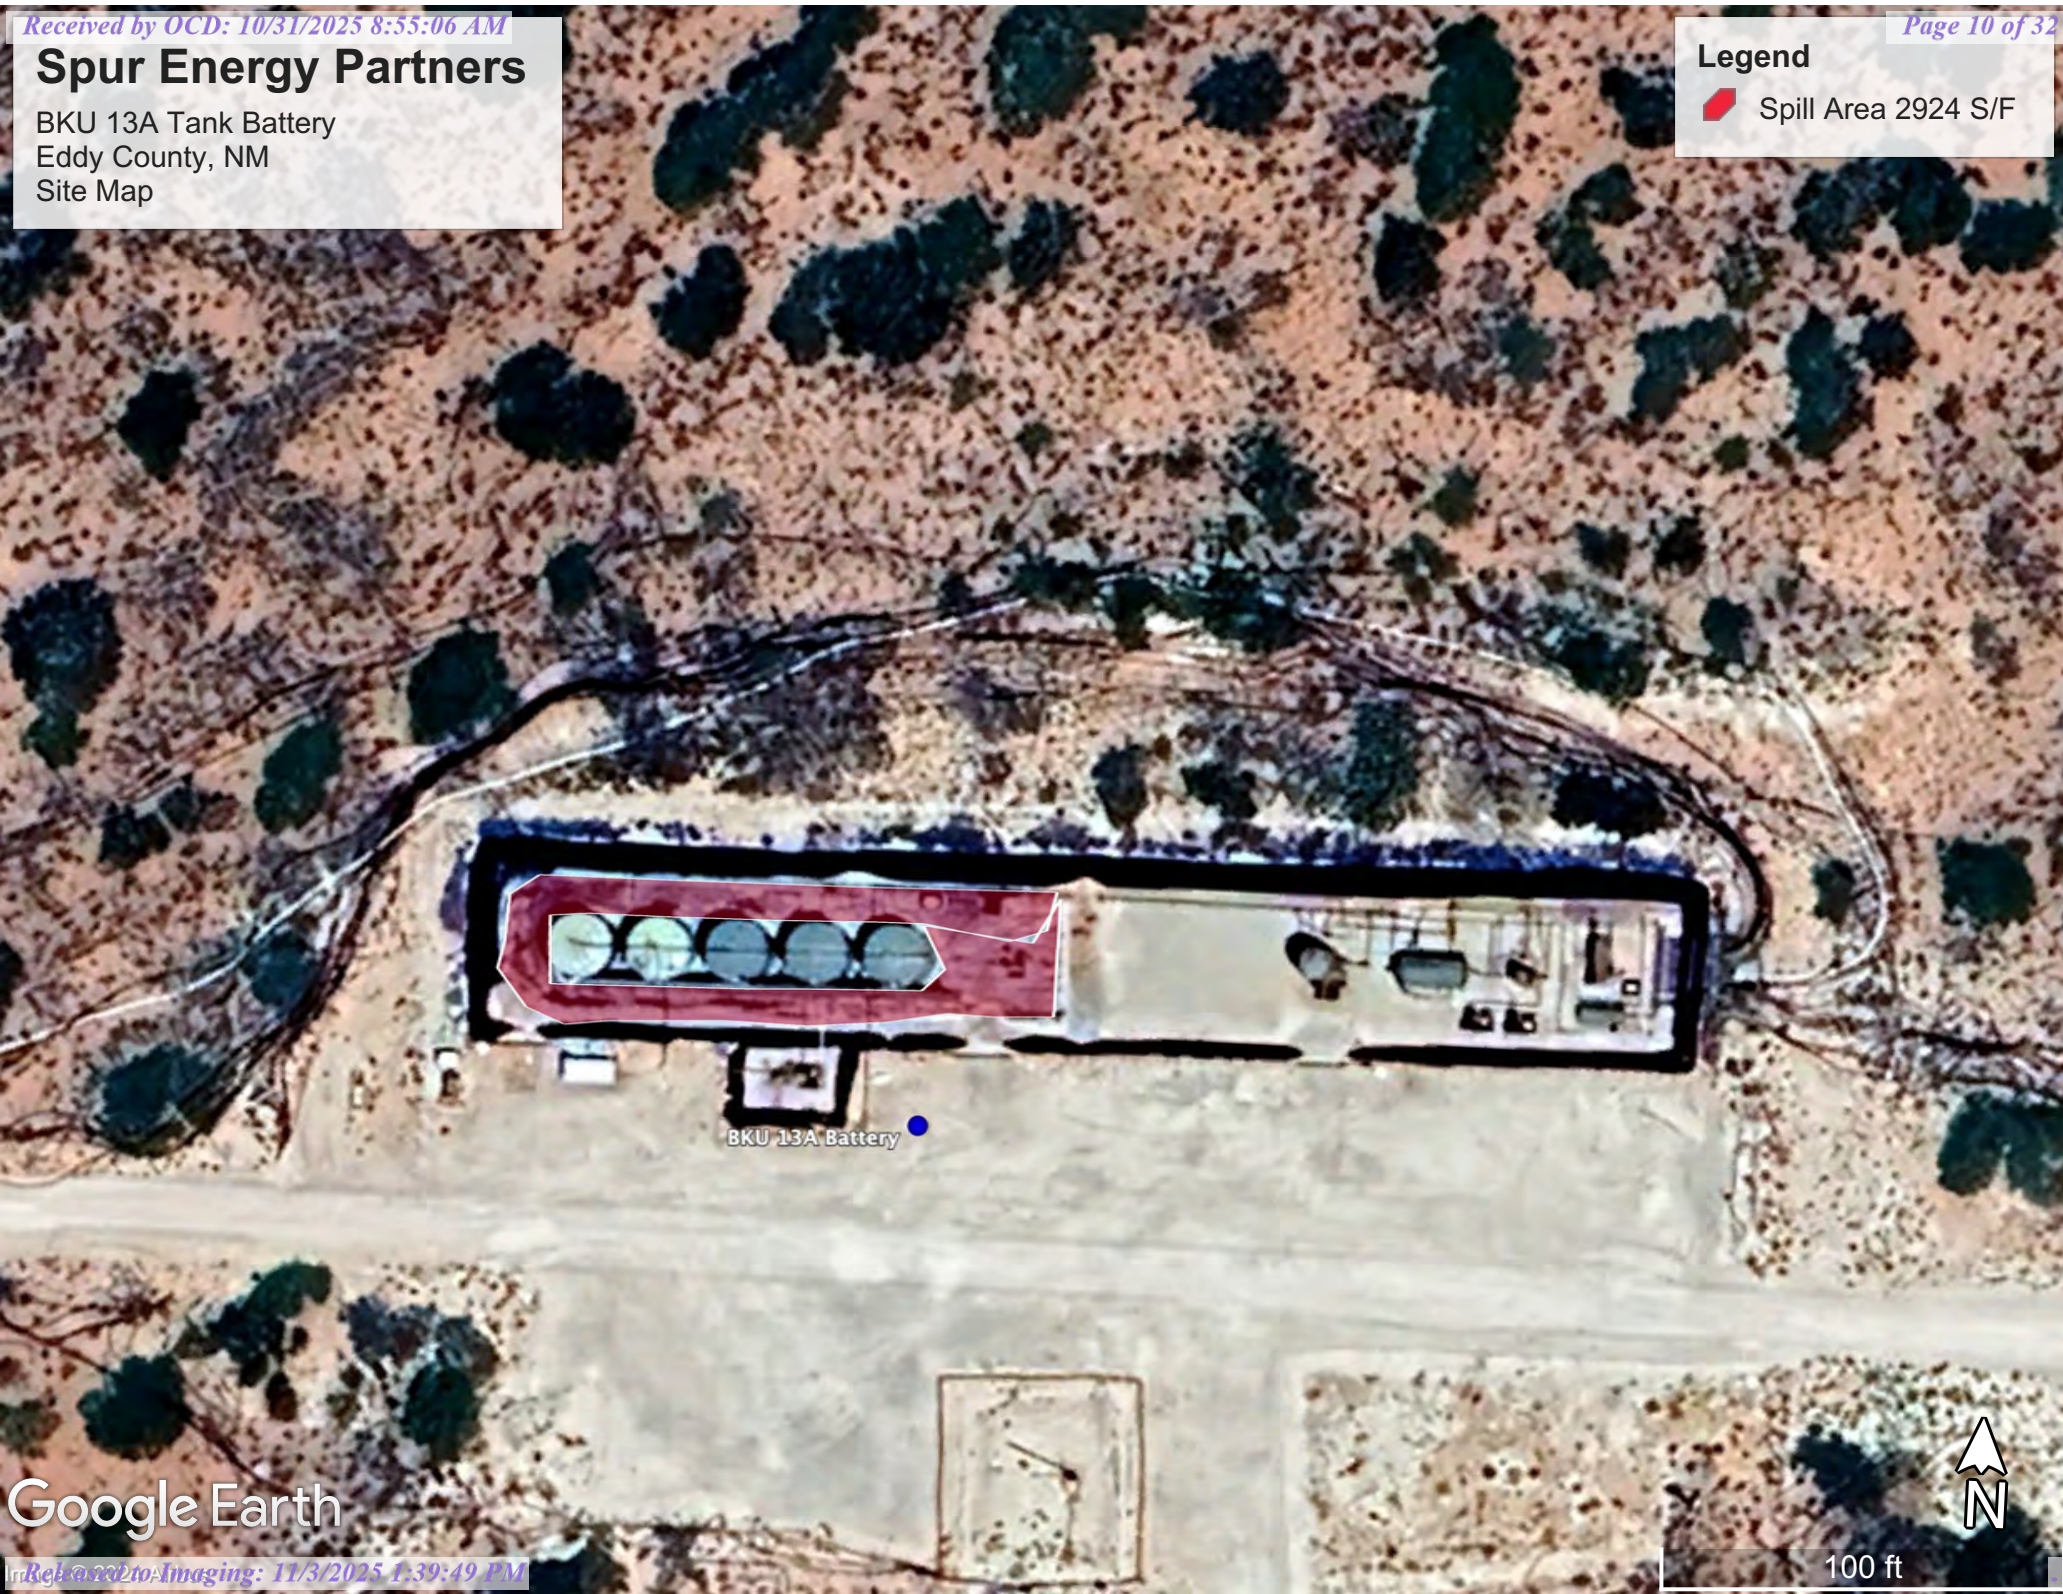
BKU 13A Tank Battery  
Eddy County, NM  
Site Map

Spill Area 2924 S/F

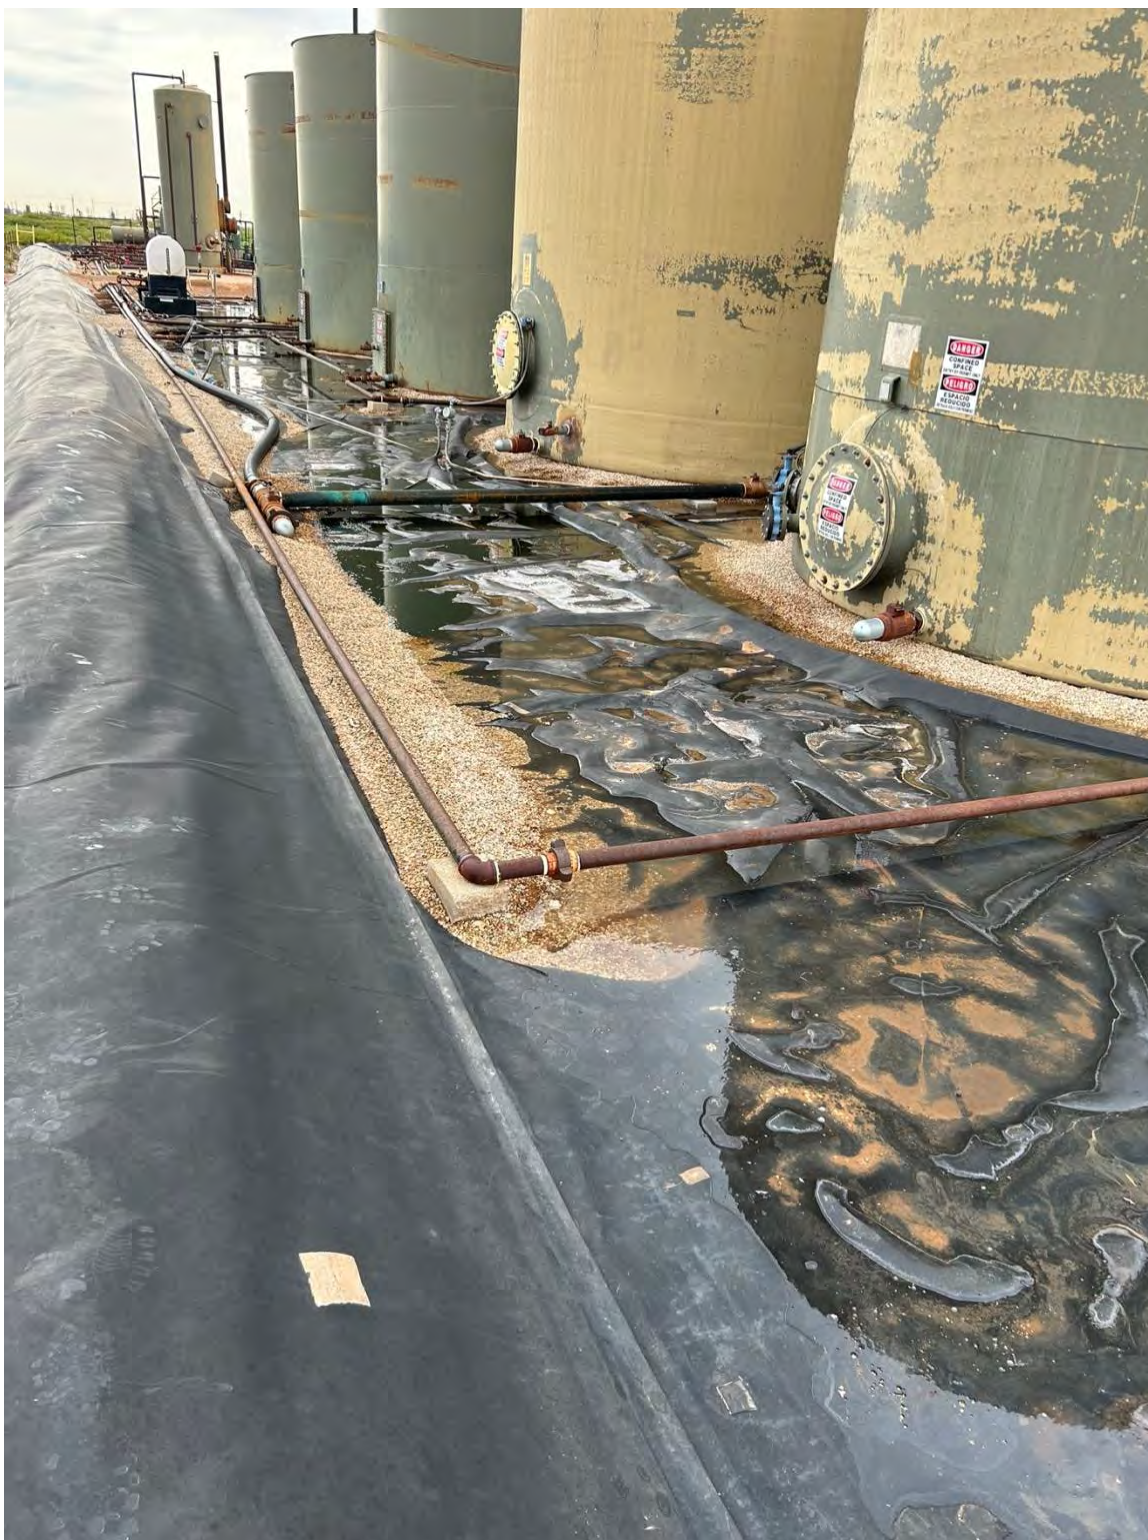
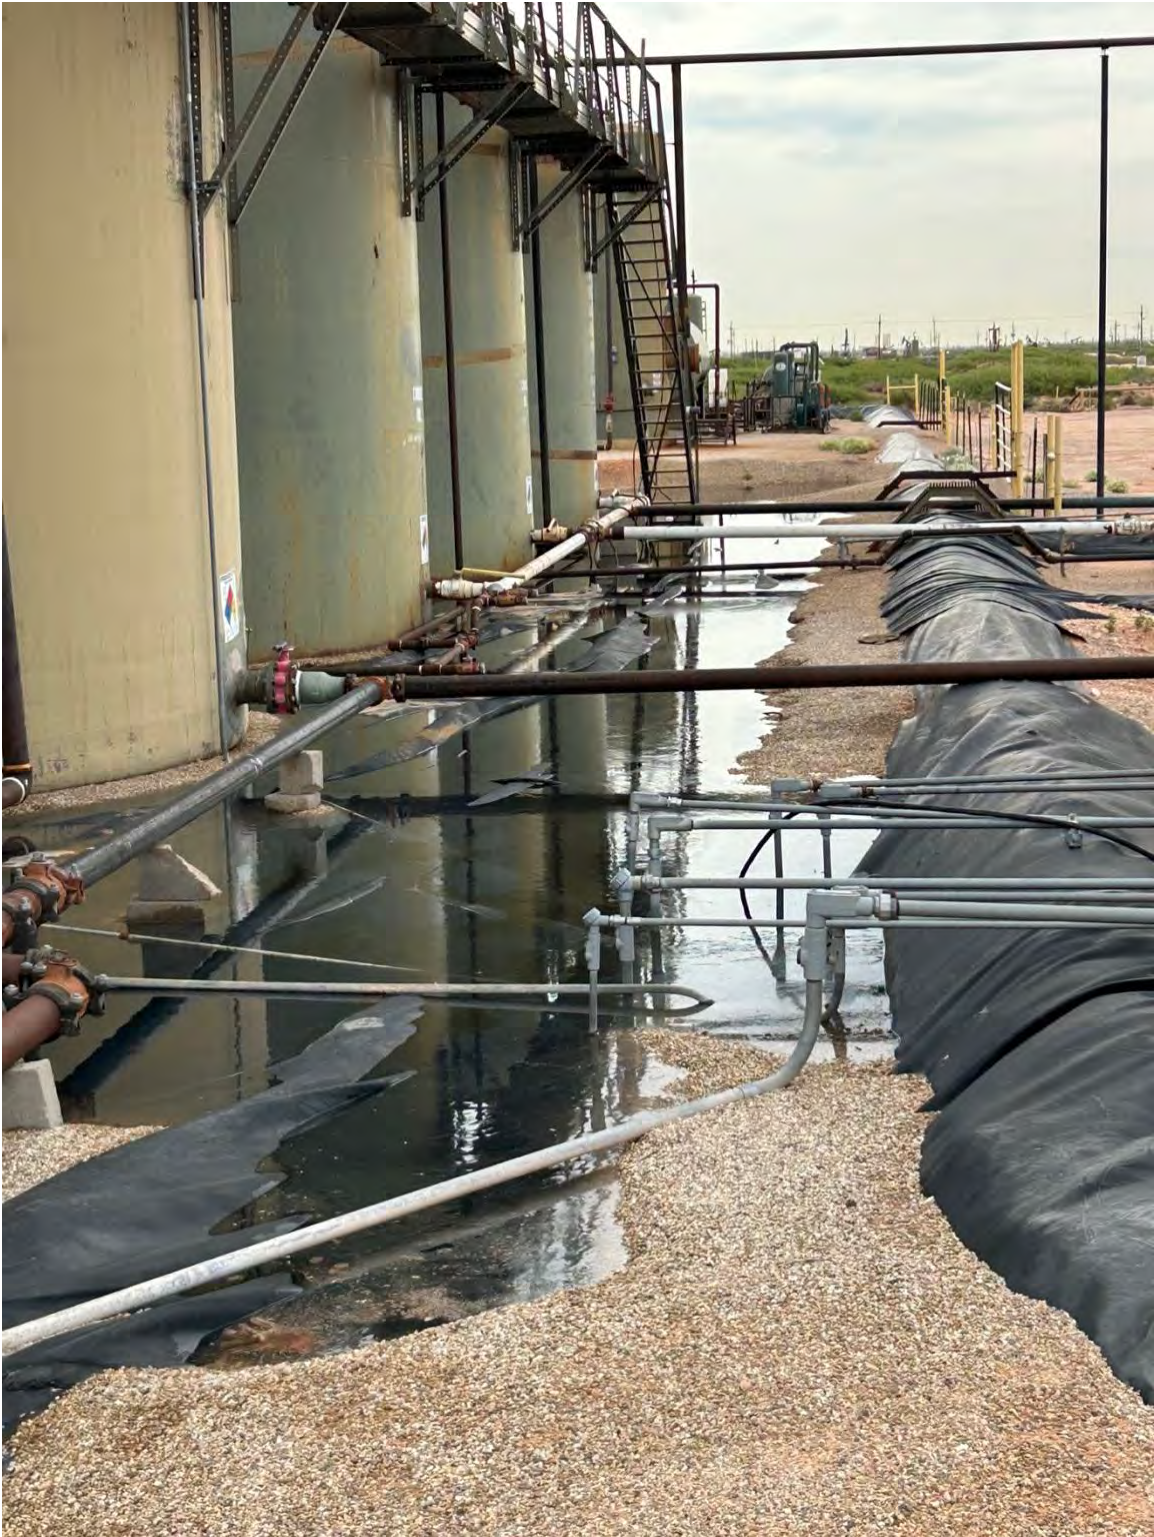
**Photographic Documentation**  
**Initial**

| Release Details | | | |
|---|---|---|---|
| 4-inch water dump line corroded, releasing produced water into the lined containment. | | | |

On May 15, 2025, Paragon visited the BKU and conducted an initial site assessment. During the initial site assessment, the liner and the surrounding location were visually inspected, and it was determined that the release had not breached the lined containment, and the liner's integrity was still intact.

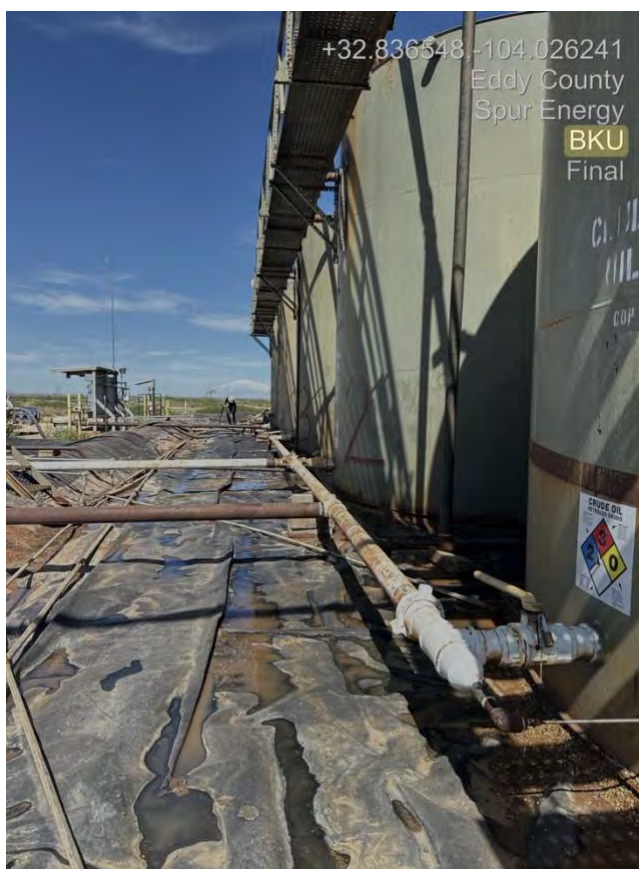
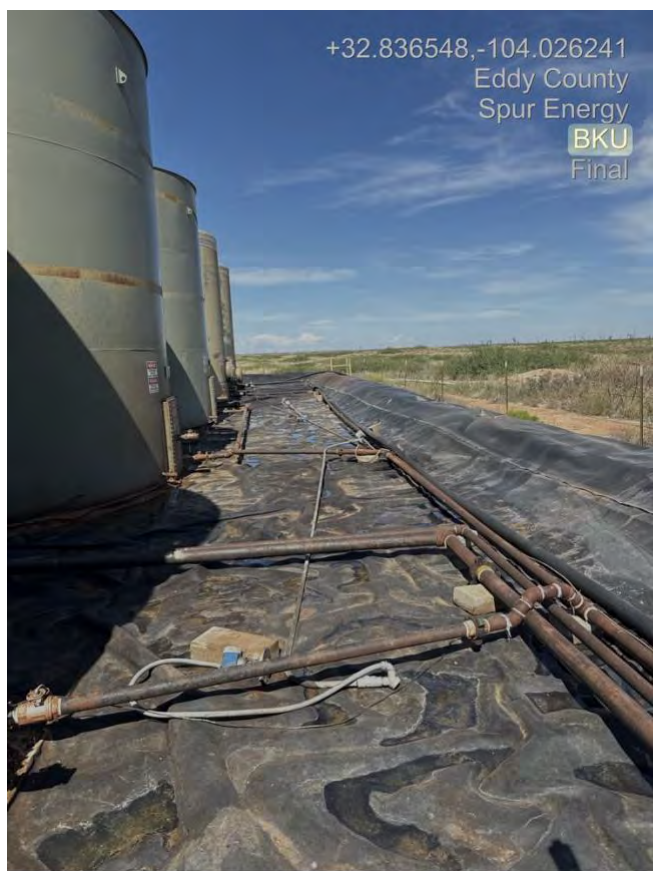
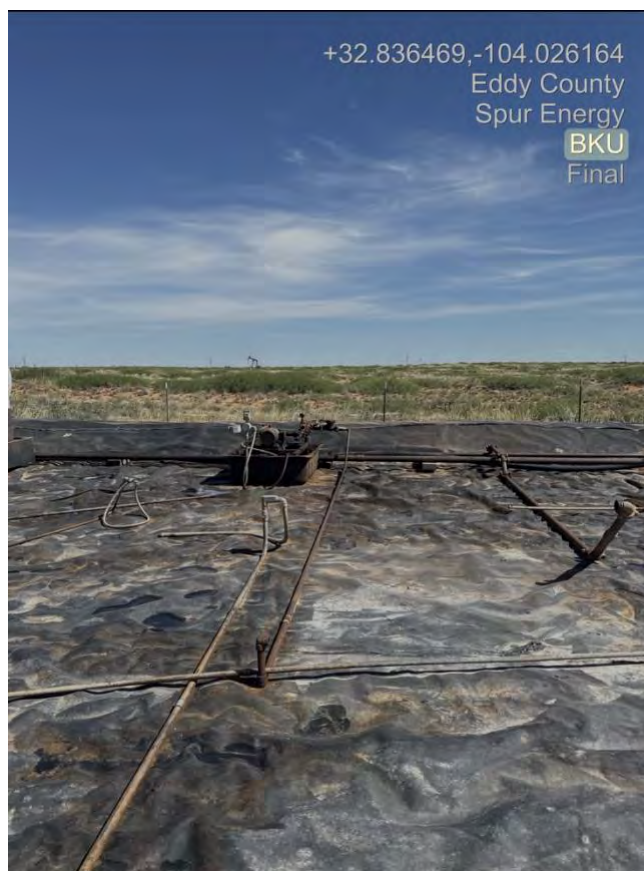
### Completed and Liner Inspection

| Visualization | Yes | No | Comments |
|---|---|---|---|
| Does the liner have integrity to contain a leak? | x | | |

The stained area measured approximately 2924 s/f. We used a hand crew to remove approximately 9 cy of peagravel from the liner, which was disposed of at Lea Land disposal facility. We then sprayed degreaser, followed by heated water to power wash the liner clean. A vac truck was on site, sucking up the fluids as the crew sprayed the liner down and used a squeegee to move the fluids to the vac truck.
