WAUKEE 36 ST COM CTB

Incident ID nAPP2526128734

## Liner Inspection and Closure Report

October 14, 2025

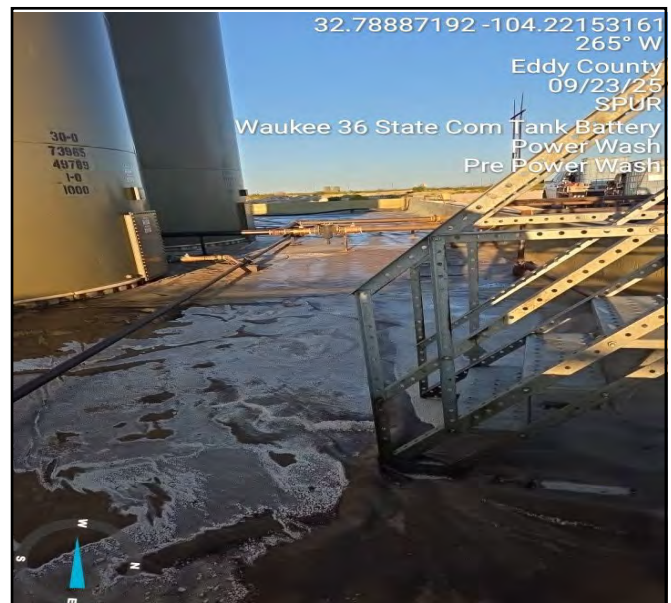
Photo of liner taken during initial liner inspection facing west.

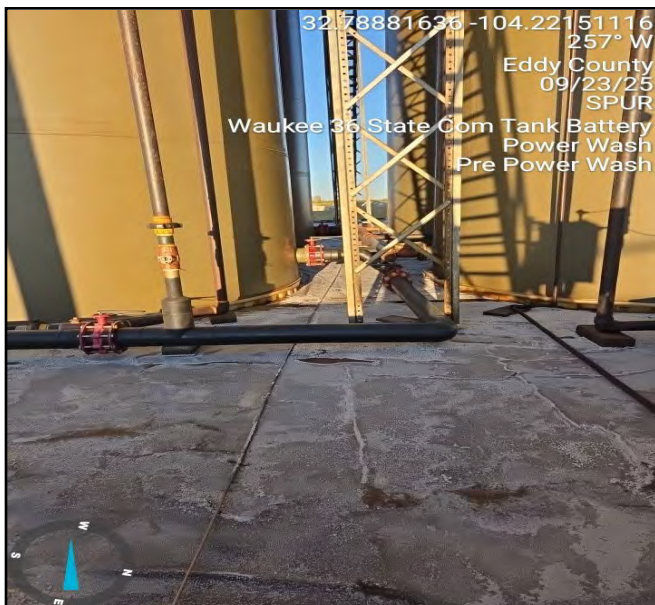
Photo of liner taken during initial liner inspection facing west.

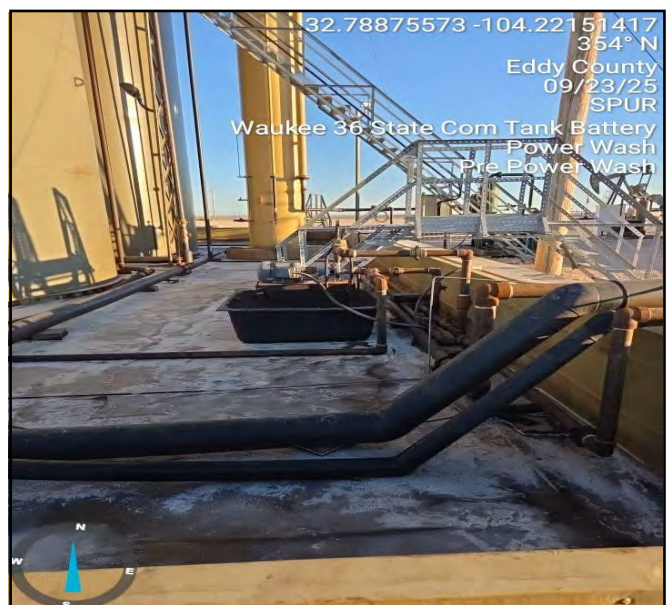
Photo of liner taken during initial liner inspection facing north.

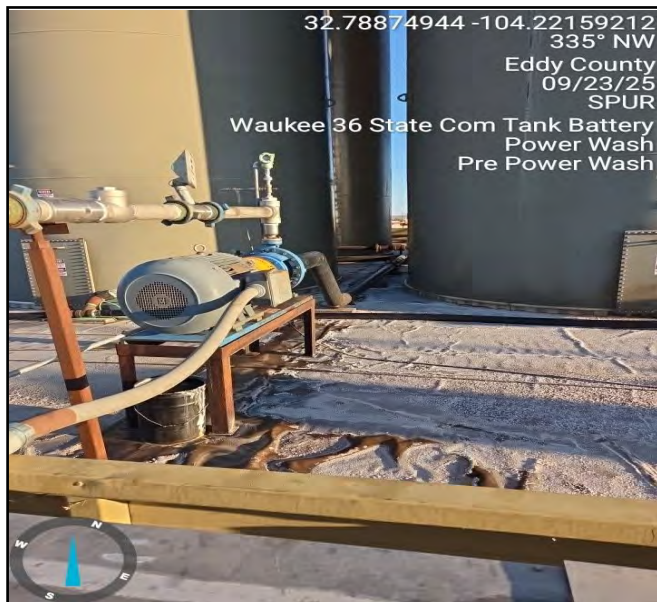
Photo of liner taken during initial liner inspection facing northwest.

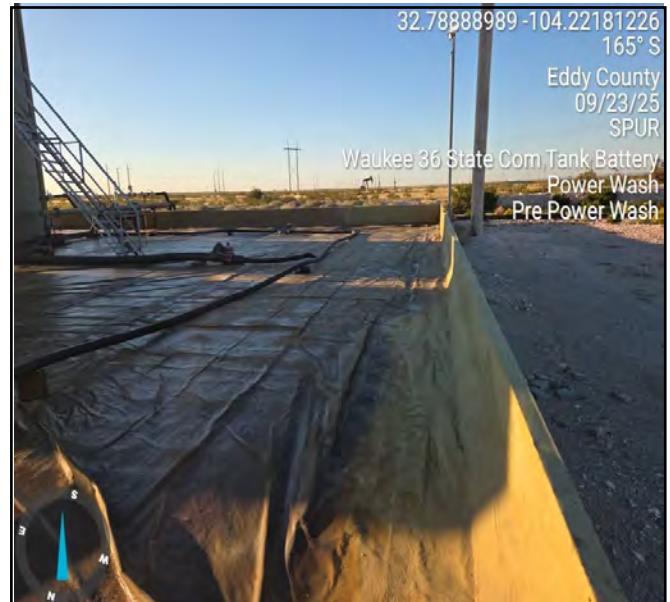
Photo of liner taken during initial liner inspection facing south.

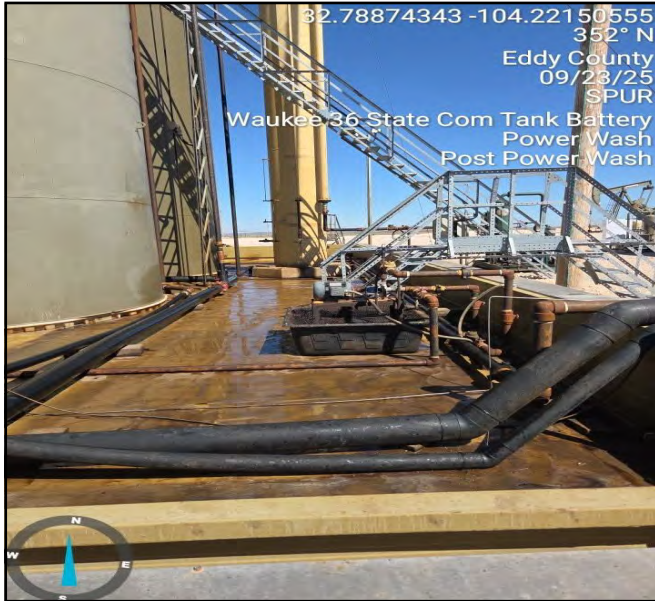
Photo of location taken post power wash facing north.

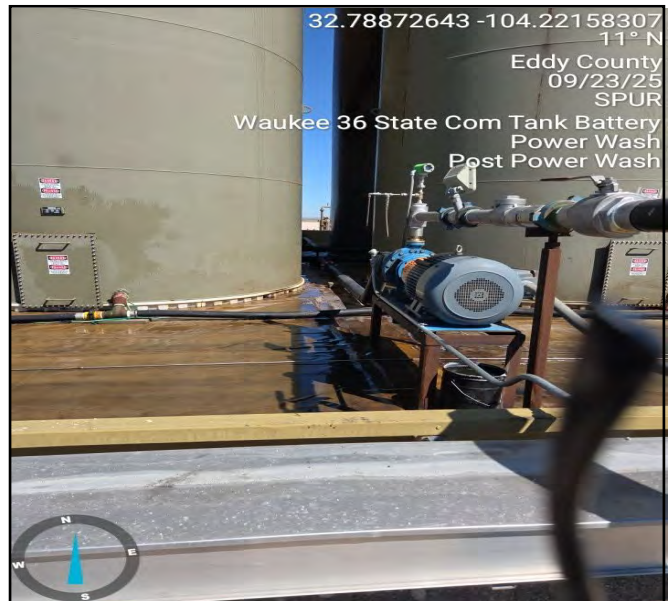
Photo of location taken post power wash facing north.

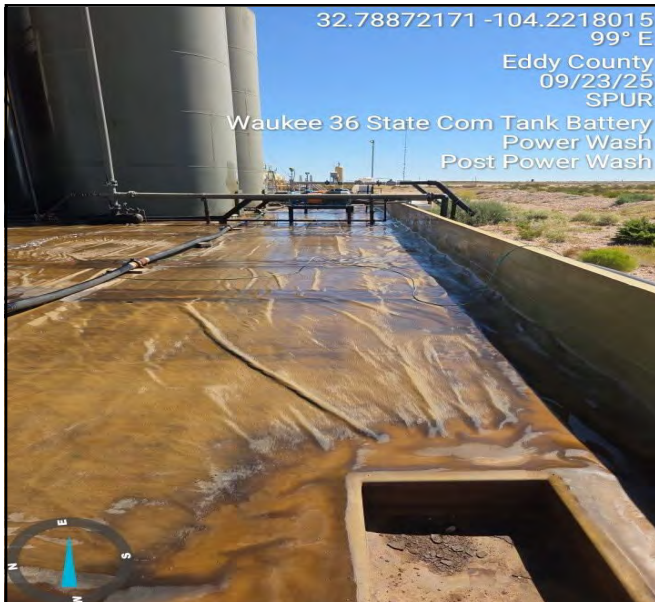
Photo of location taken post power wash facing east.

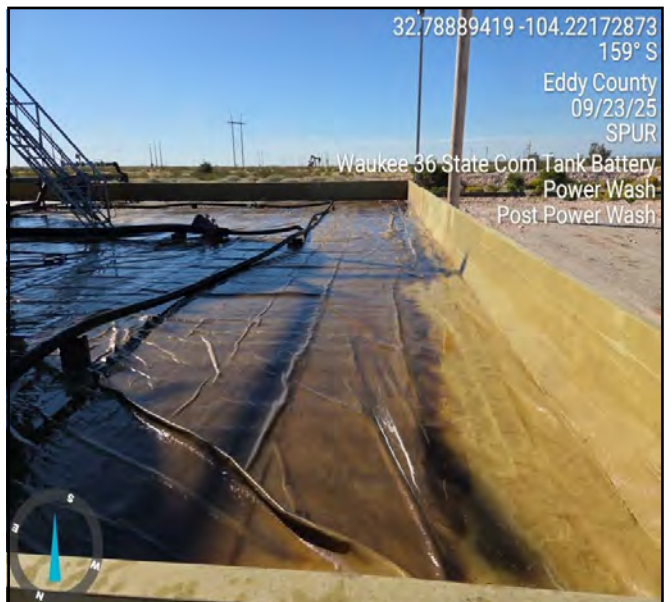
Photo of location taken post power wash facing south.

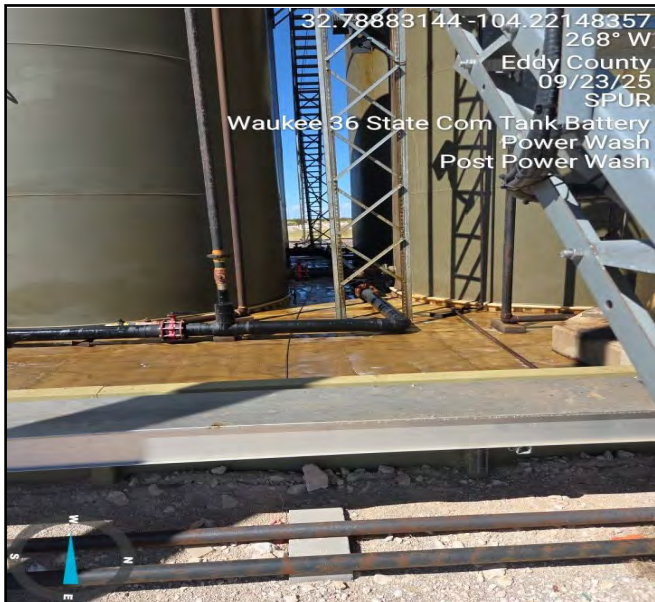
Photo of location taken post power wash  
facing west.

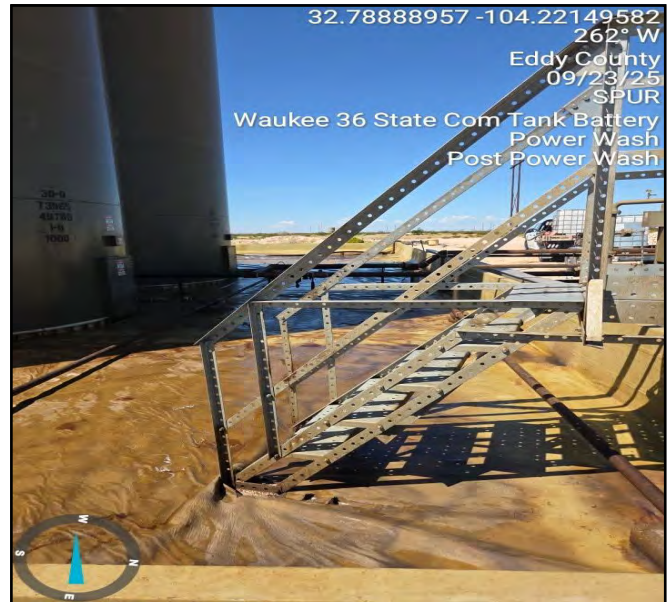
Photo of location taken post power wash  
facing west.
