LINER INSPECTION AND CLOSURE REPORT

PREPARED FOR:
DEVON ENERGY PRODUCTION, LP.

LOCATION: Boundary Raider 6 CTB 3

NMOCD REF. NO. NAPP2520944309

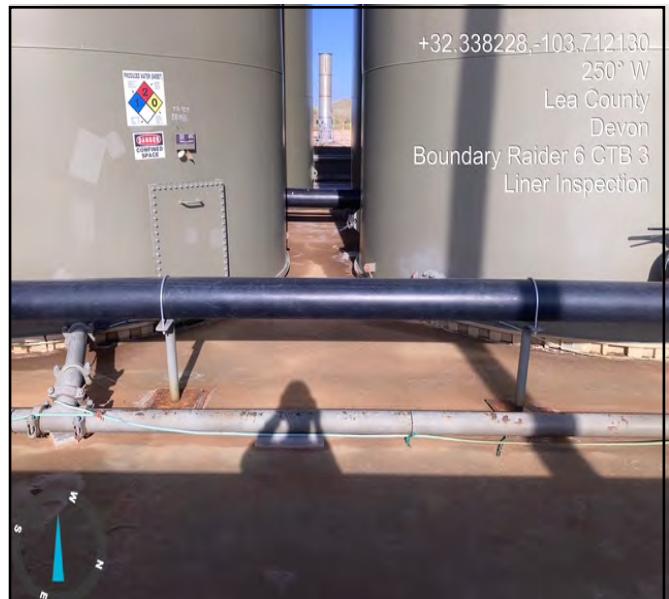
Photo of liner taken during initial liner inspection facing west.

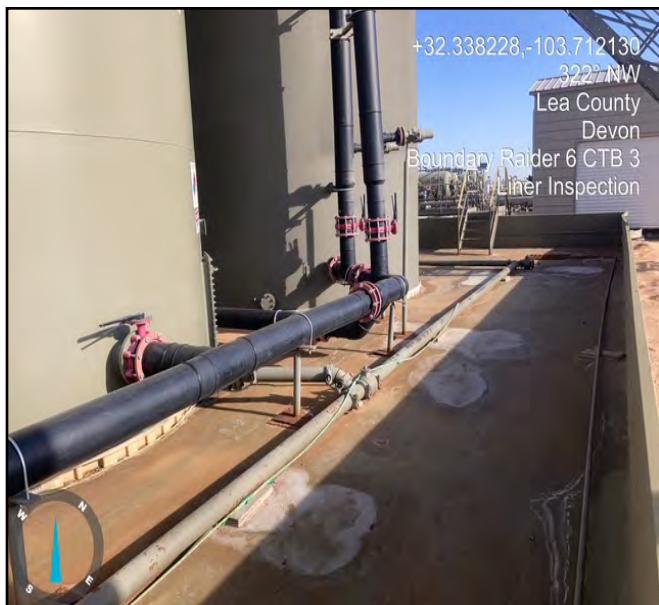
Photo of liner taken during initial liner inspection facing northwest.

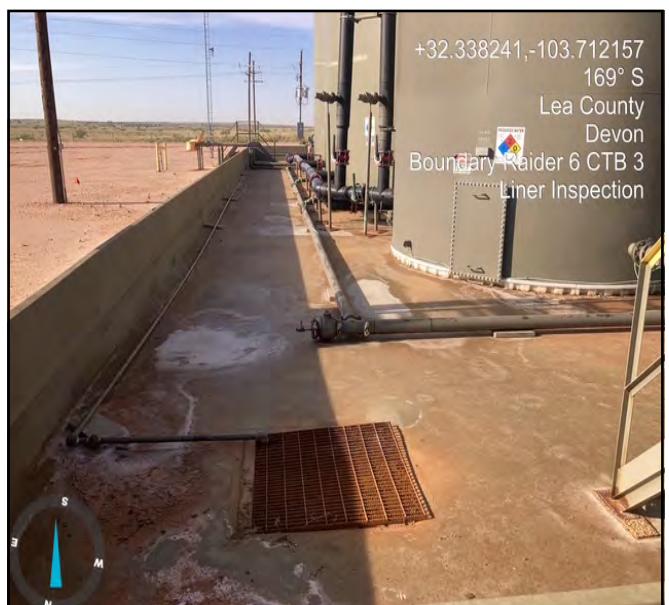
Photo of liner taken during initial liner inspection facing south.

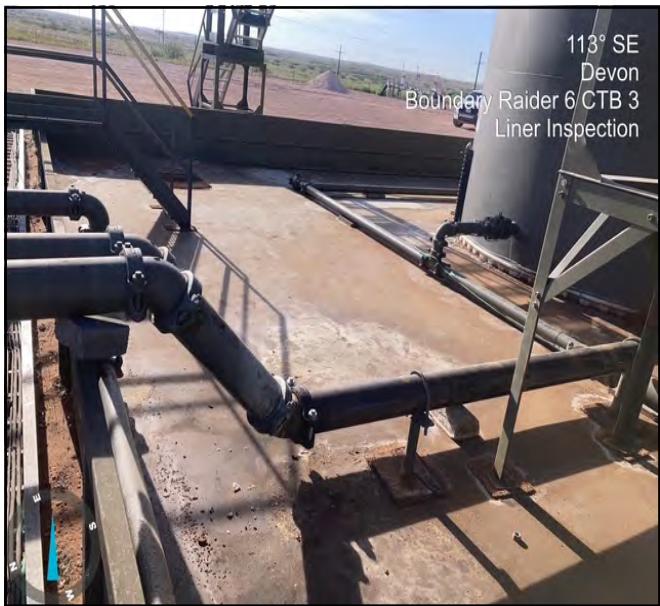
Photo of liner taken during initial liner inspection facing southeast.

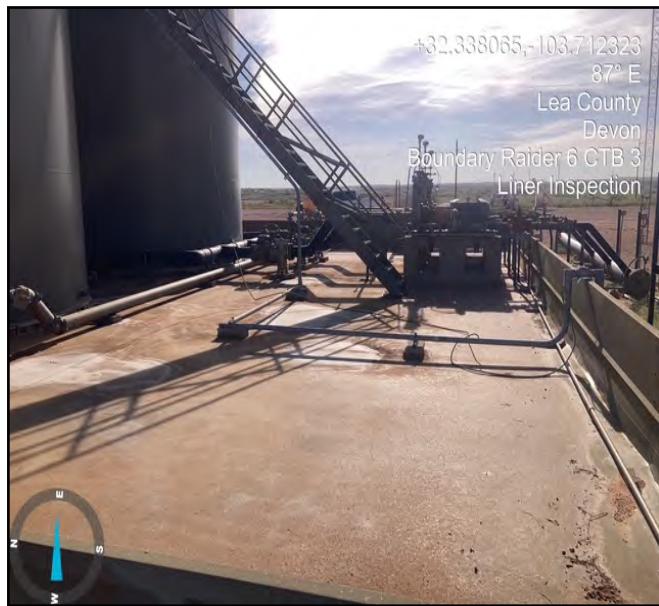
Photo of liner taken during initial liner inspection facing east.

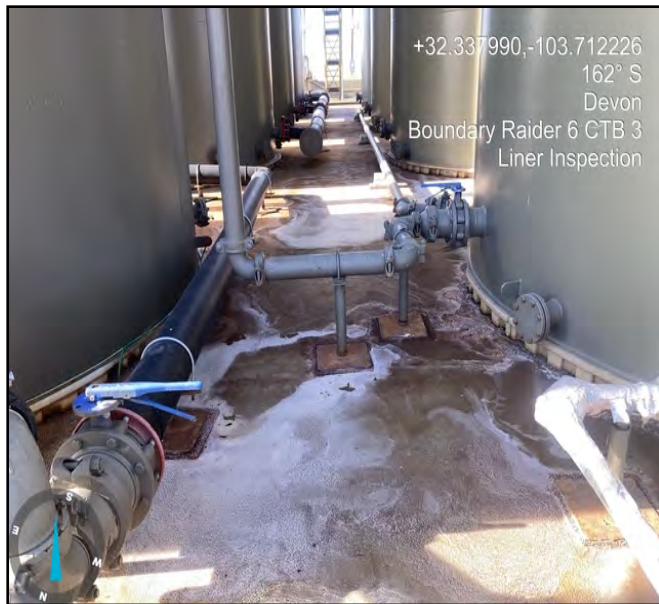
Photo of liner taken during initial liner inspection facing south.

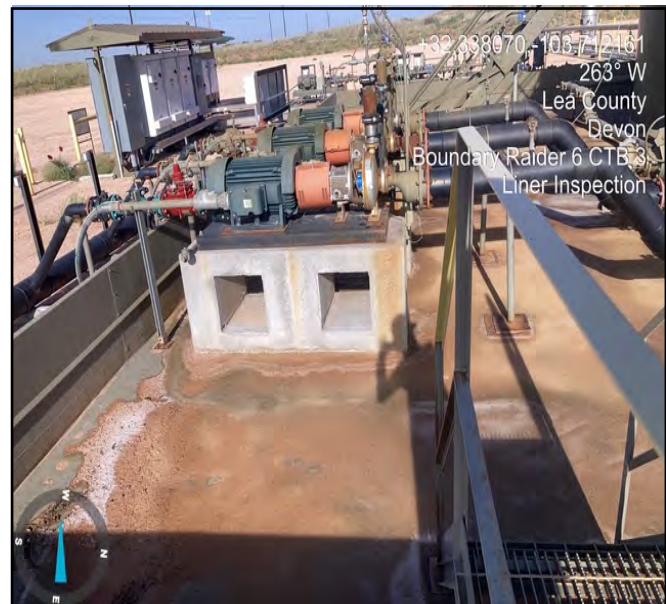
Photo of liner taken during initial liner inspection facing west.

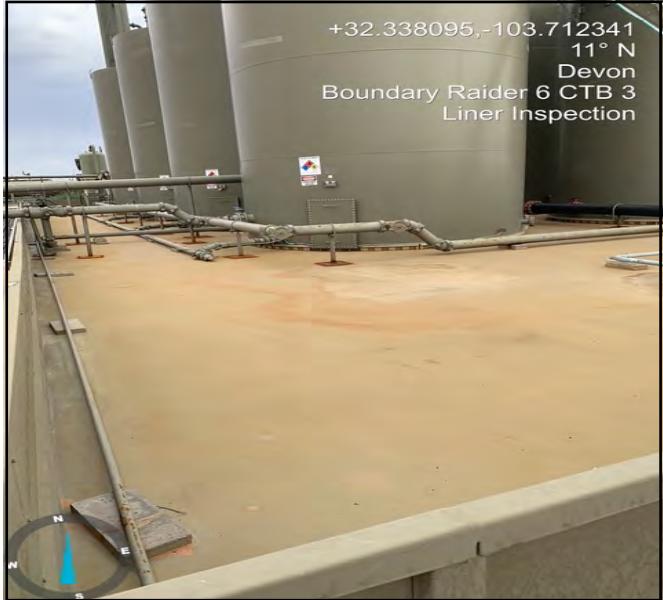
Photo of location taken during Liner Inspection facing north.

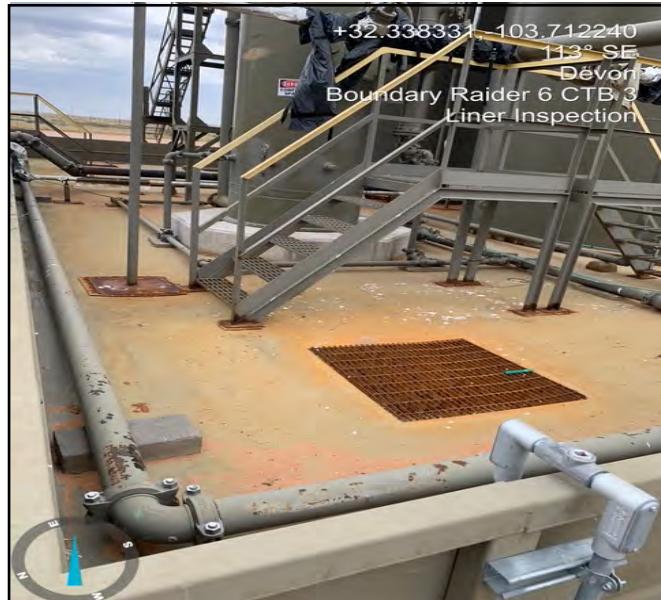
Photo of location taken during Liner Inspection facing southeast.

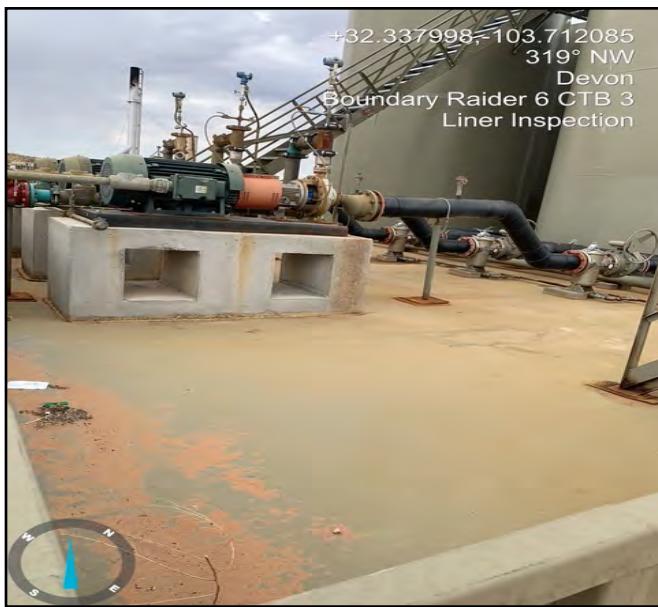
Photo of location taken during Liner Inspection facing northwest.

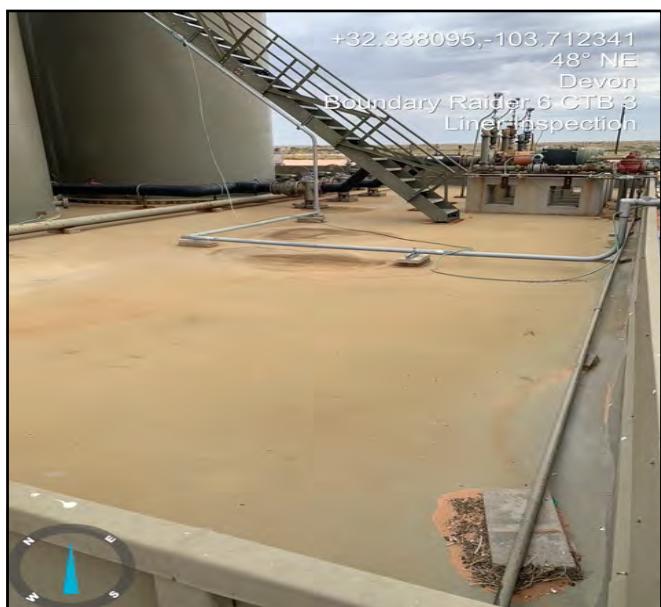
Photo of location taken during Liner Inspection facing northeast.

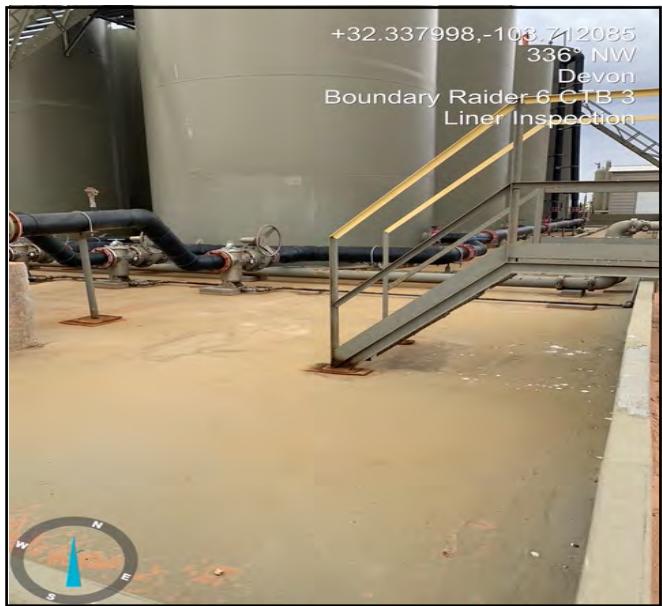
Photo of location taken during Liner Inspection facing northwest.

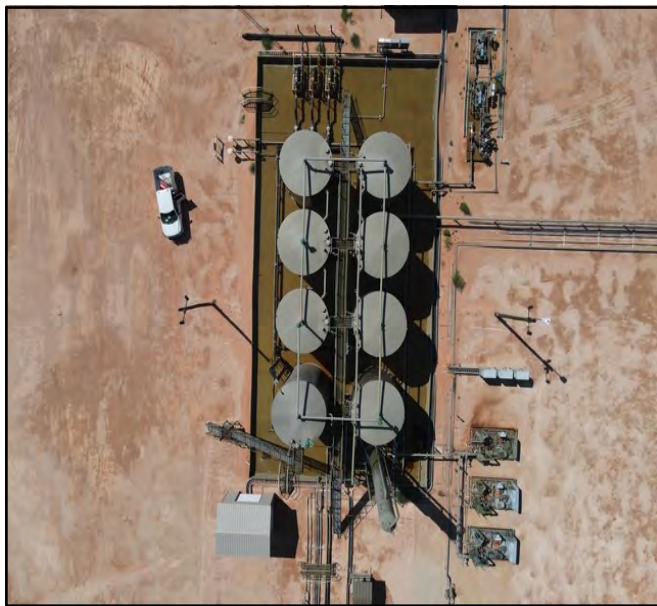
Photo of location taken during Liner Inspection.

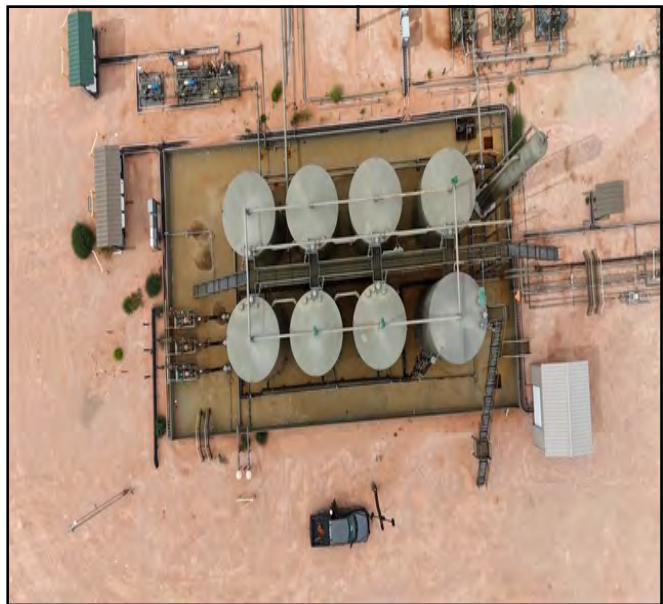
Photo of location taken during Liner Inspection.
