Our ref.: 12672657-NMOCD-1

November 10, 2025

Closure Report  
Devon Energy Production Company, LP  
Mule 23 CTB 2  
Unit Letter B, Section 23, T25S, R31E  
GPS: 32.1218234, -103.7471688  
Eddy County, New Mexico

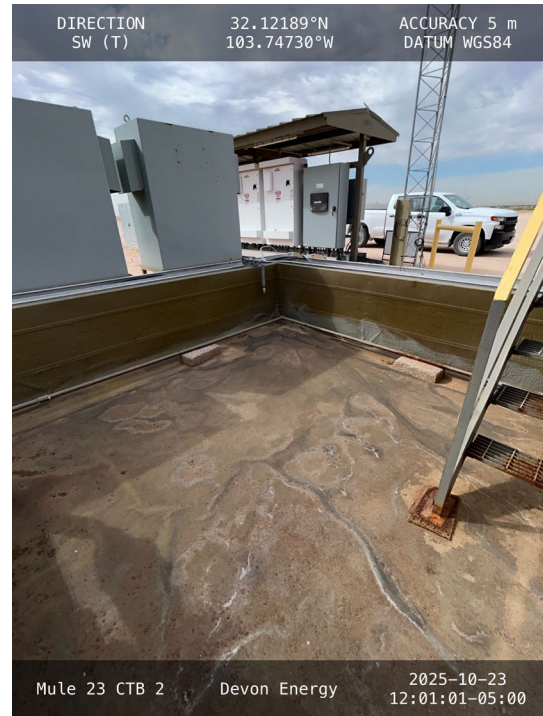
Photo 2 View of southwest corner of containment.

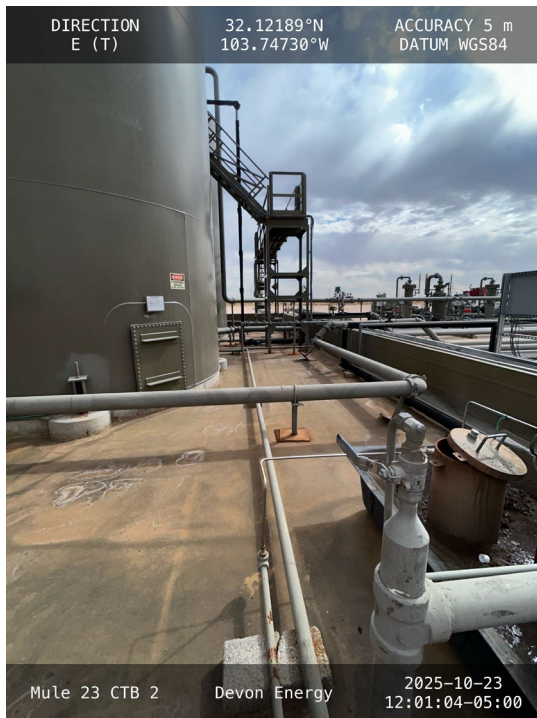
Photo 3 View of south side containment towards east.

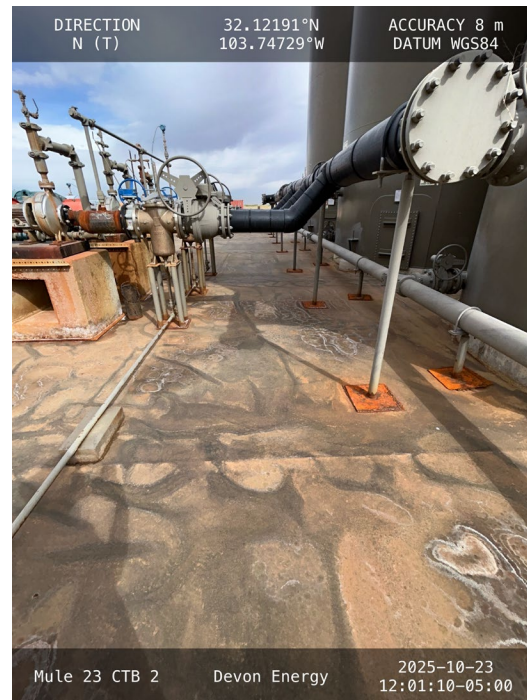
Photo 4 View of west side of containment towards north.

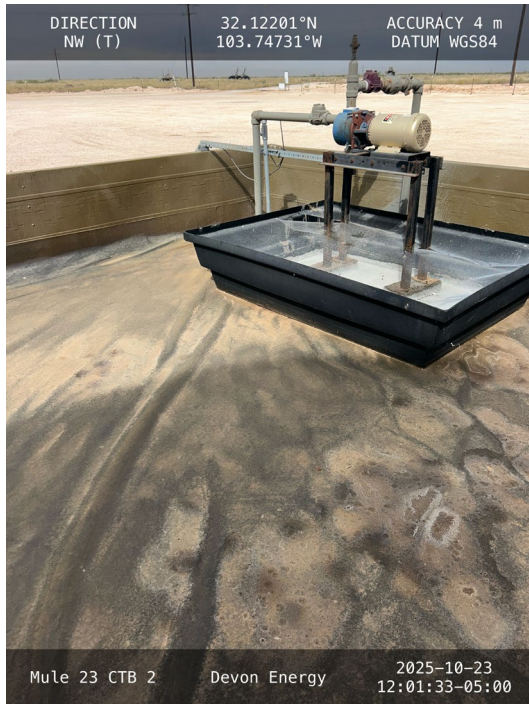
Photo 5 View of northwest corner of containment.

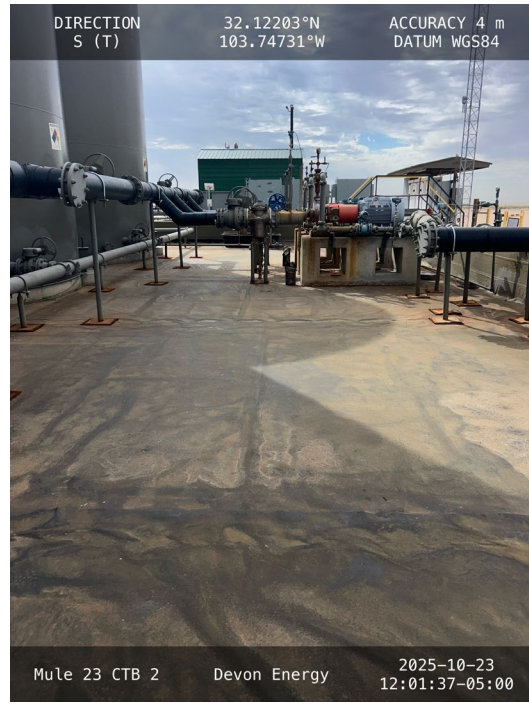
Photo 6 View of west side containment facing south.

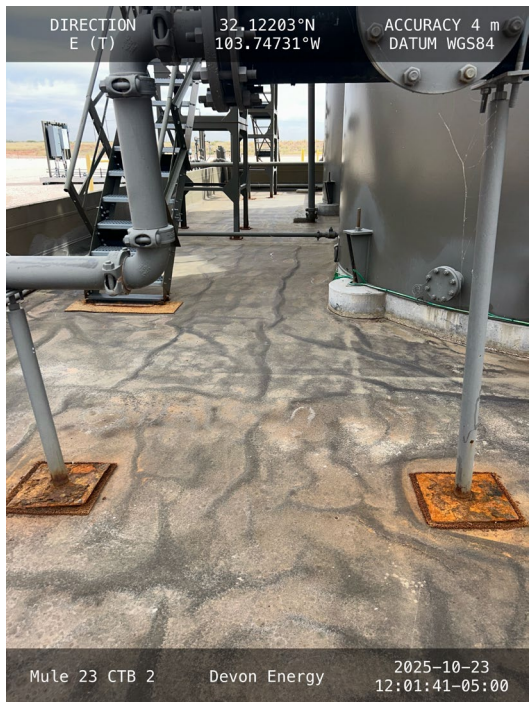
Photo 7 View of north side of containment towards east.

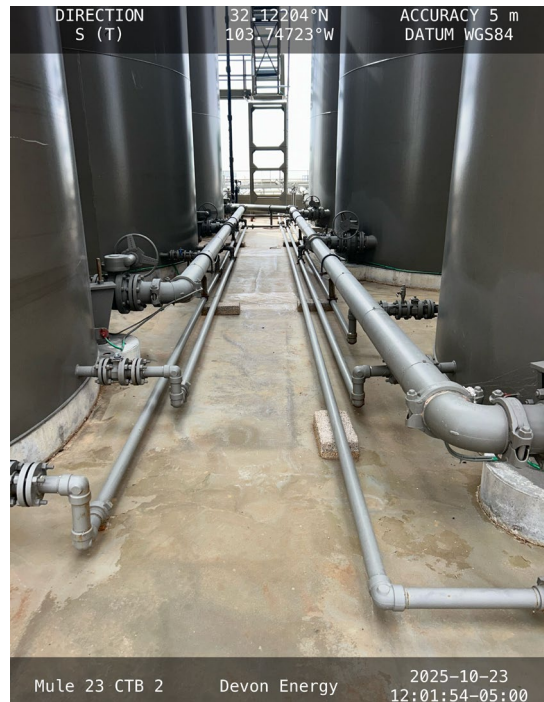
Photo 8 View of central portion of containment towards south.

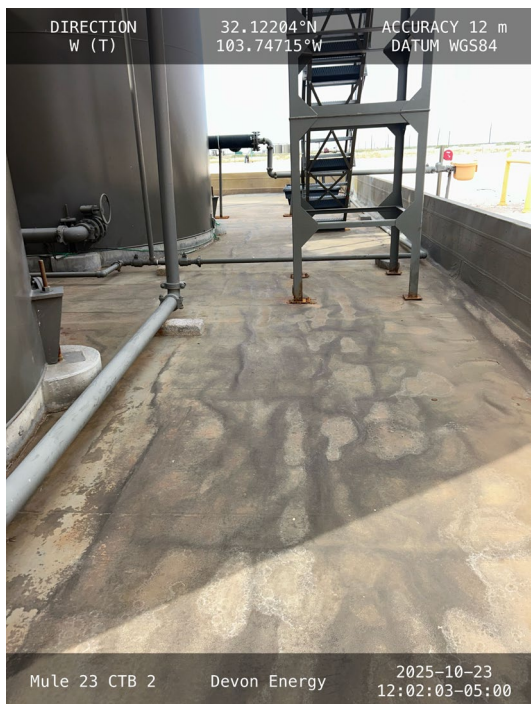
Photo 9 View of north side containment towards west.

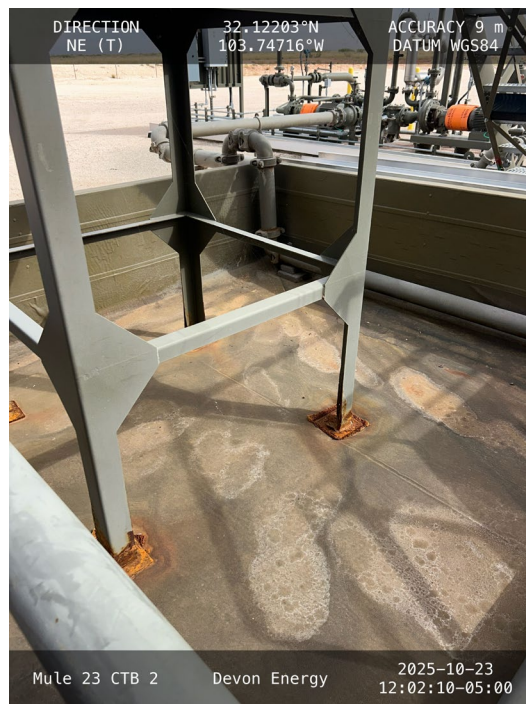
Photo 10 View of northeast corner of containment.

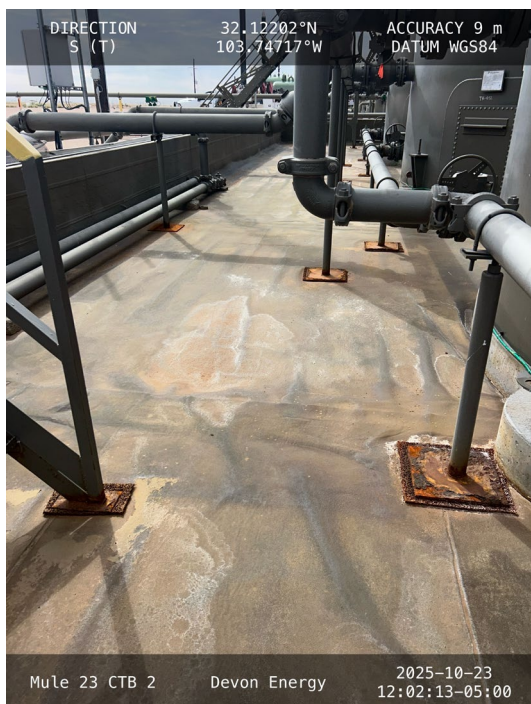
Photo 11 View of east side secondary containment towards south.

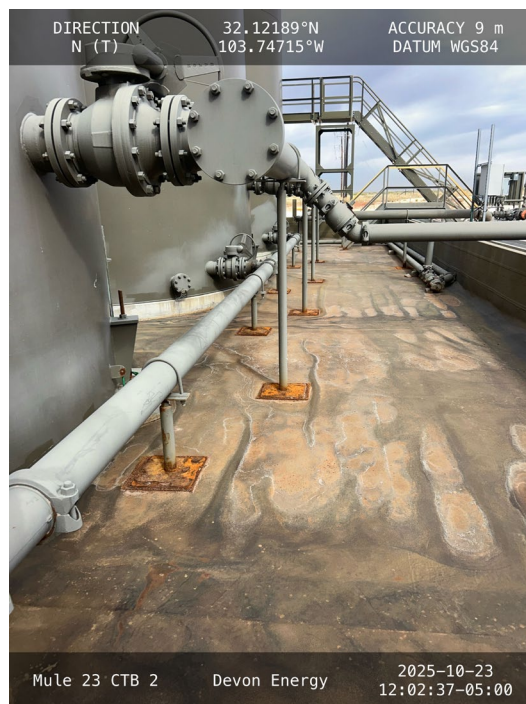
Photo 12 View of east side of containment towards north.

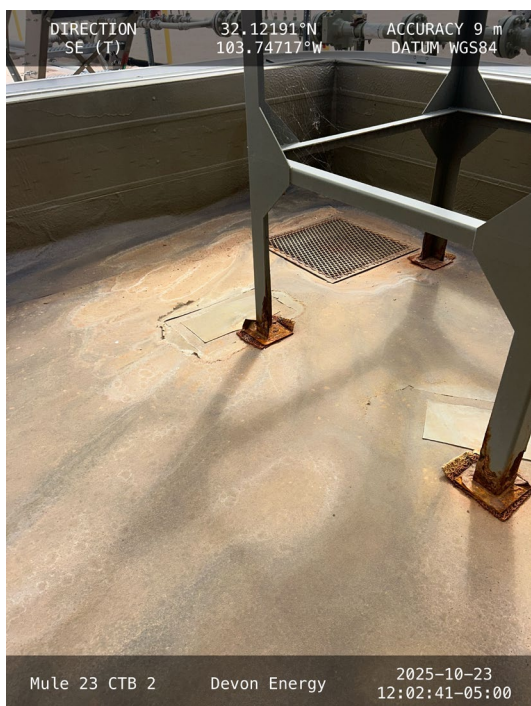
**Photo 13** View of southeast corner of secondary containment.

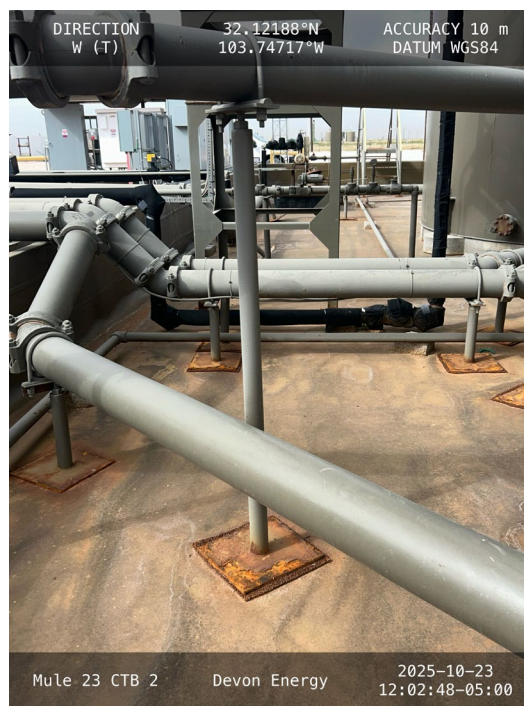
**Photo 14** View of south side of containment towards west.
