Our Ref.: 12679377 – NMOCD – 1

December 4, 2025

Closure Report  
Devon Energy Production Company, LP  
Exmoor 15 CTB 2  
Unit Letter A, Section 15, TS25, R31E  
GPS: 32.134225, -103.757538  
Eddy County, New Mexico

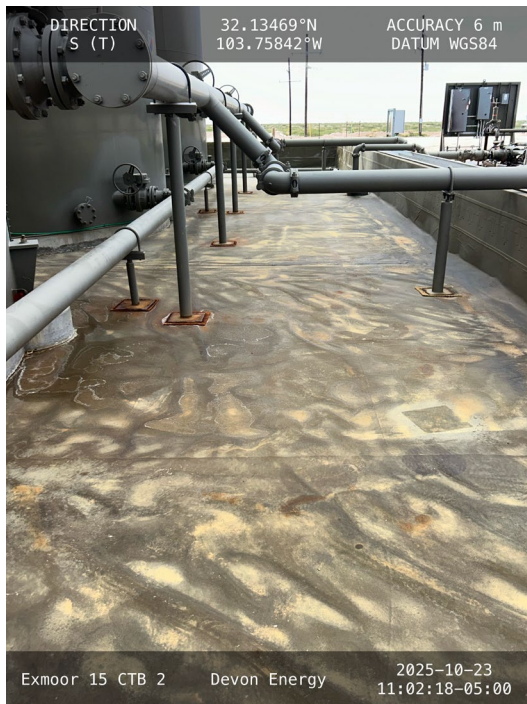
**Photo 9** View of western portion of secondary containment facing south.

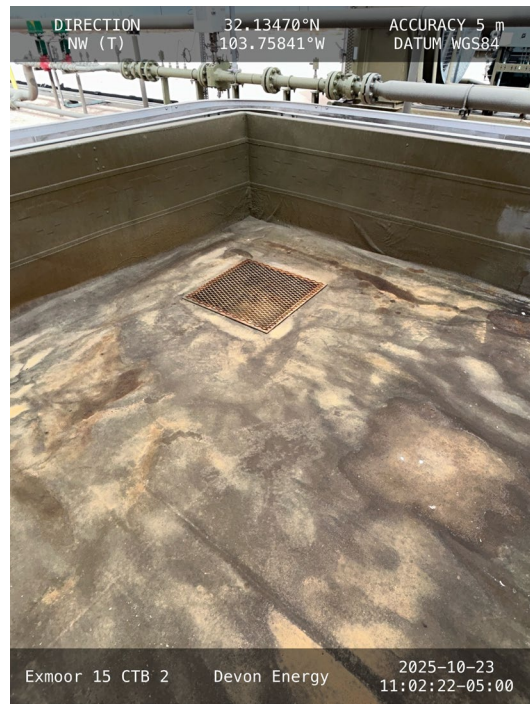
**Photo 10** View of northwest corner of secondary containment.

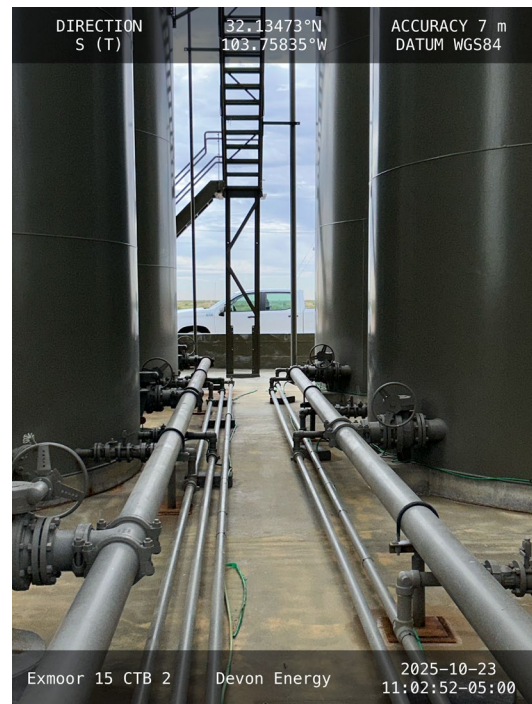
**Photo 12** View of central portion of secondary containment facing south.

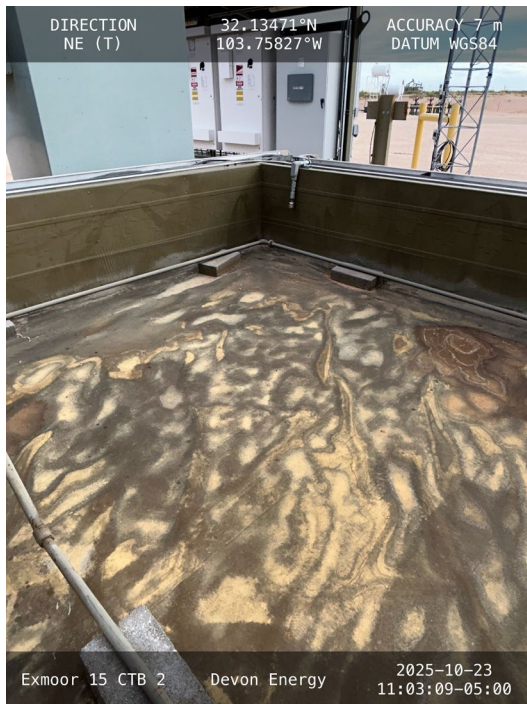
**Photo 13** View of northeast corner of secondary containment.
