Our Ref.: 12676590-NMOCD-1

December 04, 2025

Closure Report
Devon Energy Production Company, LP
Chaparral 32 State Wellpad 2
Unit Letter C, Section 32, TS19, R29E
GPS: 32.62378386, -104.0991521
Eddy County, New Mexico

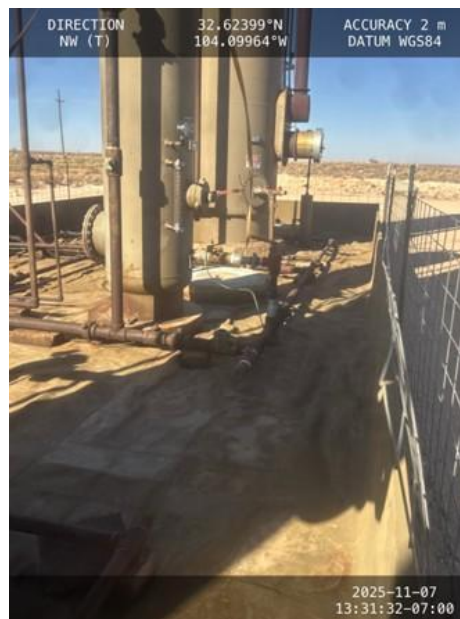
Photo 2 View of eastern portion of containment facing northwest.

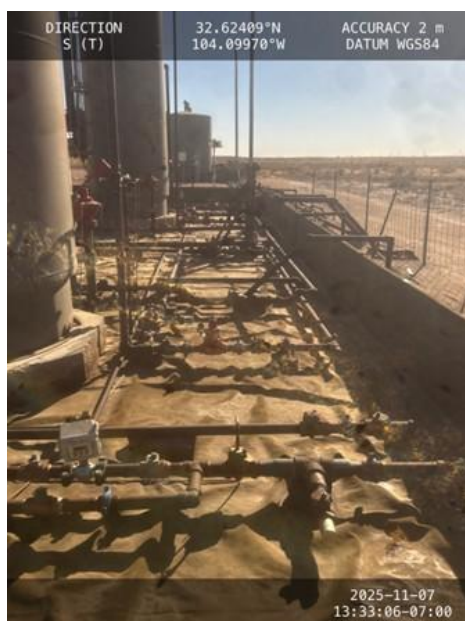
Photo 3 View of western portion of containment facing south.

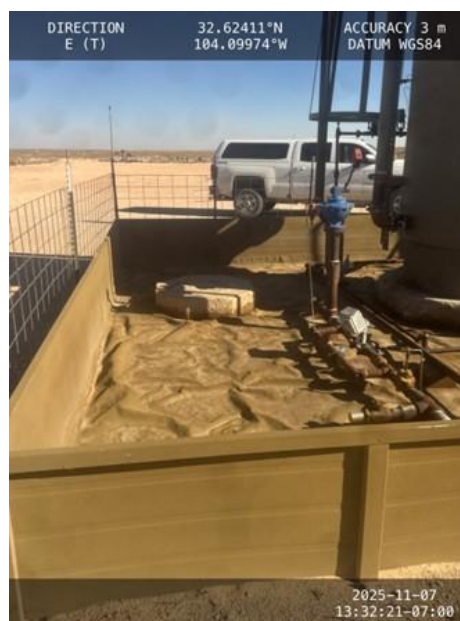
Photo 4 View of northern portion of containment facing east.

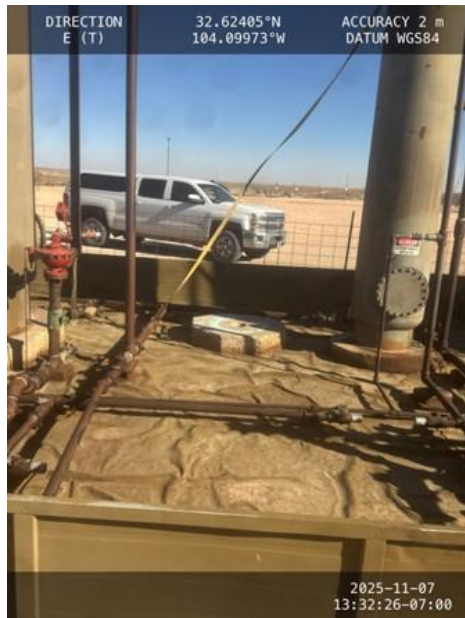
Photo 5 View of central portion of containment facing east.

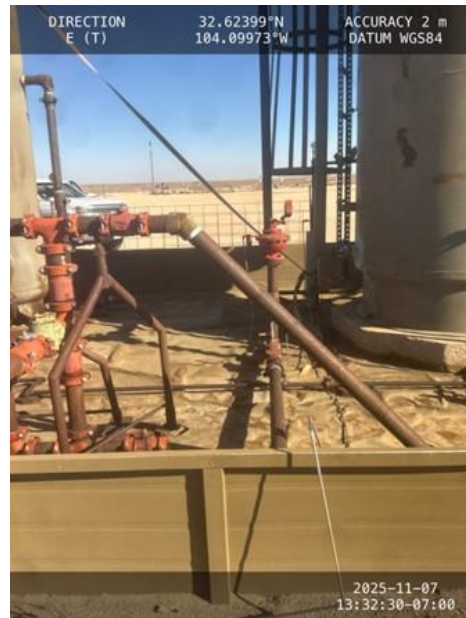
Photo 6 View of central portion of containment facing east.

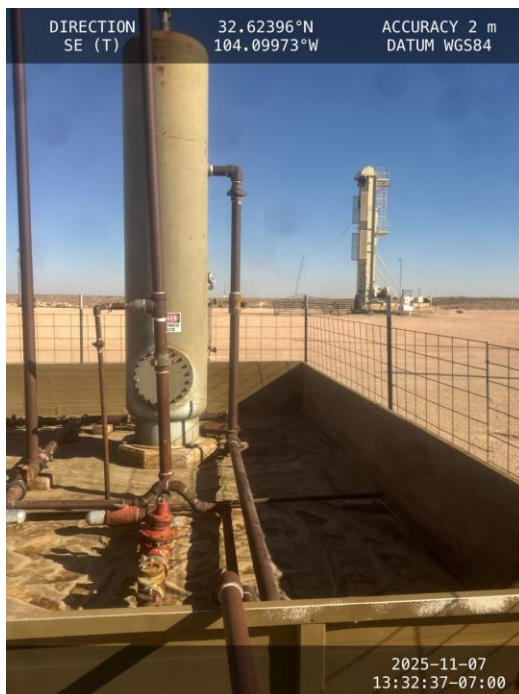
Photo 7 View of southern portion of containment facing southeast.
