Liner Inspection and Closure Request

Devon Energy Production Company, LP

Gato Grande 16 CTB 1

NMOCD Incident # NAPP2535868597

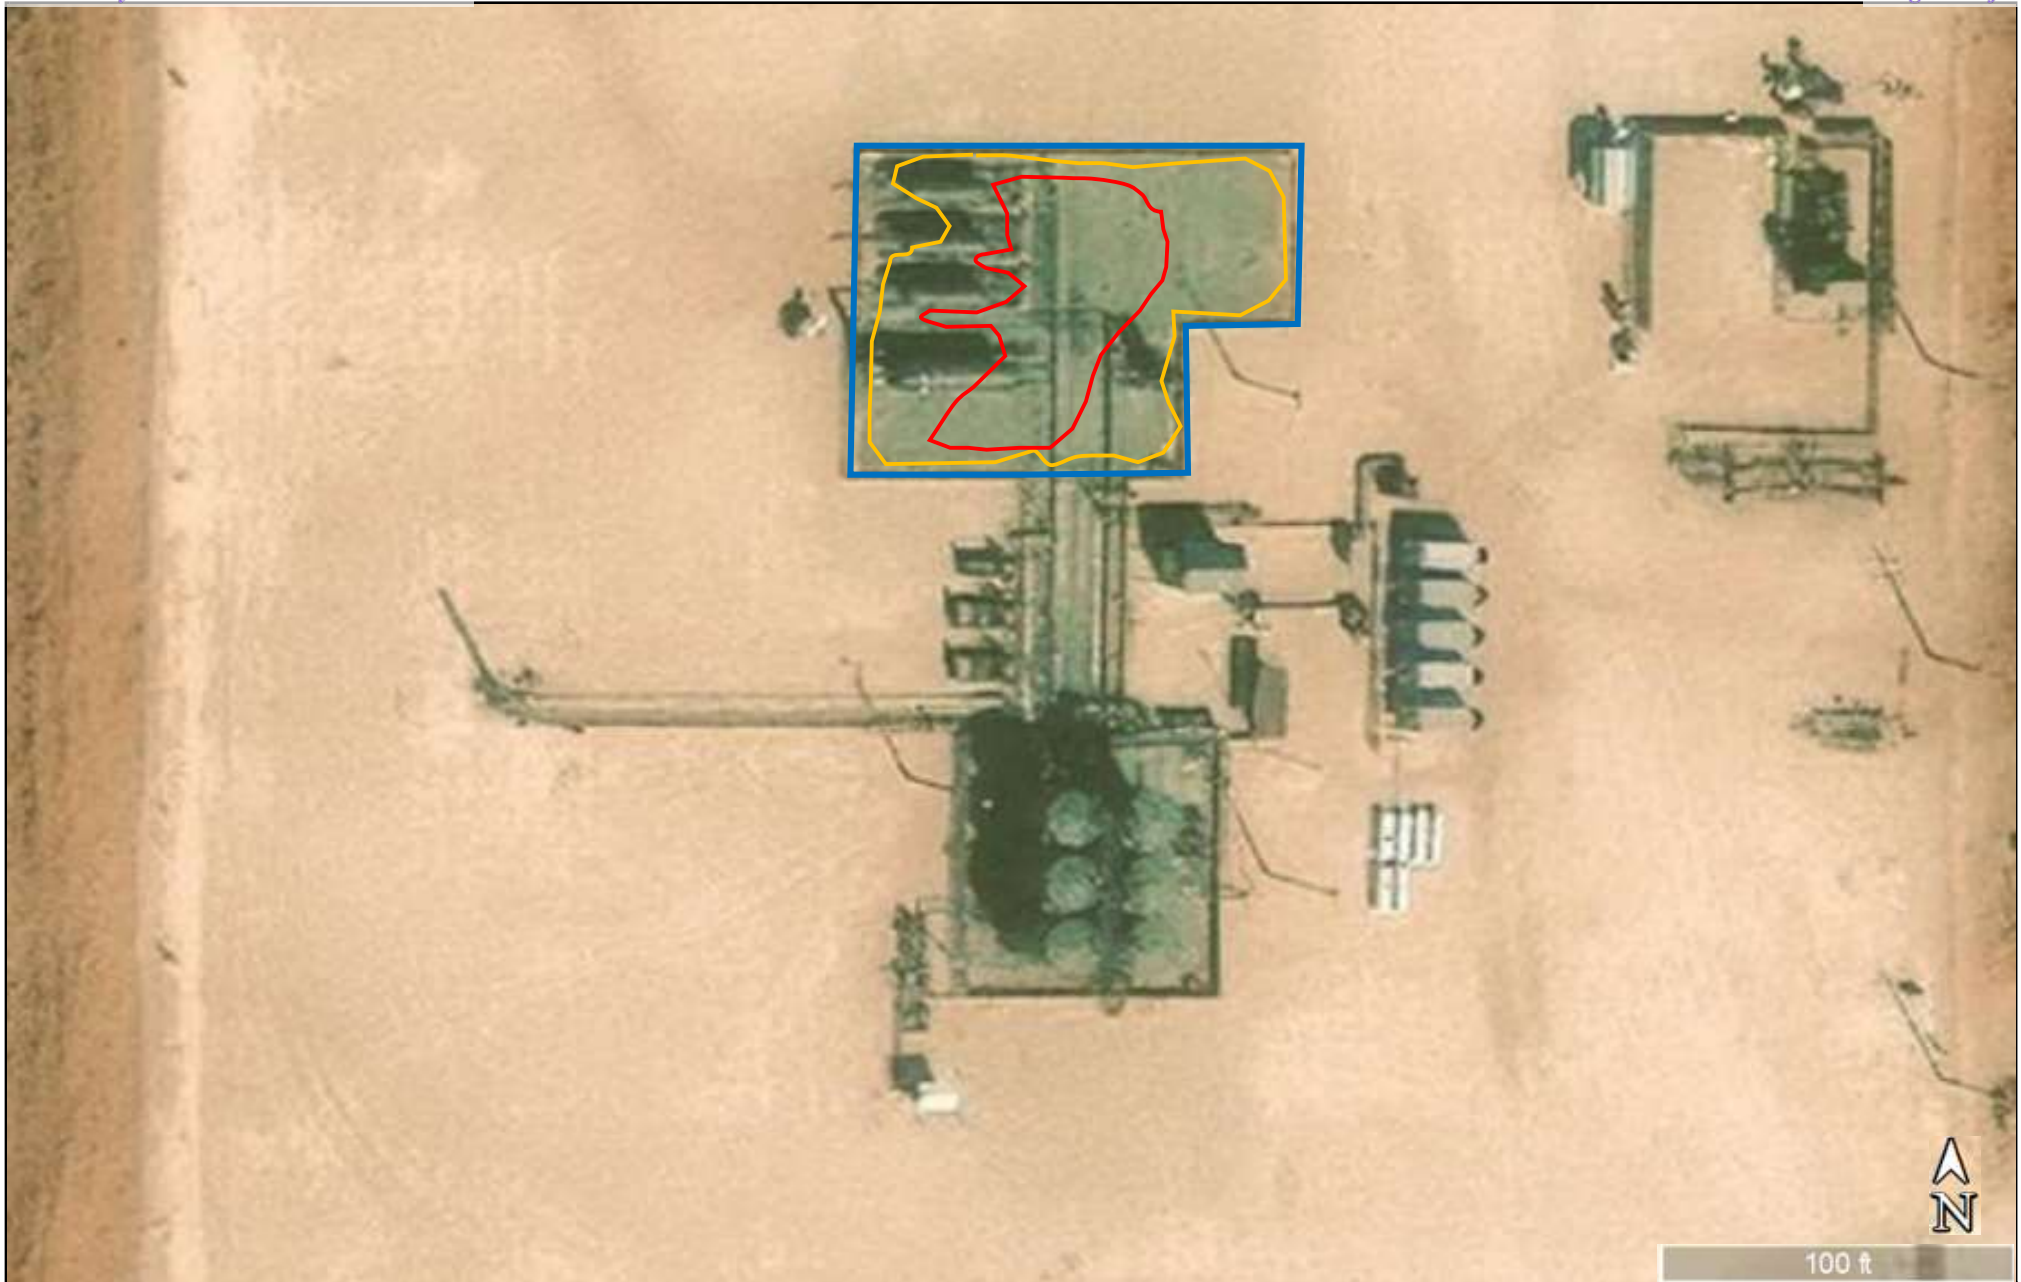
Figure 4

On April 13, 2026, Hungry Horse personnel arrived on location to inspect the liner. The liner and metal containment were thoroughly inspected form edge to edge, as well as around the tanks and process equipment installed on the liner itself. Site Photographs are provided as Attachment III. The liner was found to be in place, intact, with no visible breaks or tears. There was no evidence of the release escaping the metal containment area. A completed Liner Inspection Form is attached as Attachment V.
