Our Ref.: 12679377 – NMOCD – 2

April 15, 2026

Closure Report  
Devon Energy Production Company, LP  
Exmoor 15 CTB 2  
Unit Letter A, Section 15, TS25, R31E  
GPS: 32.134225, -103.757538  
Eddy County, New Mexico

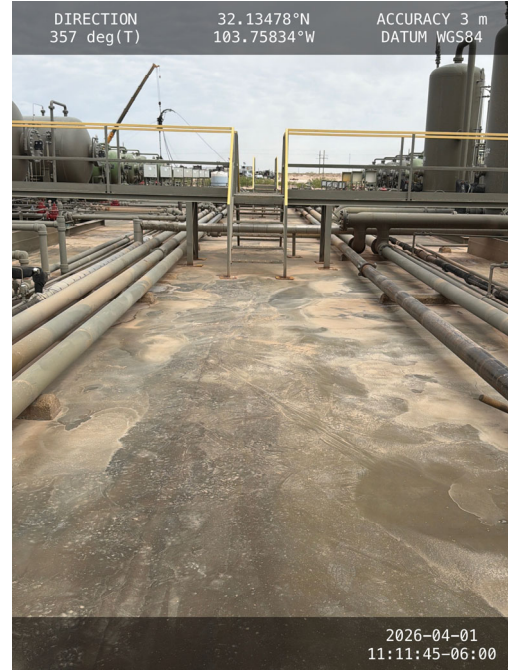
Photo 10 Photo of containment towards north.
