CONTINENTAL STATE 15A TB

PREPARED BY:  
PIMA ENVIRONMENTAL SERVICES, LLC

PREPARED FOR:  
Spur Energy

Liner Inspection and Closure Report

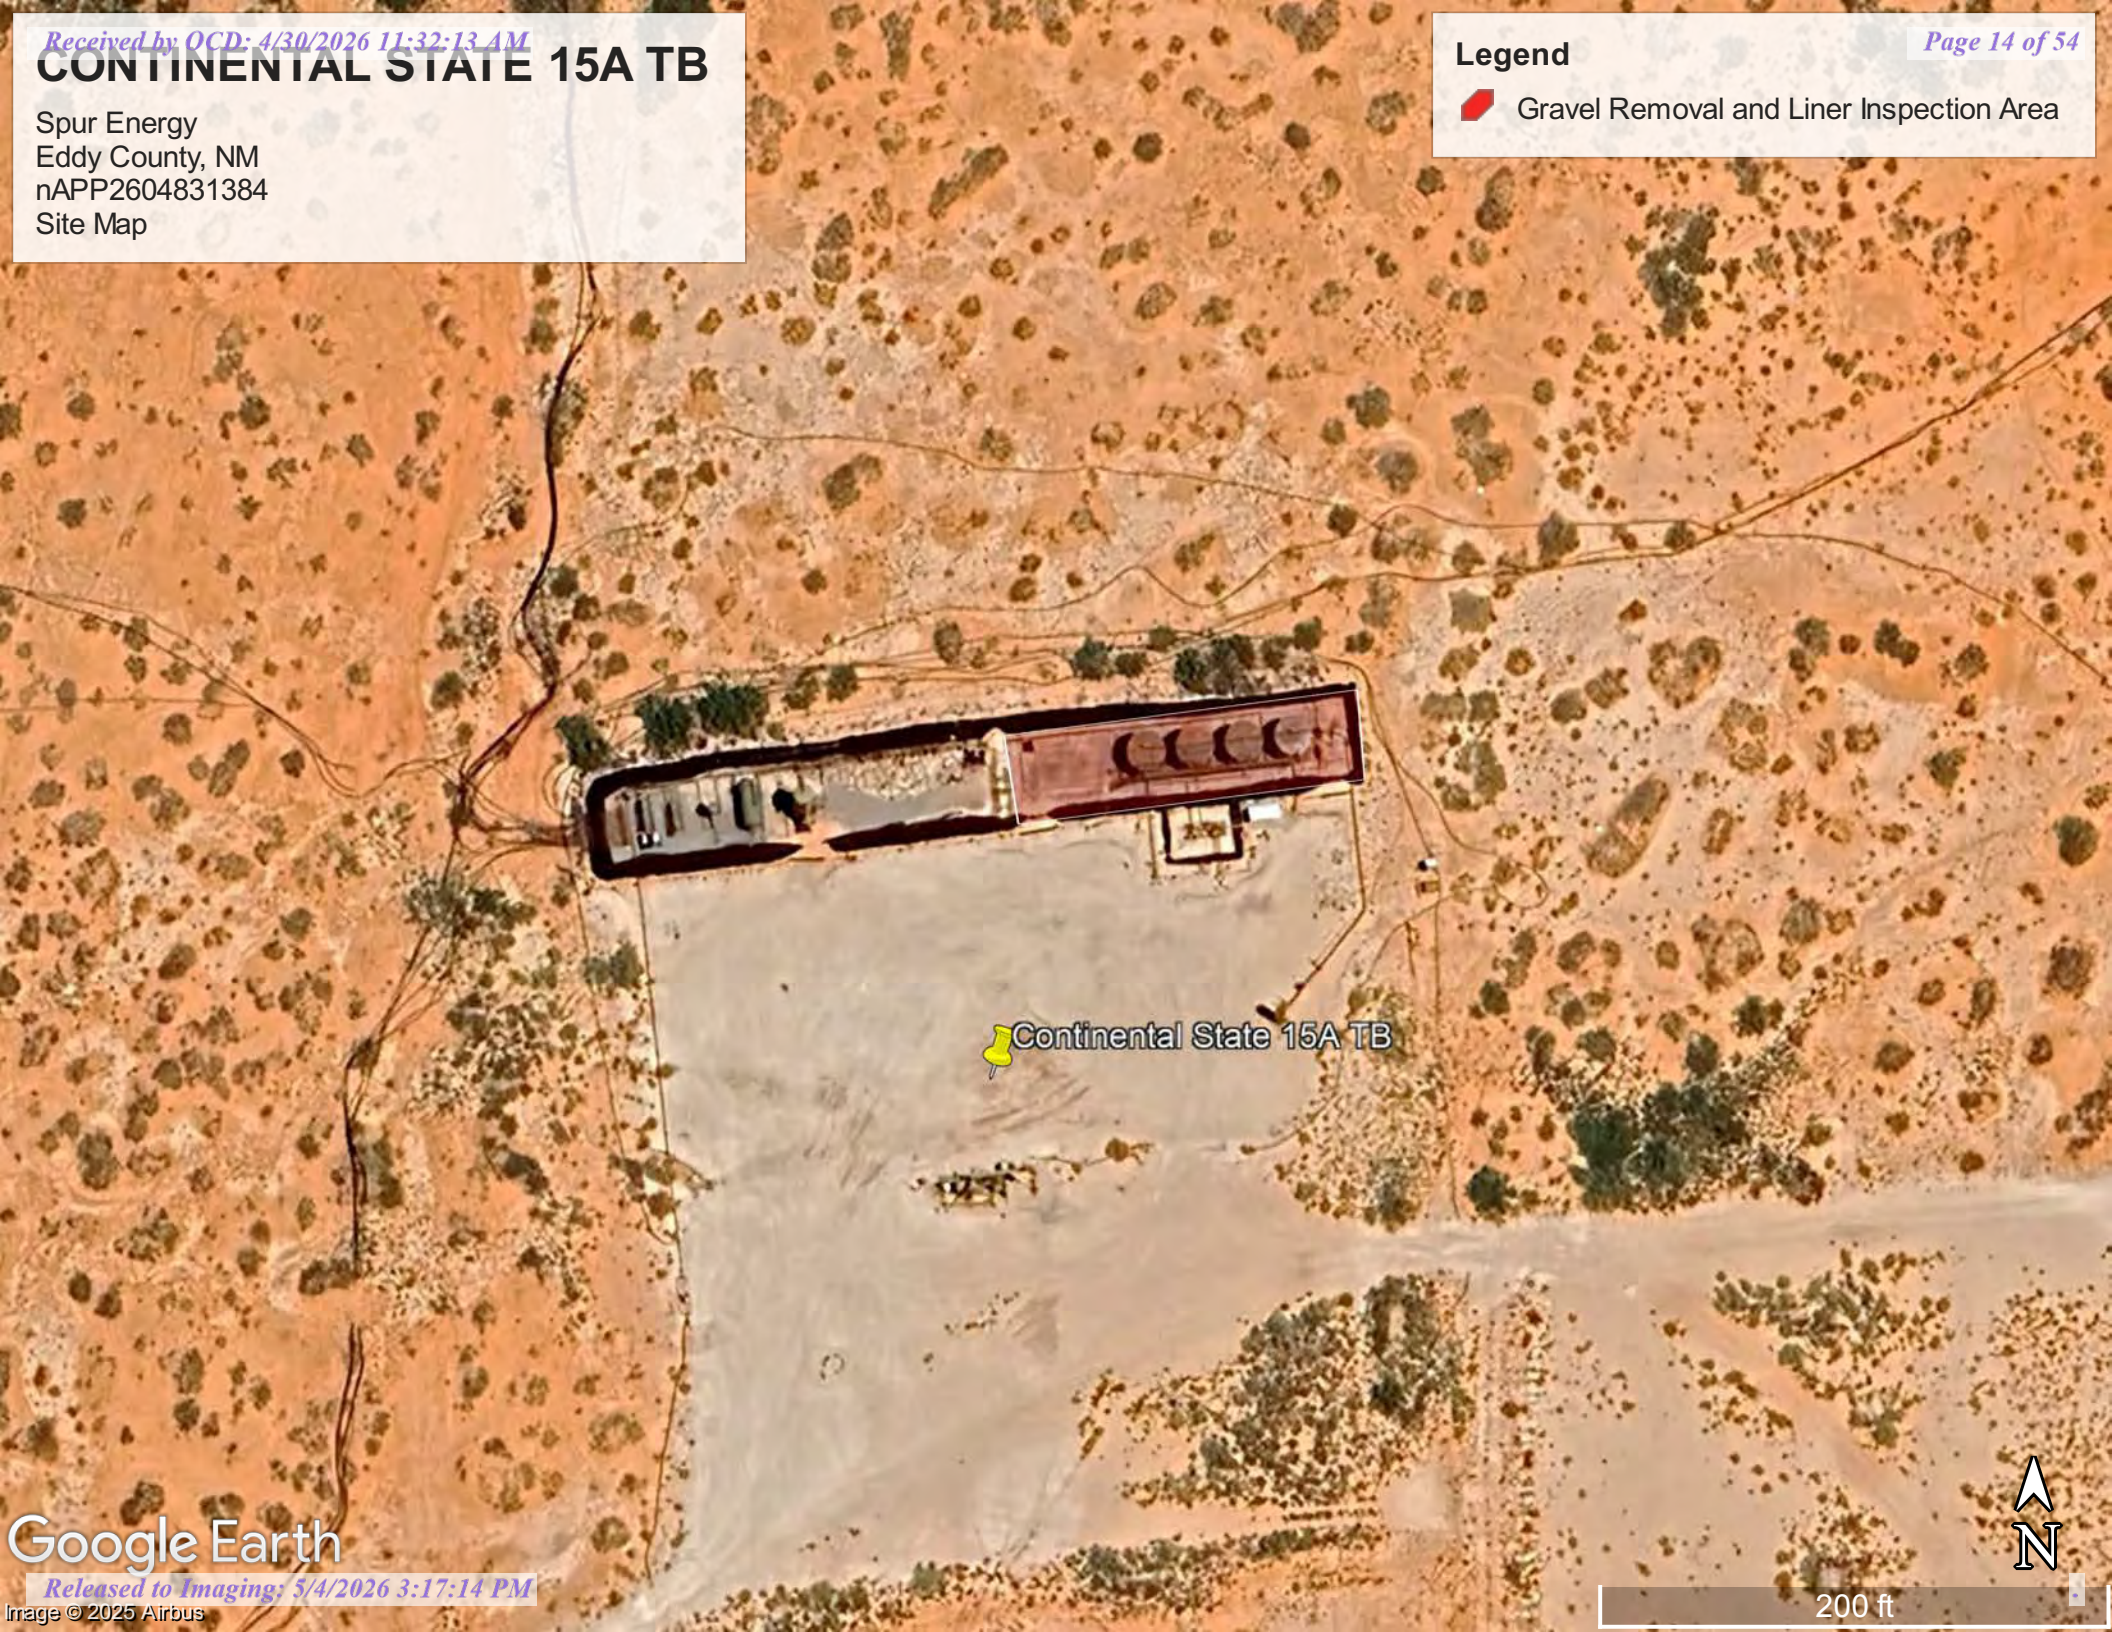
Figure 4- Site Map

Gravel Removal and Liner Inspection Area

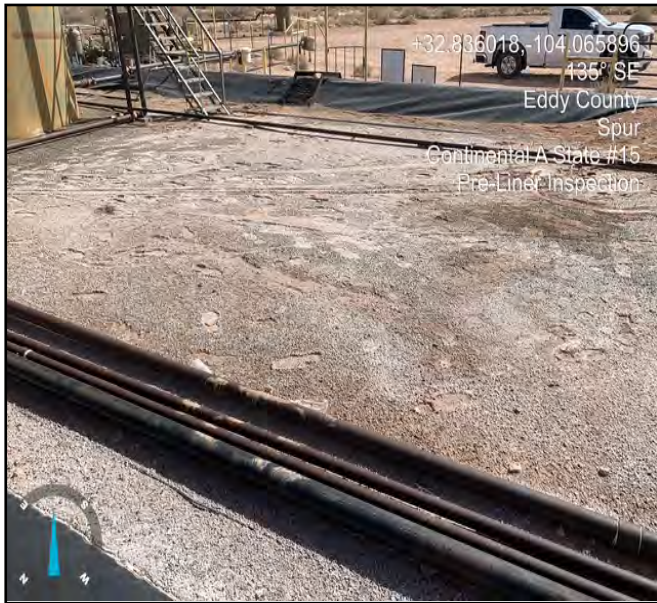
Photograph taken during the initial site assessment facing southeast.

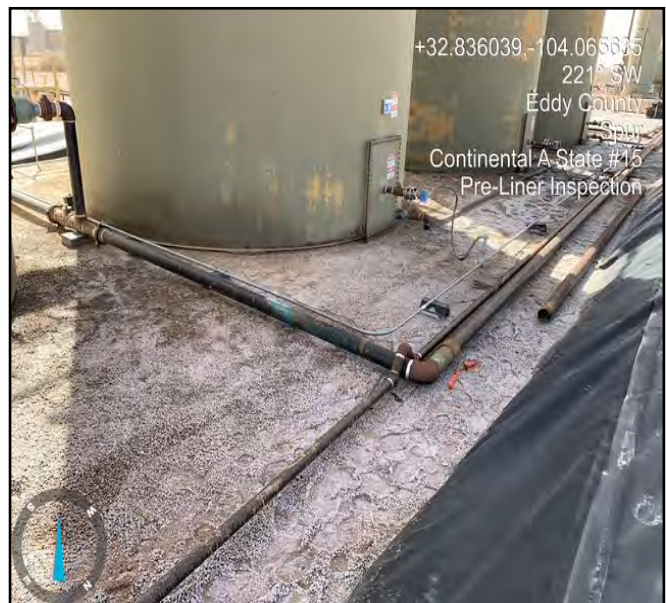
Photograph taken during the initial site assessment facing southwest.

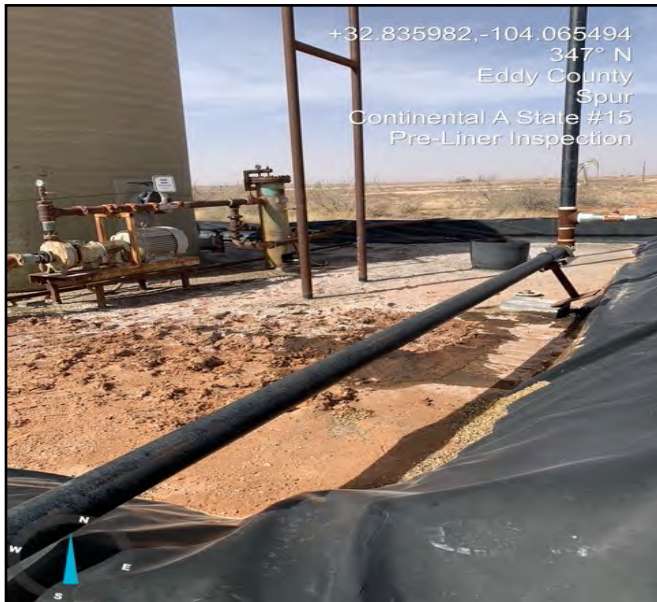
Photograph taken during the initial site assessment facing north.

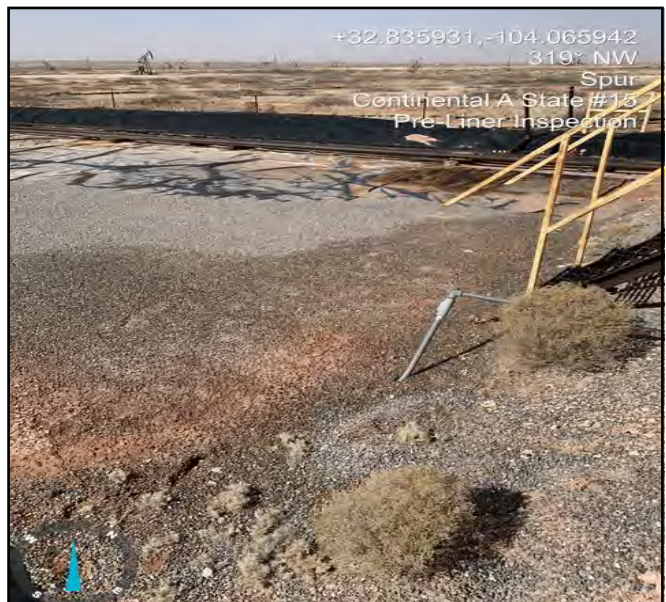
Photograph taken during the initial site assessment facing northwest.

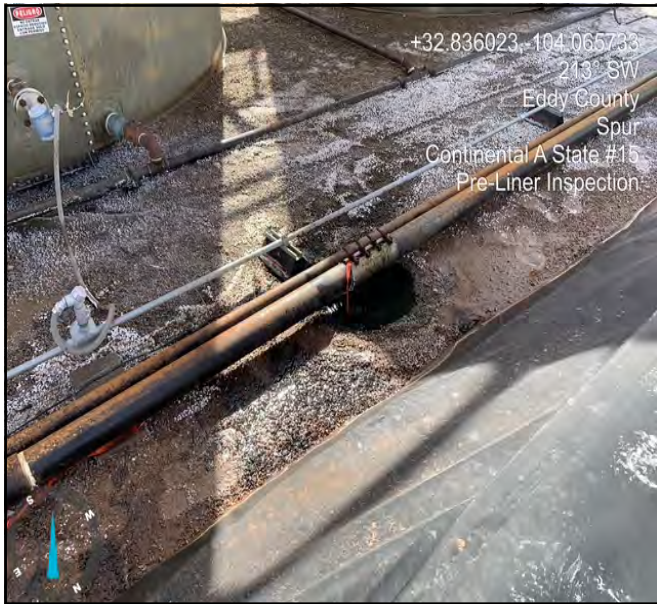
Photograph taken during the initial site assessment facing southwest.

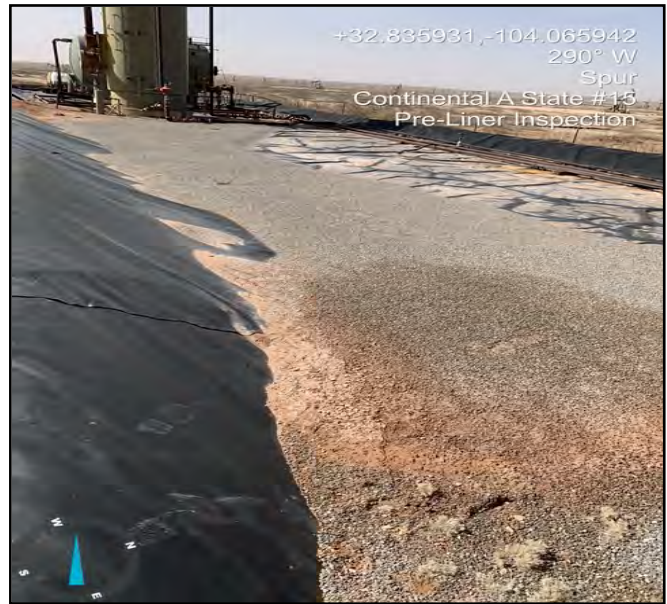
Photograph taken during the initial site assessment facing west.

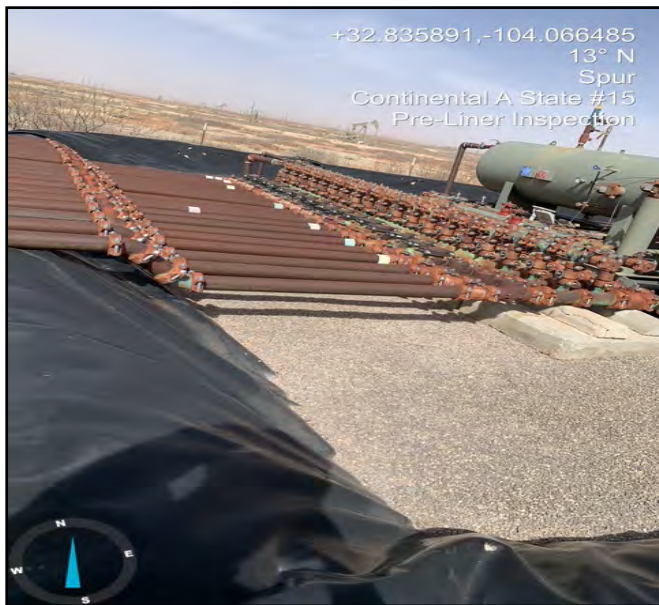
Photograph taken during the initial site assessment facing north.

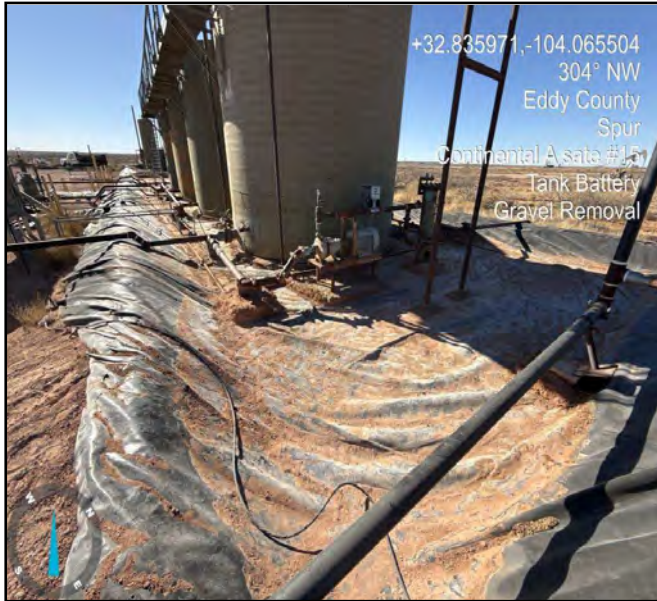
Photograph taken during the gravel removal process facing northwest.

From March 15 to March 18, Pima Environmental mobilized a hand crew to the site and removed approximately 20 cubic yards of contaminated gravel from within the lined containment. The impacted material was loaded into a dump truck and transported to an NMOCD-approved landfill for disposal. Following removal of the impacted material, the liner was cleaned using a power washer, and residual fluids were recovered with a vacuum truck to ensure complete removal.

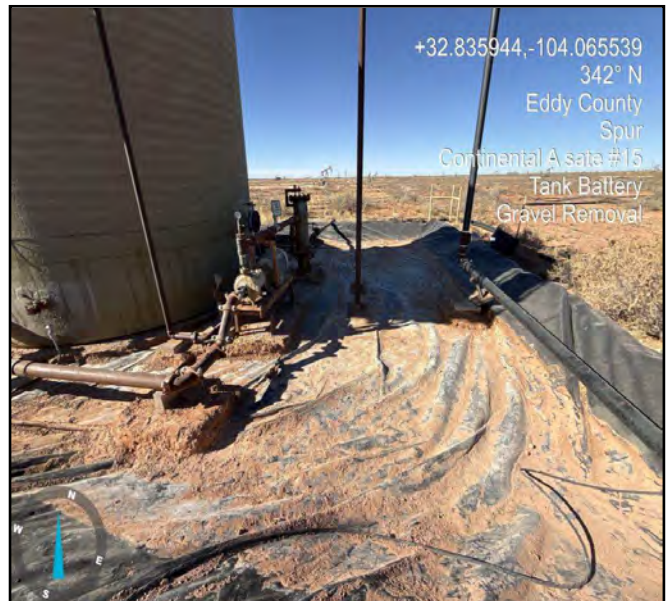
Photograph taken during the gravel removal process facing north.

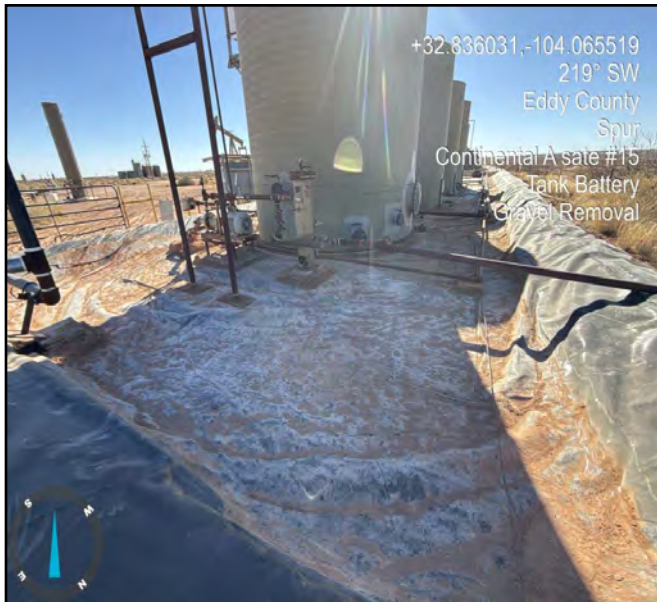
Photograph taken during the gravel removal process facing southwest.

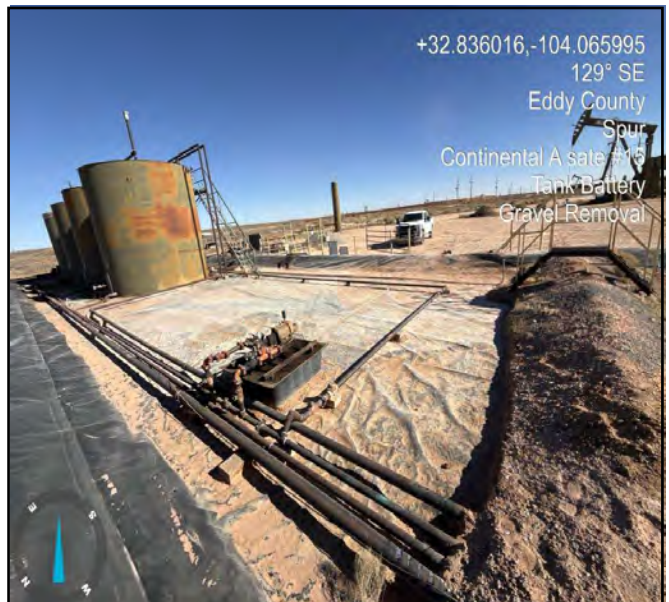
Photograph taken during the gravel removal process facing southeast.

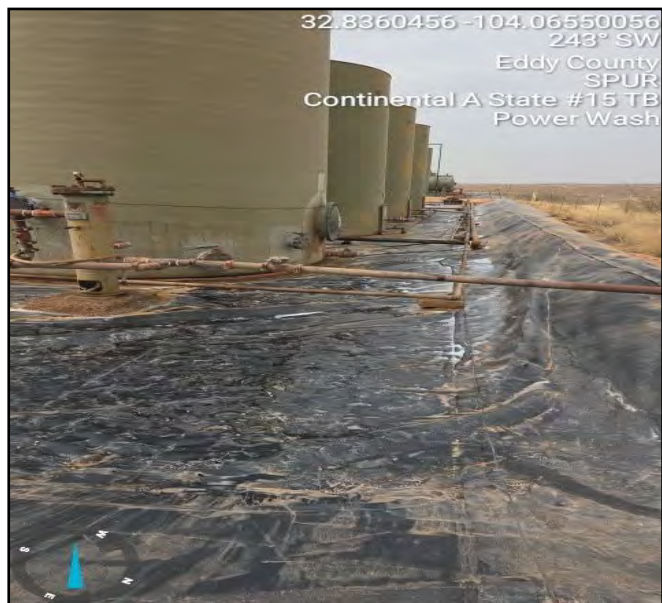
Photograph taken post powerwash facing southwest.

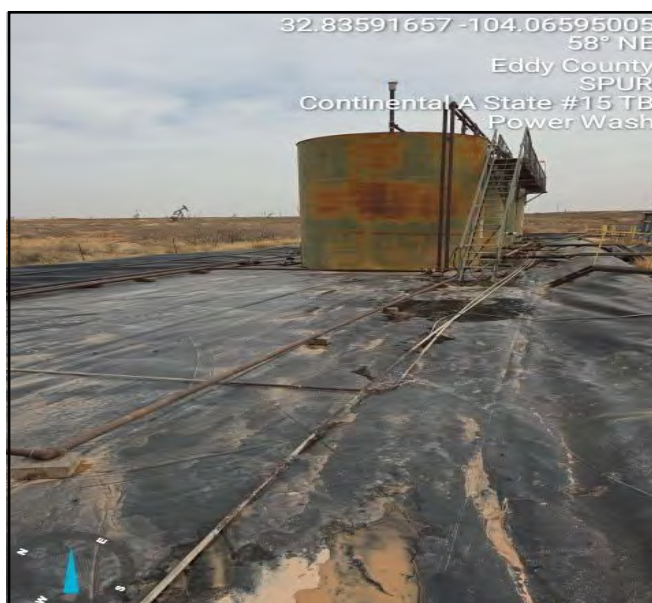
Photograph taken post powerwash facing northeast.

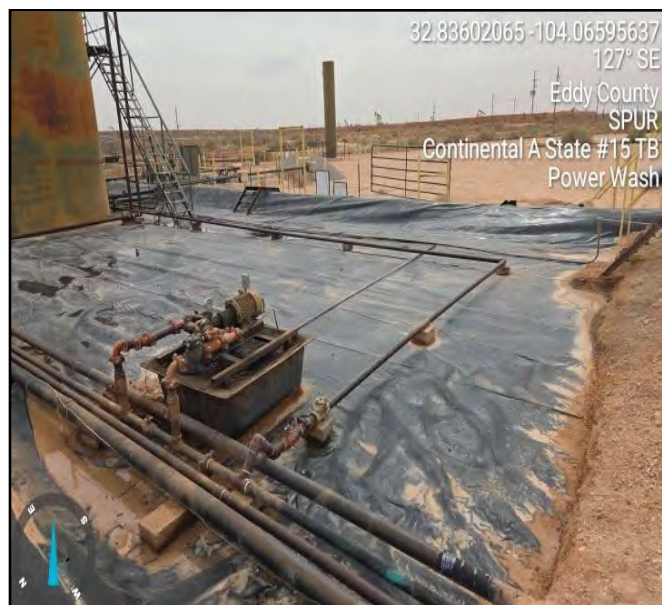
Photograph taken post powerwash facing southeast.

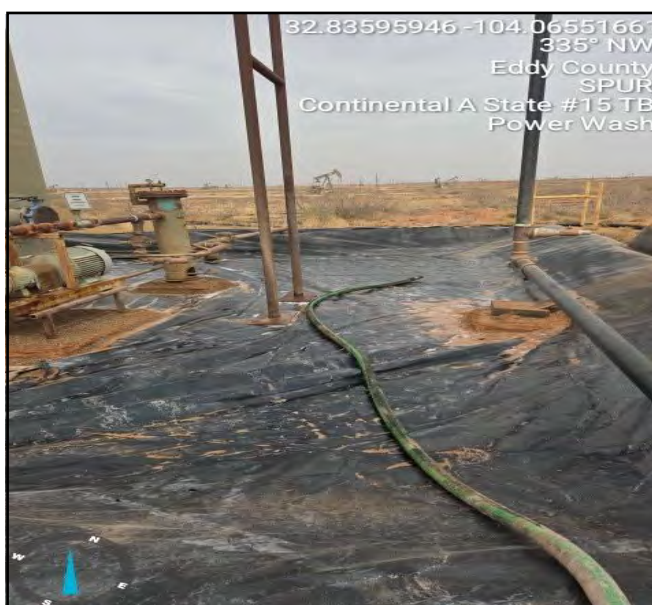
Photograph taken post powerwash facing northwest.

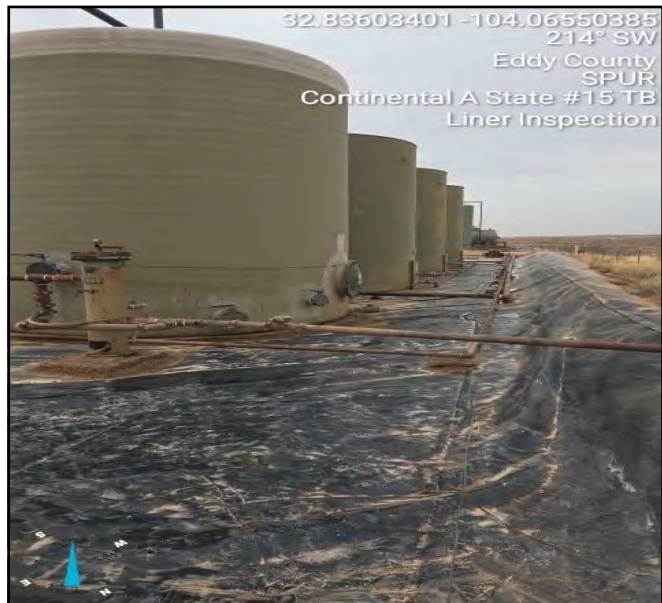
A thorough inspection of the lined containment was conducted after remediation activities, confirming that the system remained intact and effectively contained all fluids. As a result, the liner was deemed functional, with no further environmental impact observed. A detailed report, including photographic documentation, is provided in Appendices C and D.

Photograph taken during liner inspection facing southwest.

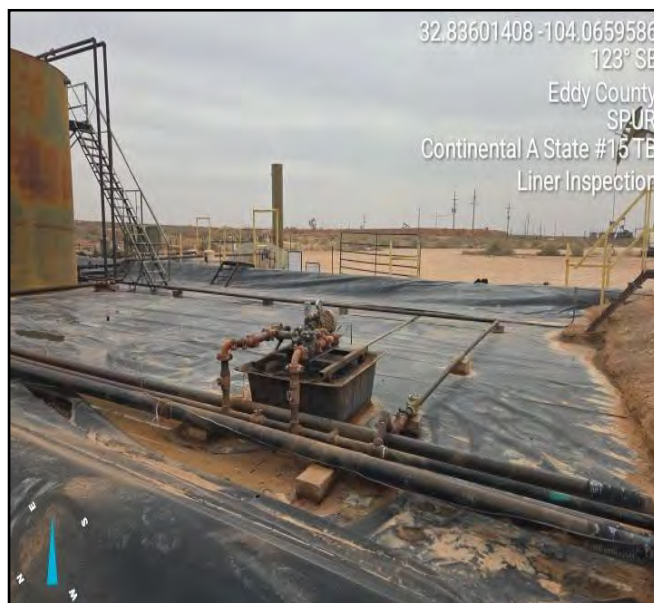
Photograph taken during liner inspection facing southeast.

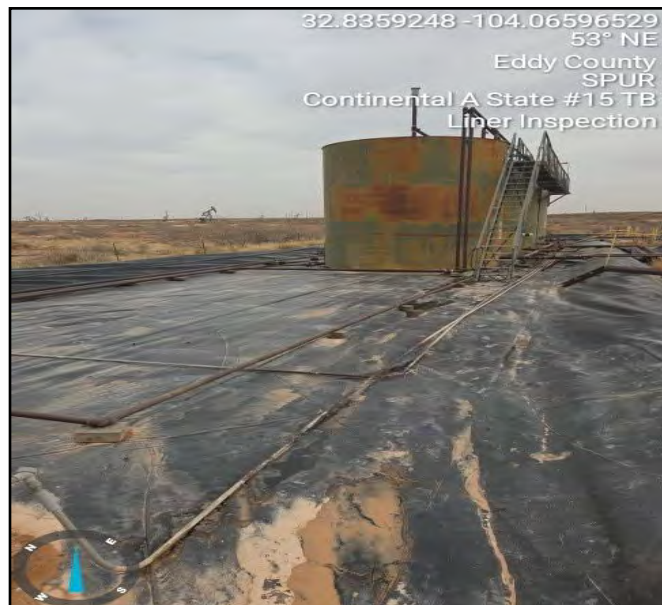
Photograph taken during liner inspection facing northeast.

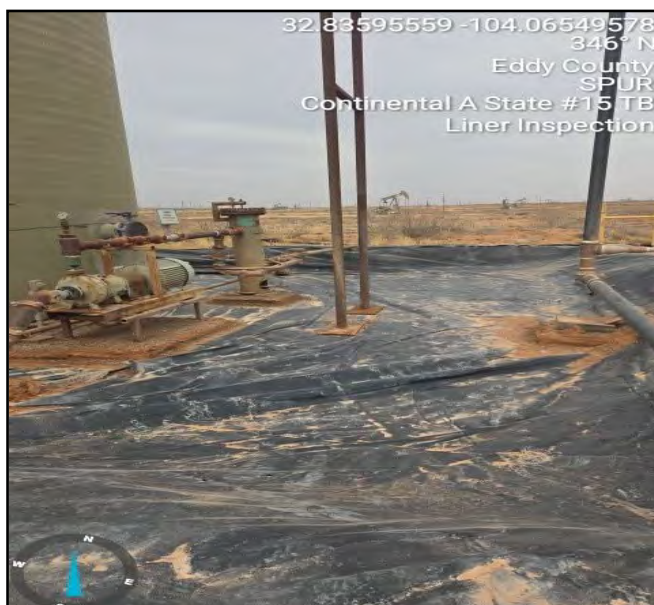
Photograph taken during liner inspection facing north.

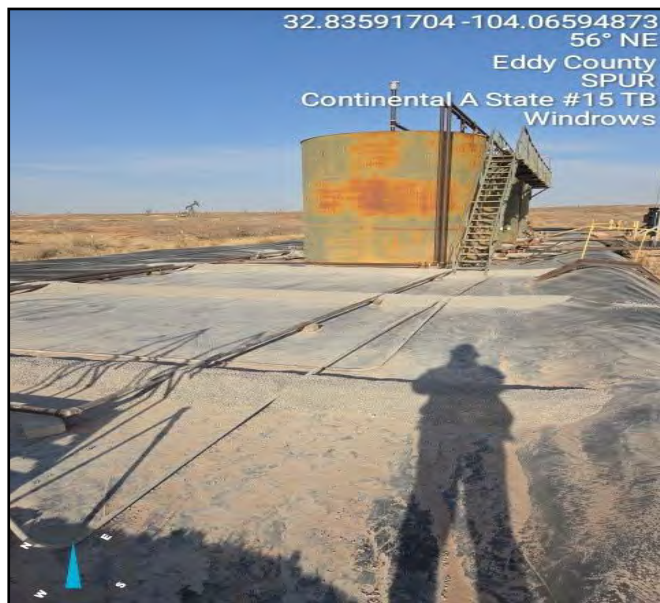
Photo taken after windrows were laid facing northeast.

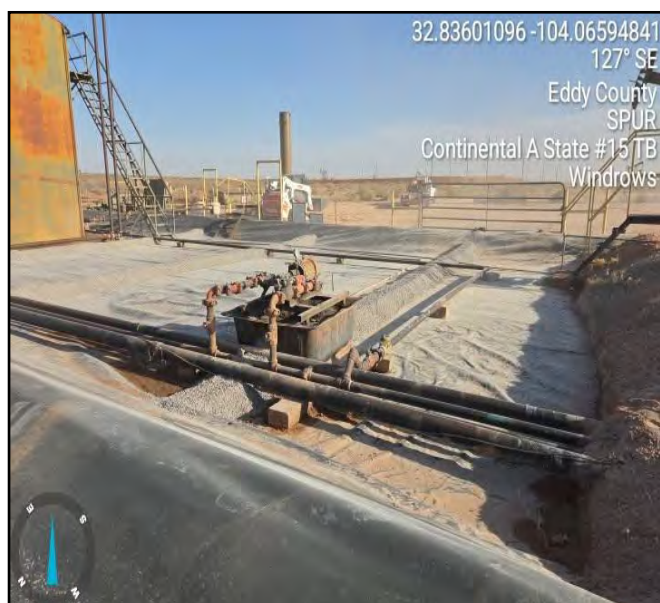
Photo taken after windrows were laid facing southeast.

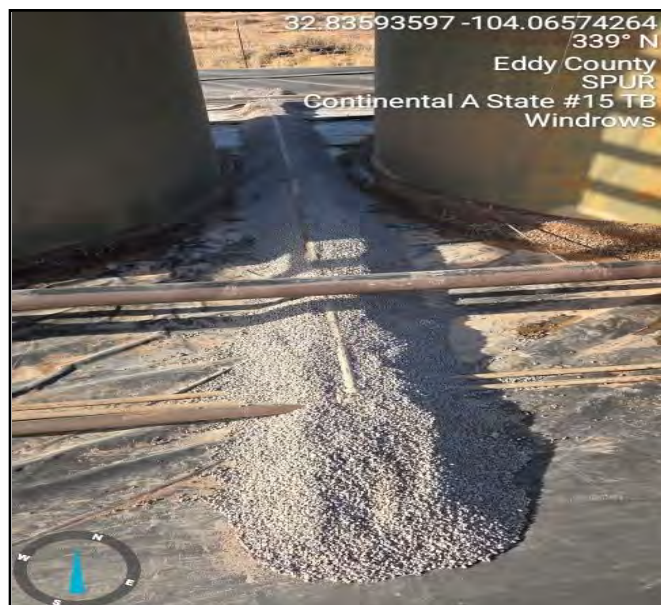
Photo taken after windrows were laid facing north.

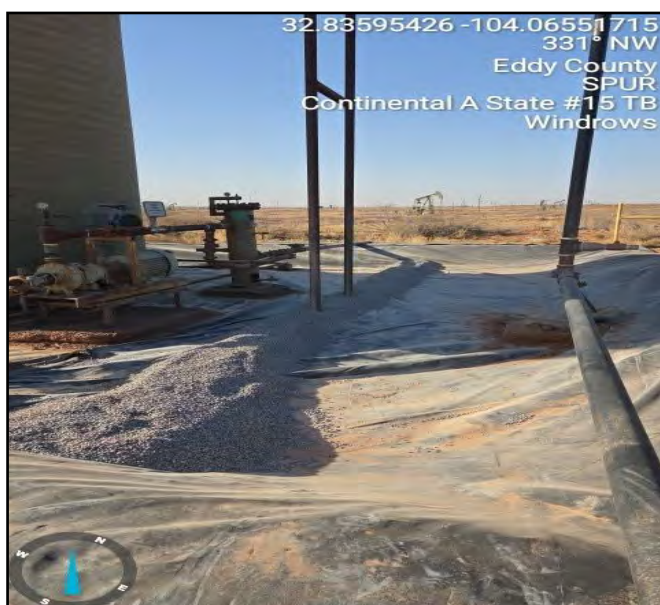
Photo taken after windrows were laid facing northwest.
