## Site Characterization and Liner Inspection Report

SERPENTINE 2 FACILITY 1

nAPP2528329987, nAPP2528930966,  
nAPP2529629057, & nAPP2600522423

Lea County, New Mexico

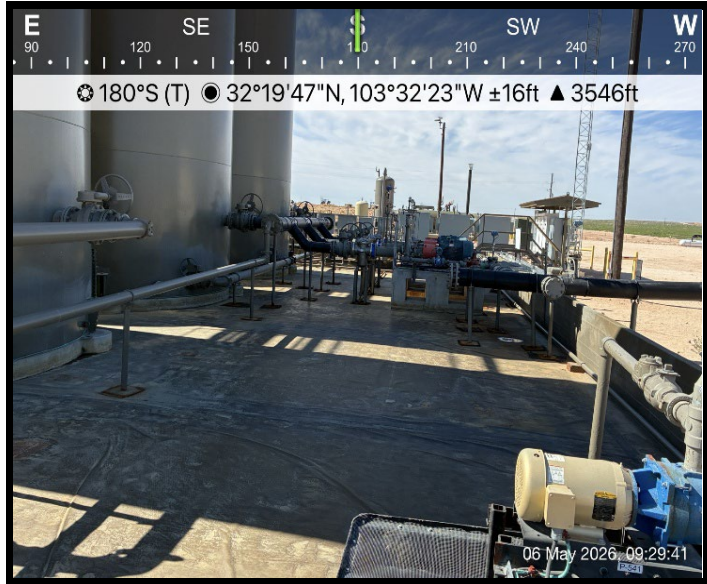
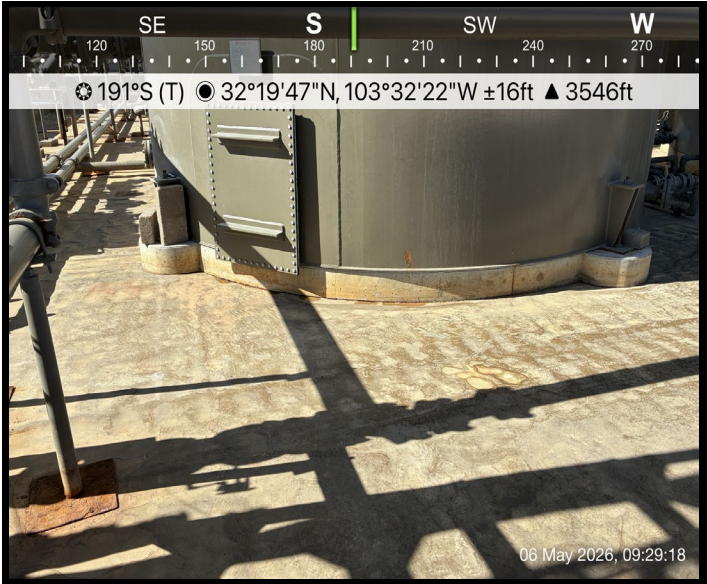
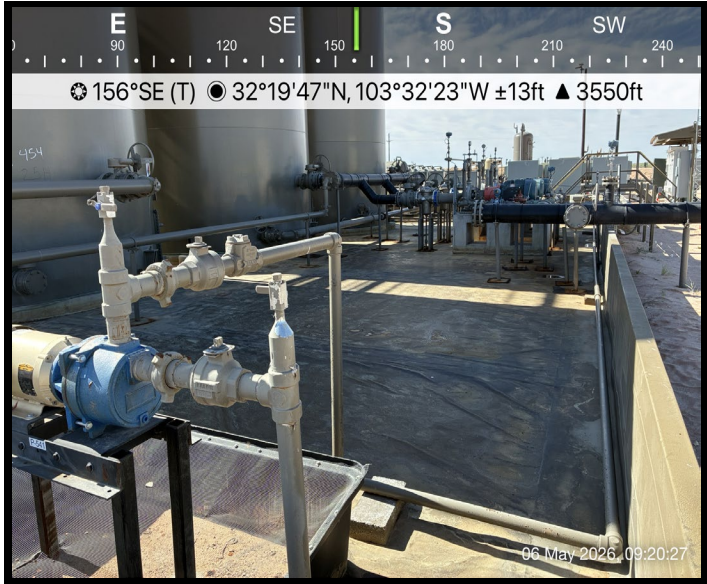
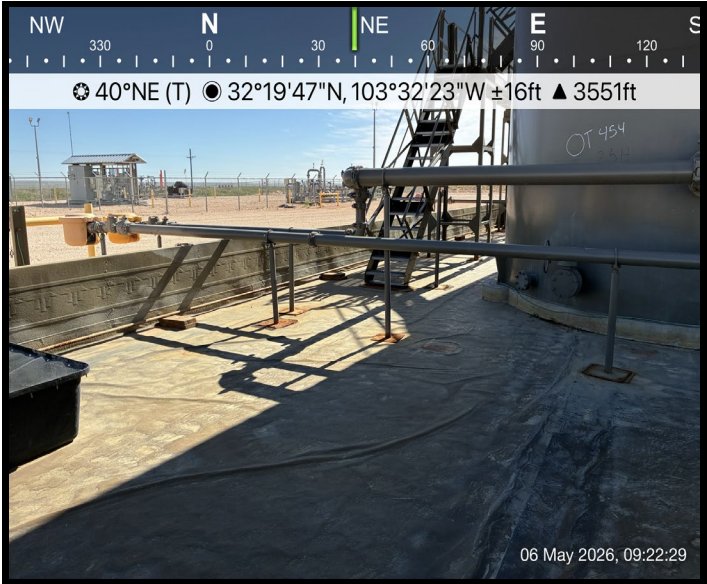
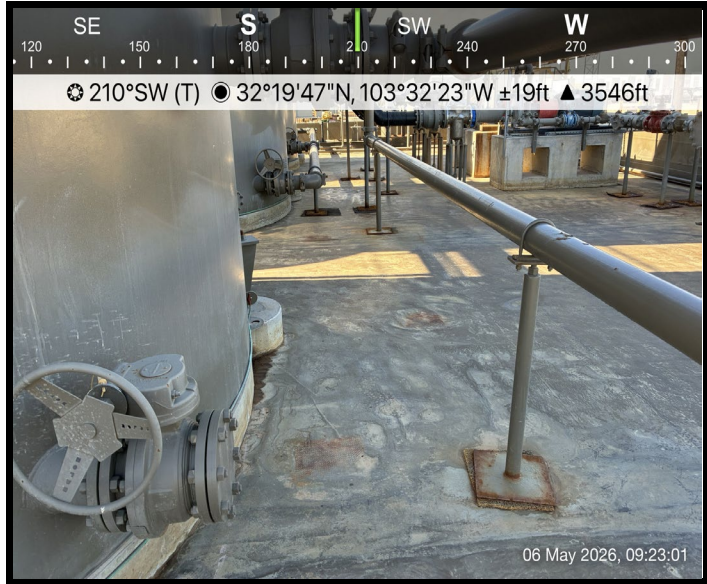
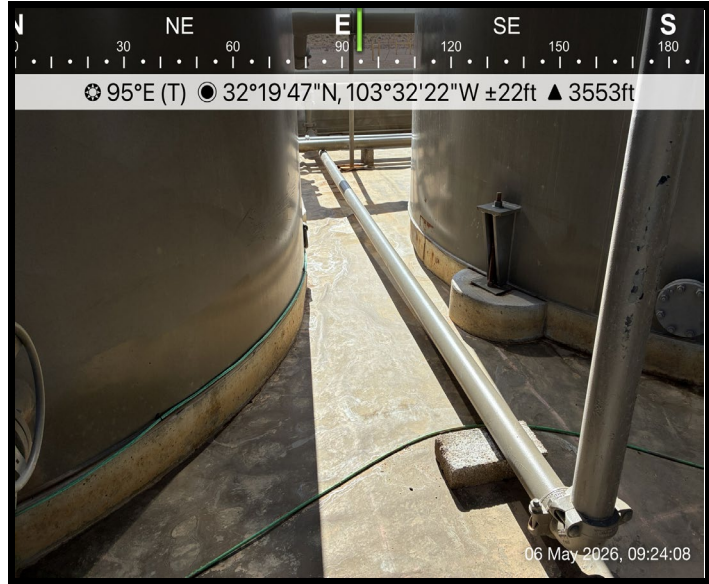
After the liner was cleaned, on May 6<sup>th</sup>, 2026, Standard performed a liner inspection. The liner was free of any standing fluid. The liner integrity was intact with no breaches or holes discovered during the inspection. Photographs taken during the liner inspection can be found under Attachment C: Photographic Log.

View of Liner
