SUBJECT: Liner Inspection and Closure Report for Tater Tot 2 CTB 2 – May 8, 2026 and May 12, 2026 Site Visits

Incident IDs: nAPP2606428628 and nAPP2612734857
Facility API (Name): fAPP2416935463 (TATER TOT 2 CTB 2)
Facility Location: Unit M of Section 2, Township 24 South, Range 29 East, New Mexico
Facility GPS Coordinates: 32.2422093, -103.9601062
Eddy County, New Mexico

LINER INSPECTION FIELD NOTES & PHOTOLOG REPORT

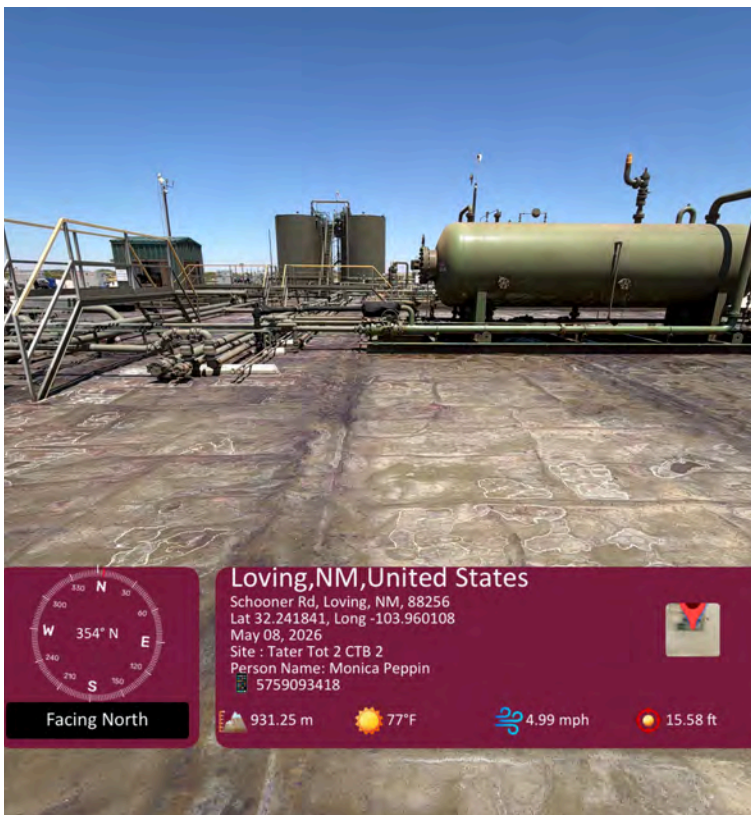
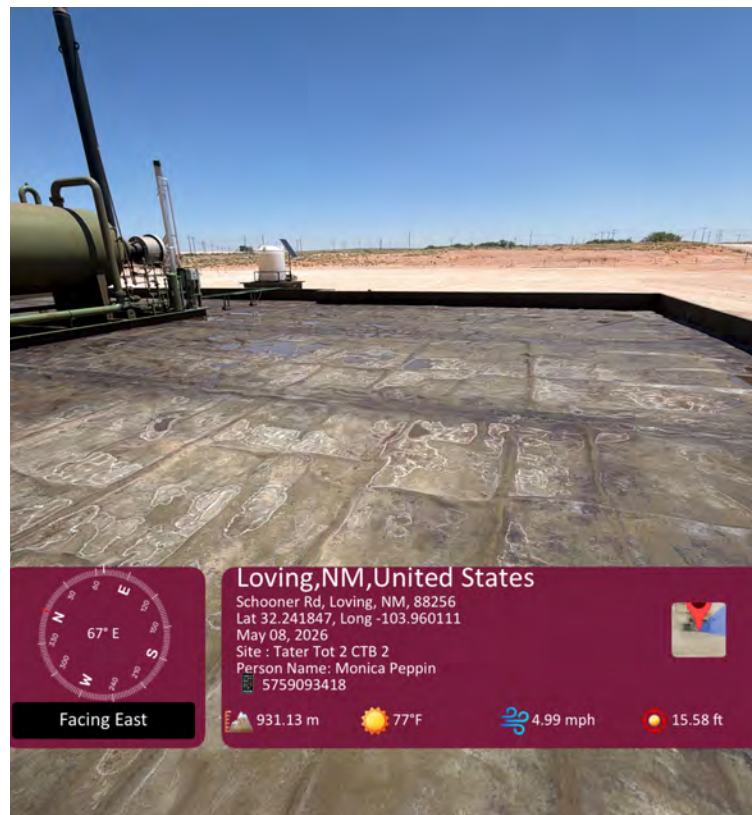
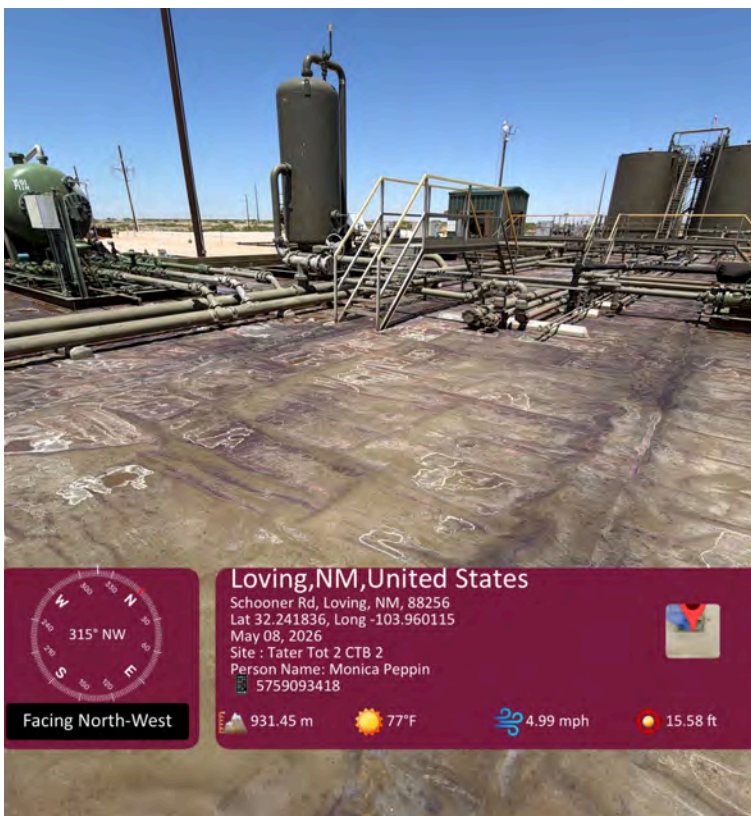
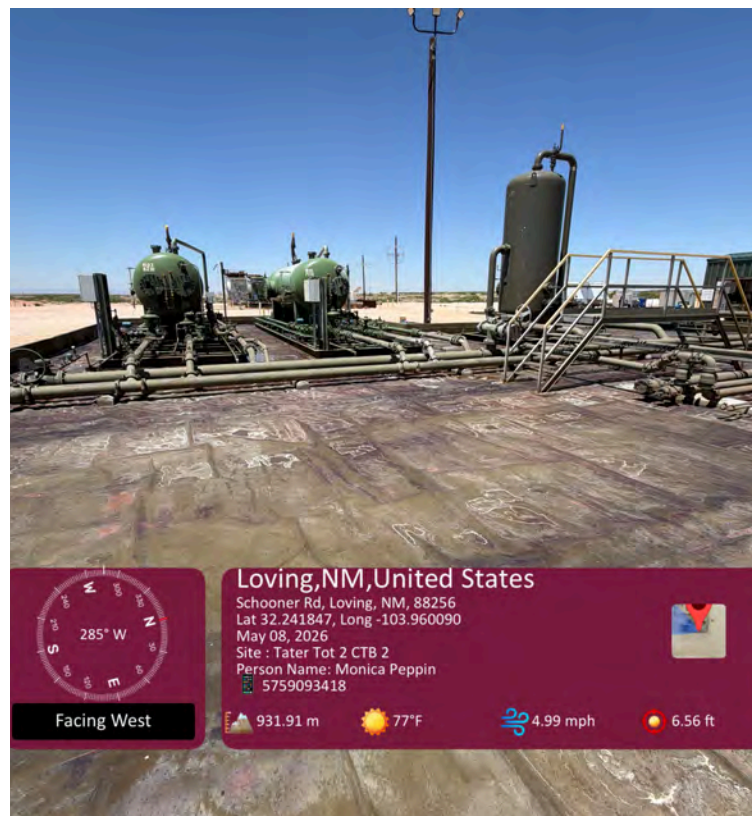
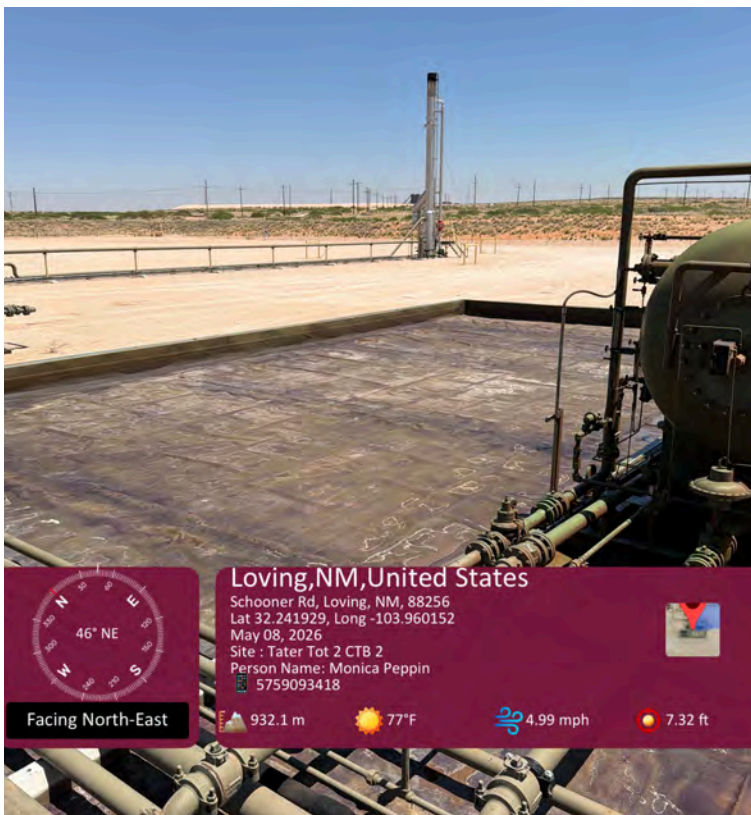
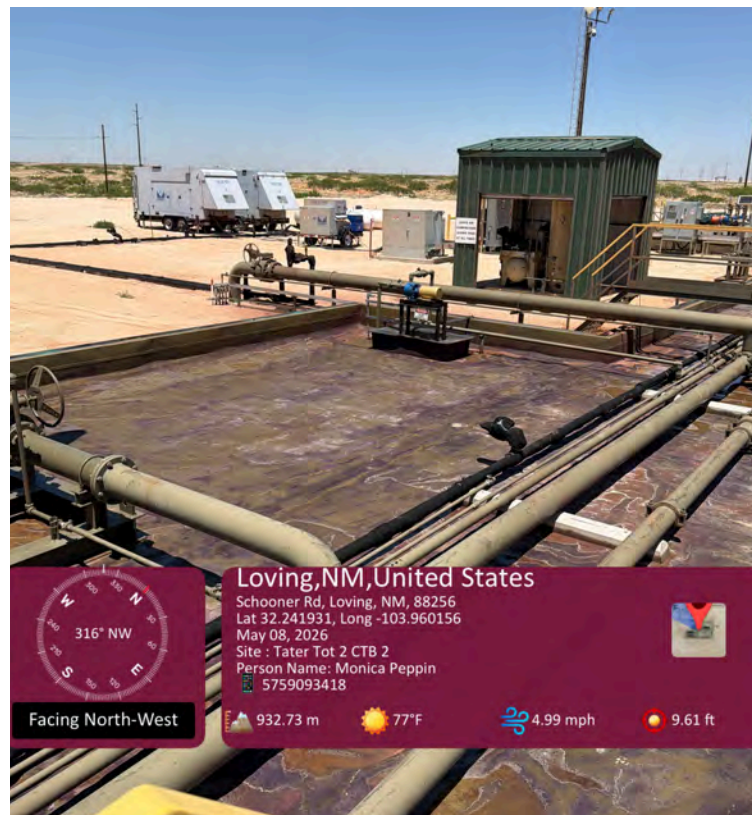
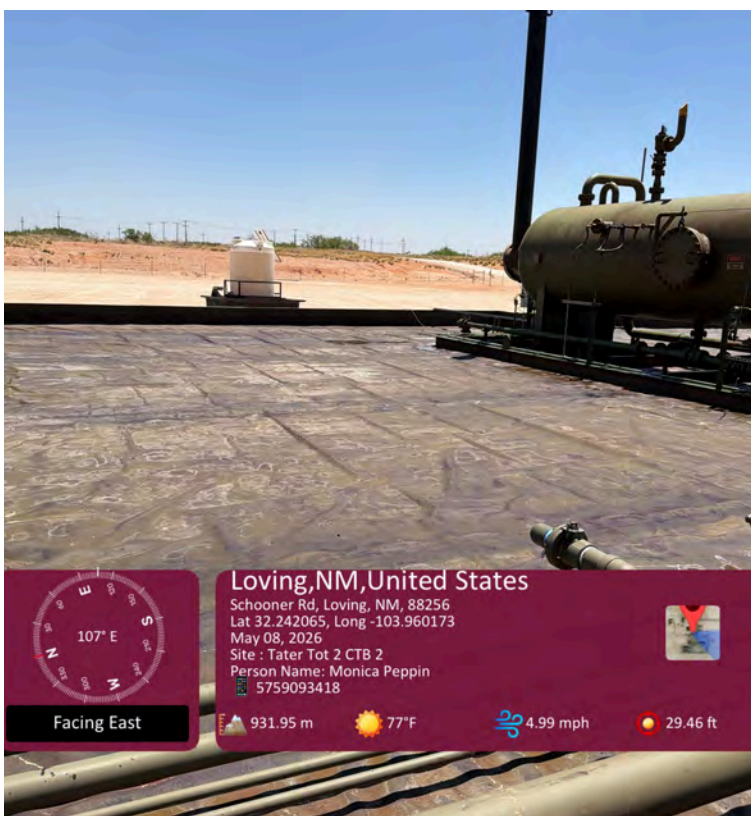
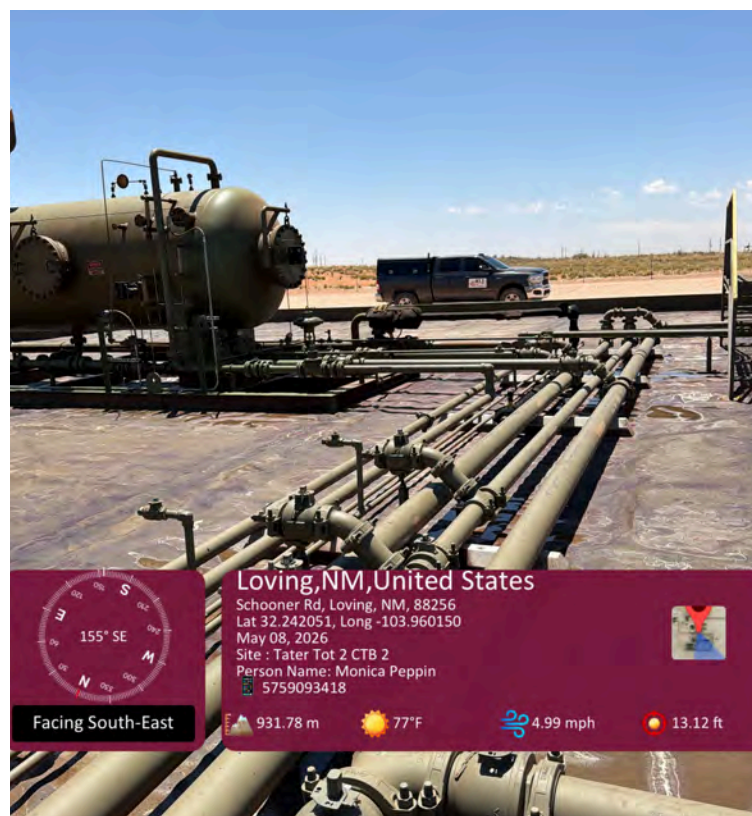
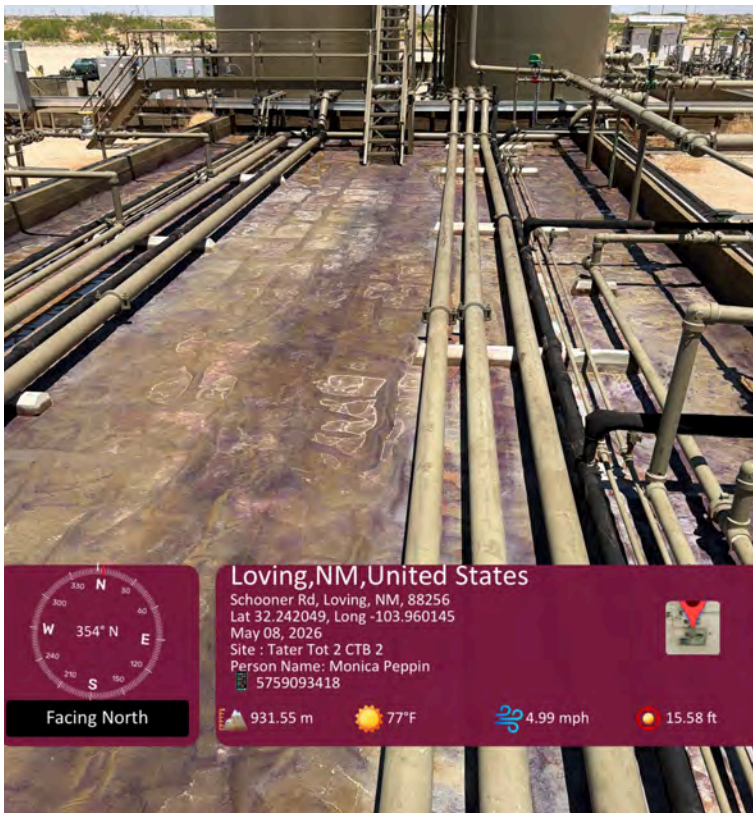
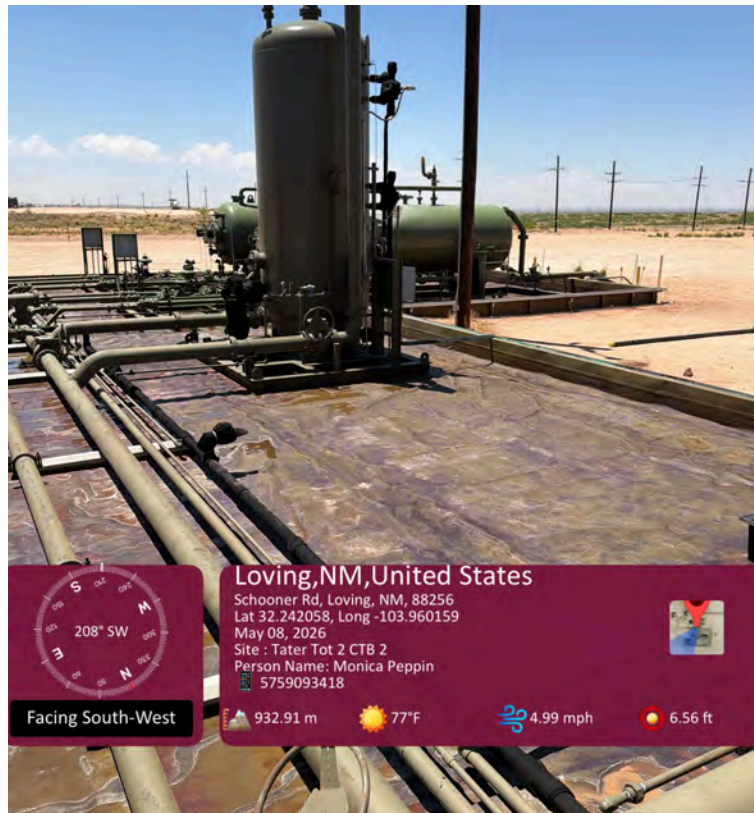
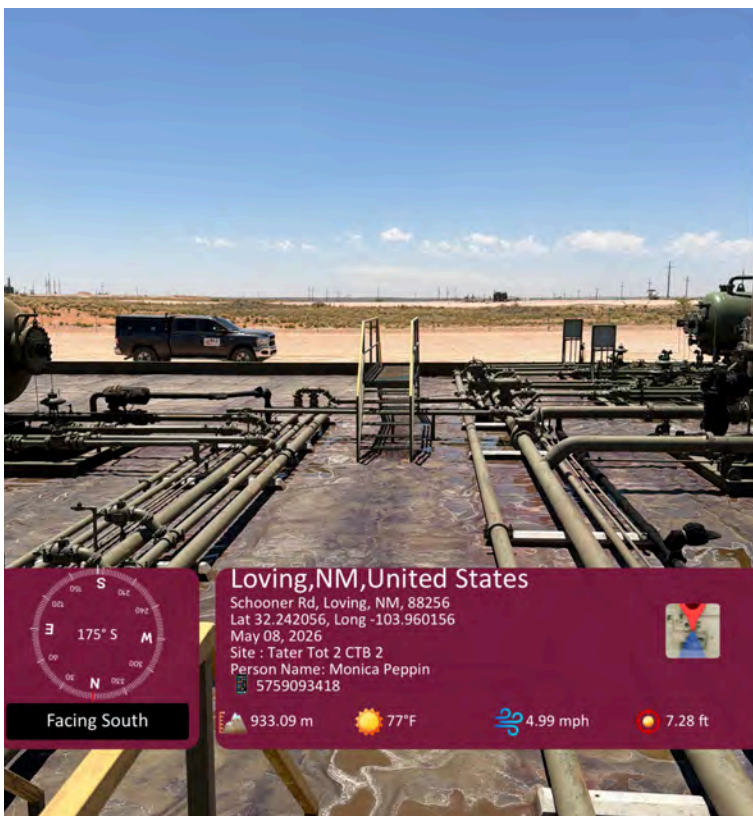
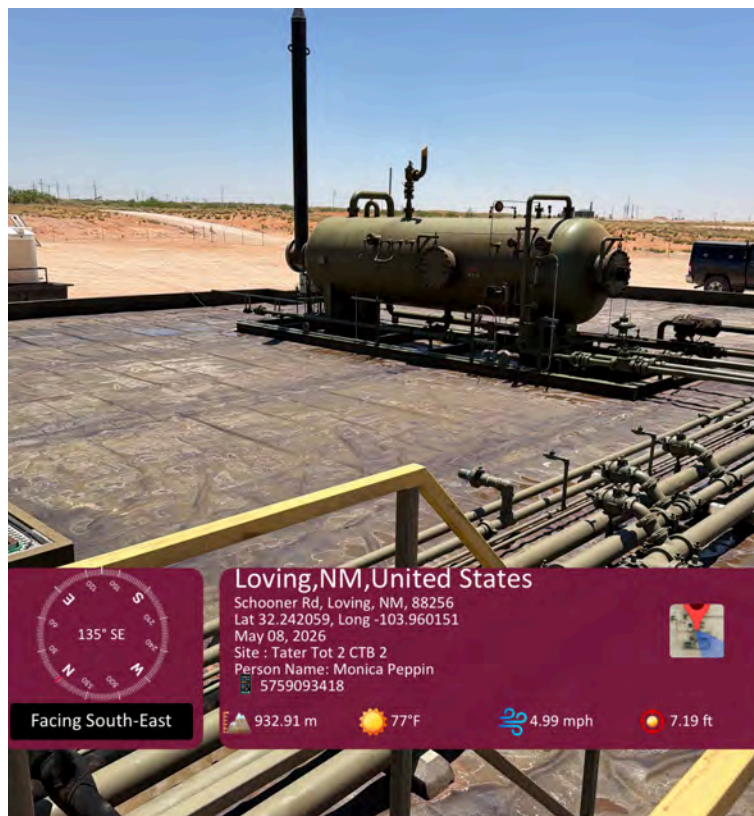
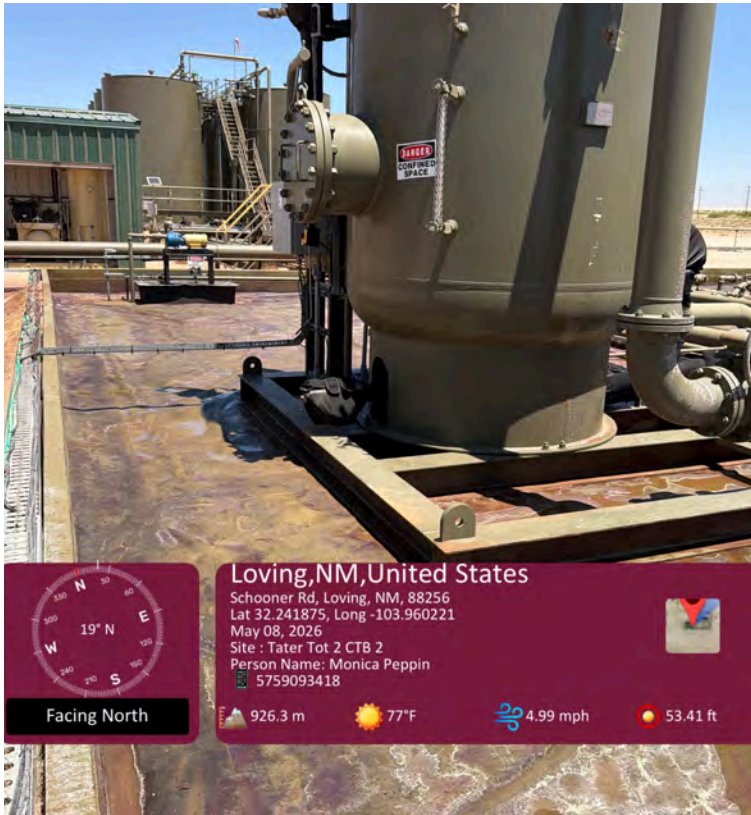
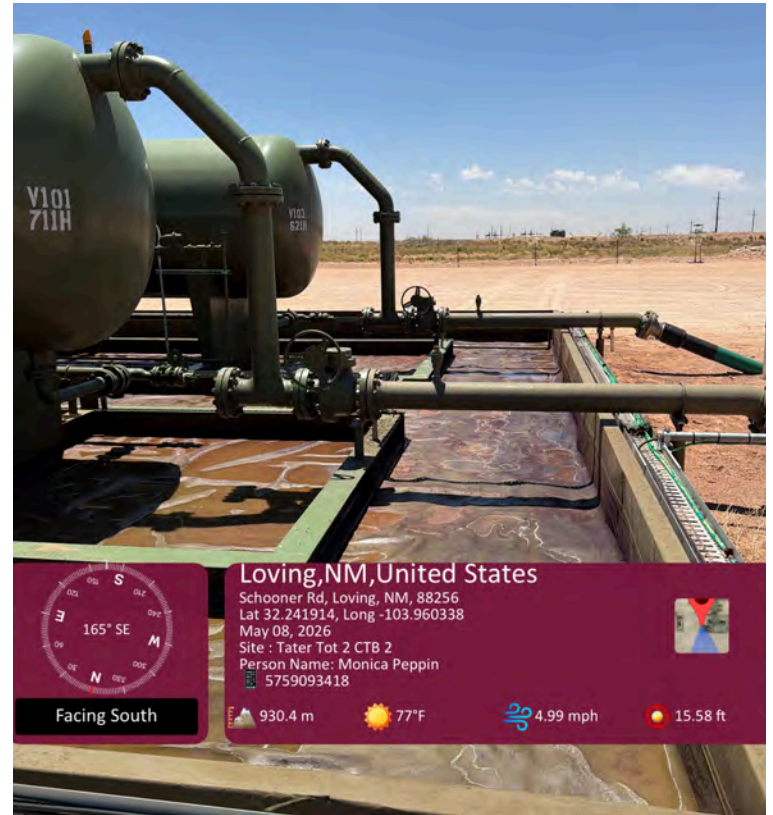
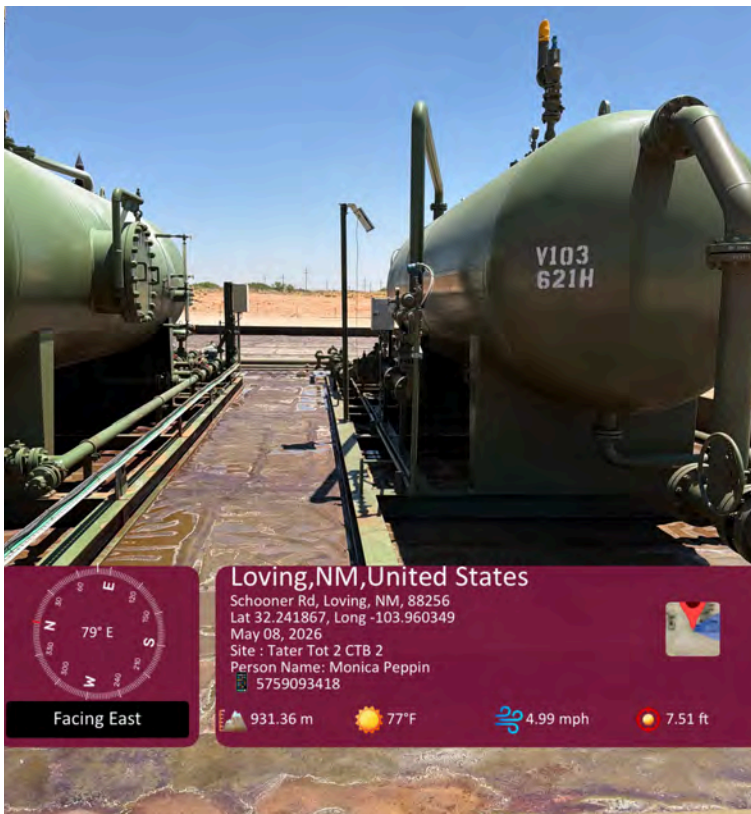
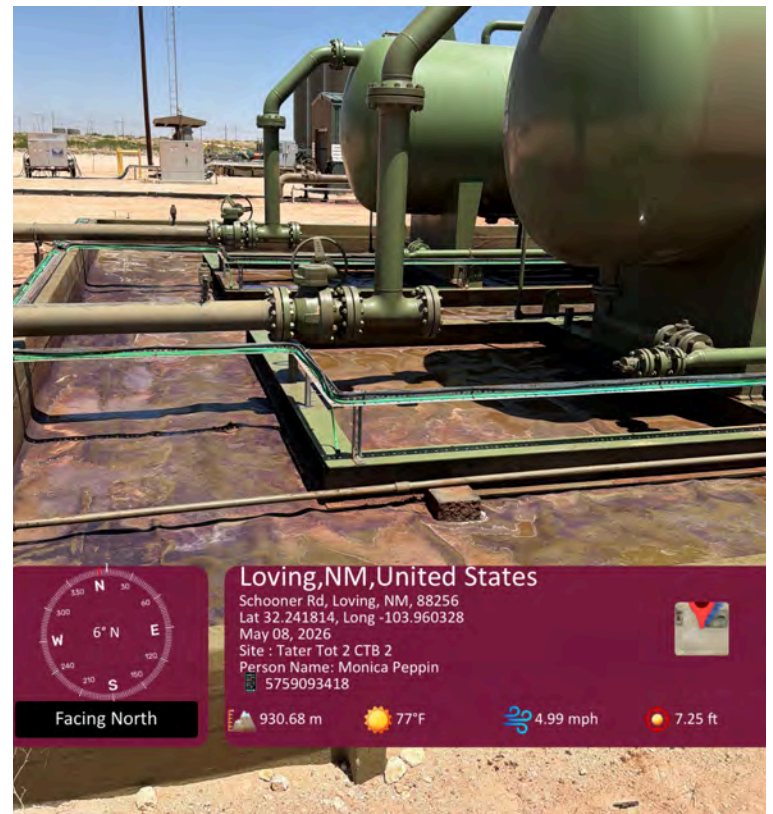
Liner integrity confirmed and passes inspection.

- Observations consisted of the base, walls, and areas where equipment is congested.
- No signs of visible damage including cuts, holes, and UV wear.
- Liner integrity confirmed and passes inspection.
- No further assessment needed.
