SUBJECT: Liner Inspection and Closure Report for Tater Tot 2 CTB 2 – May 8, 2026 and May 12, 2026 Site Visits

Incident IDs: nAPP2606428628 and nAPP2612734857
Facility API (Name): fAPP2416935463 (TATER TOT 2 CTB 2)
Facility Location: Unit M of Section 2, Township 24 South, Range 29 East, New Mexico
Facility GPS Coordinates: 32.2422093, -103.9601062
Eddy County, New Mexico

LINER INSPECTION FIELD NOTES & PHOTOLOG REPORT

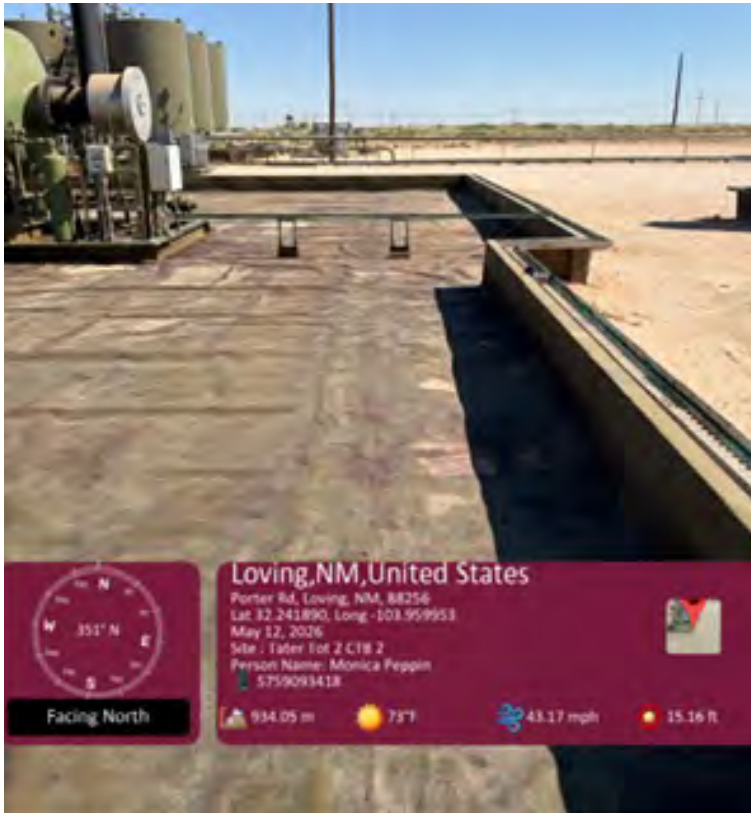
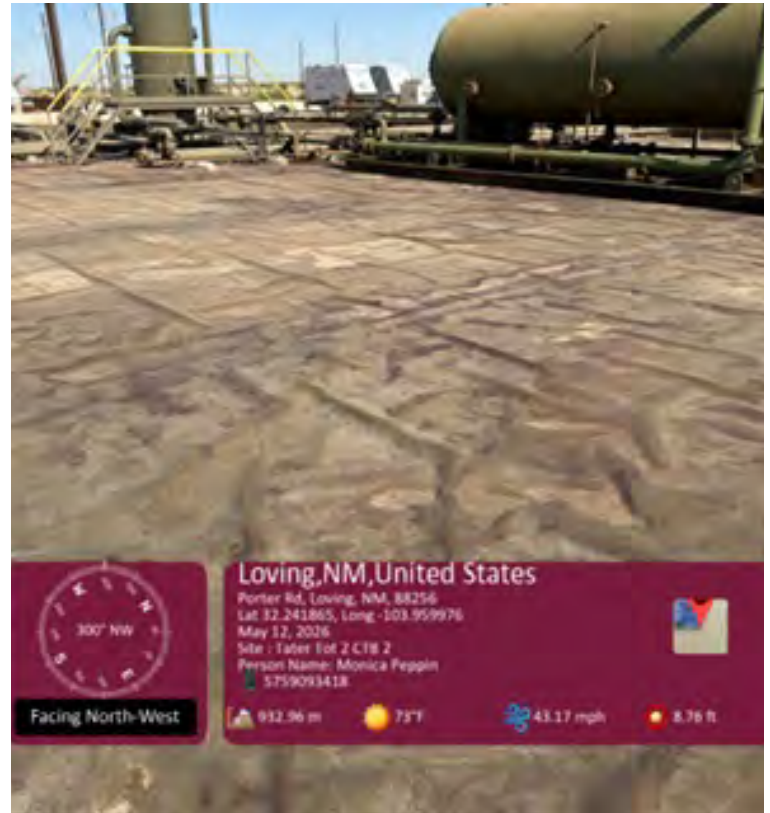
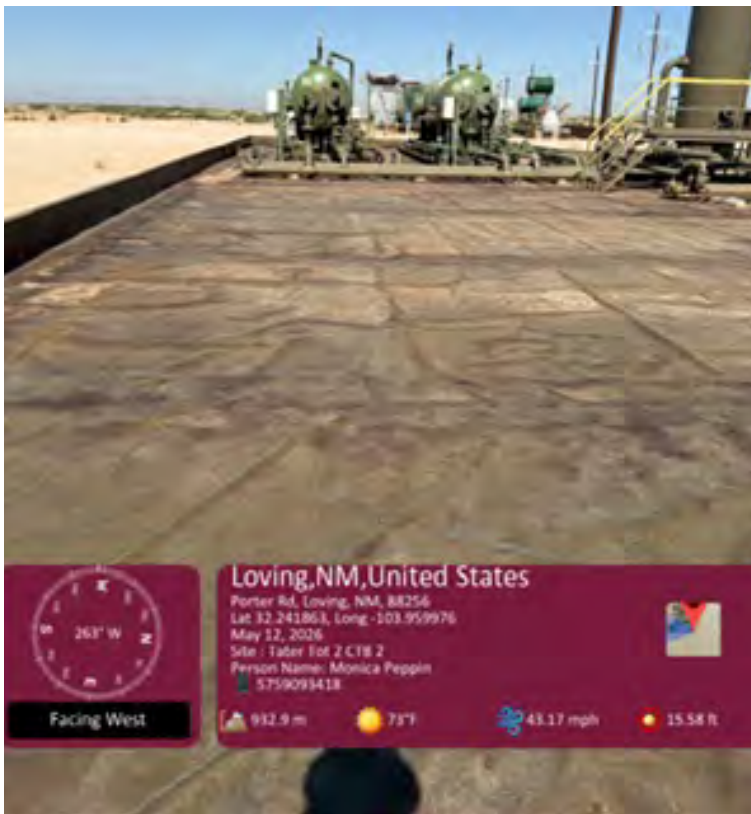
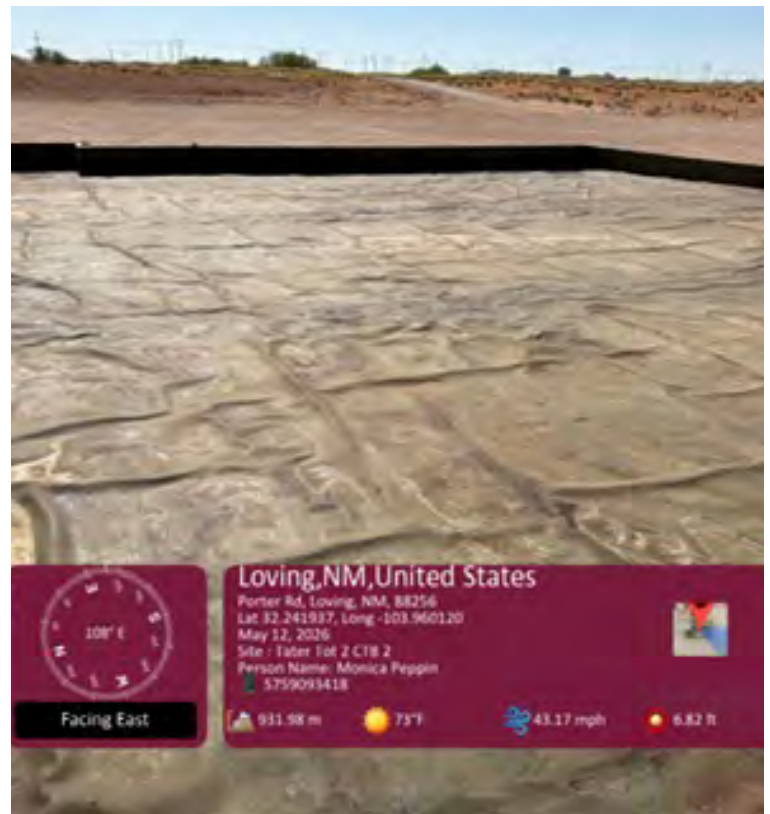
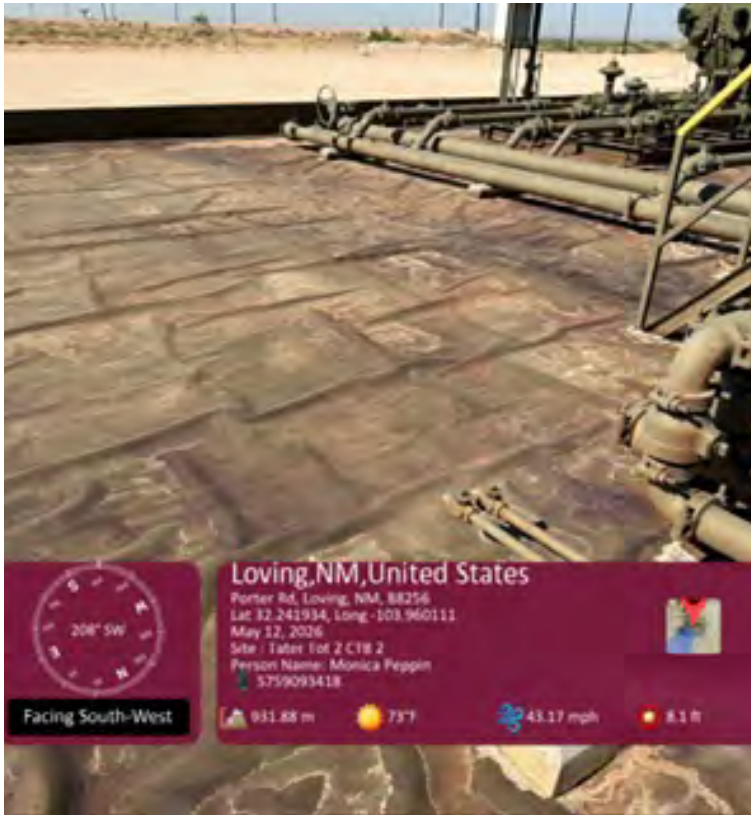
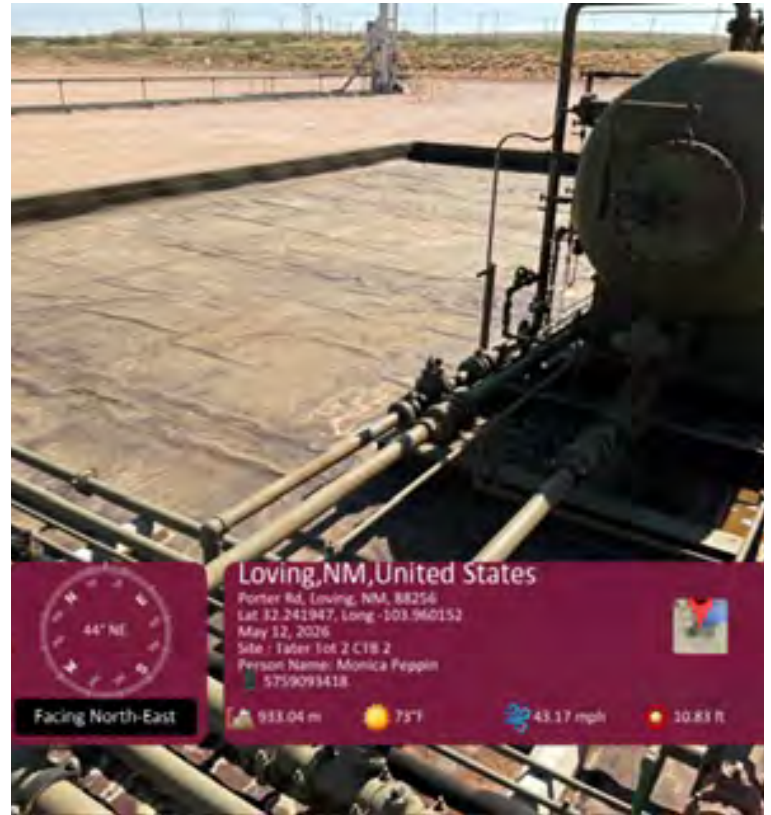
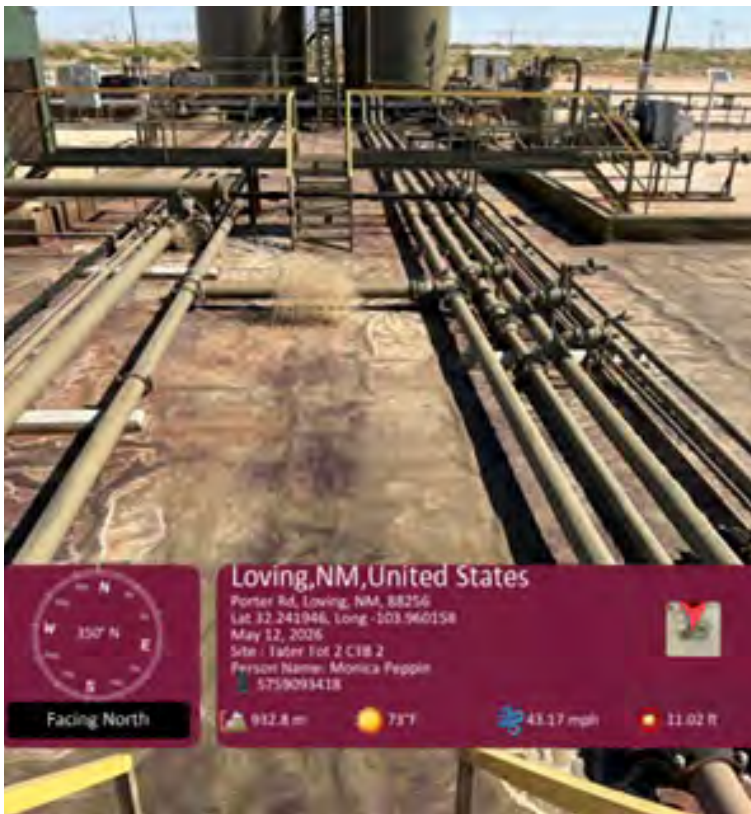
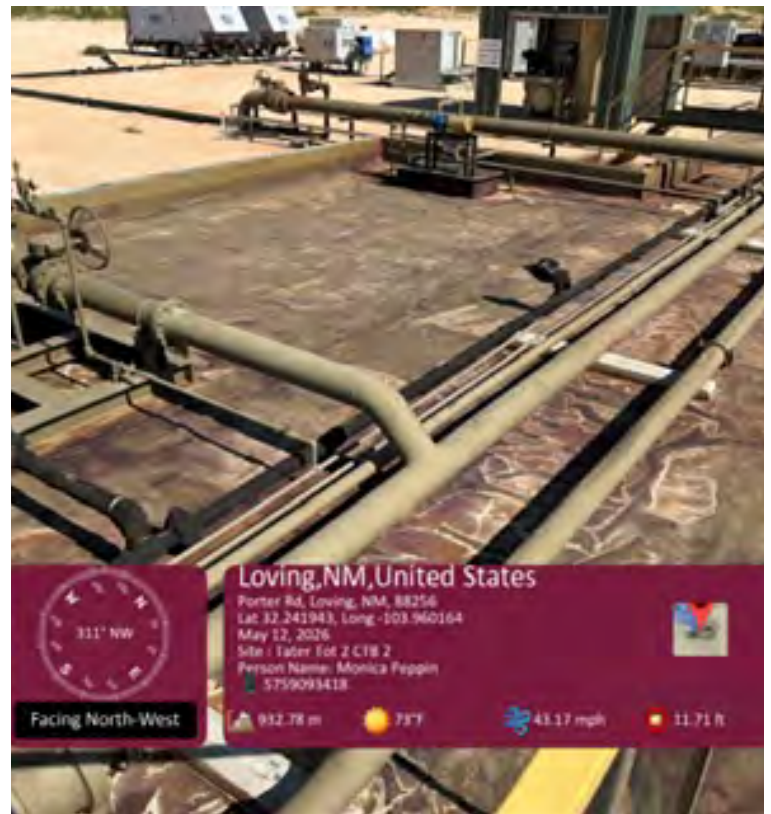
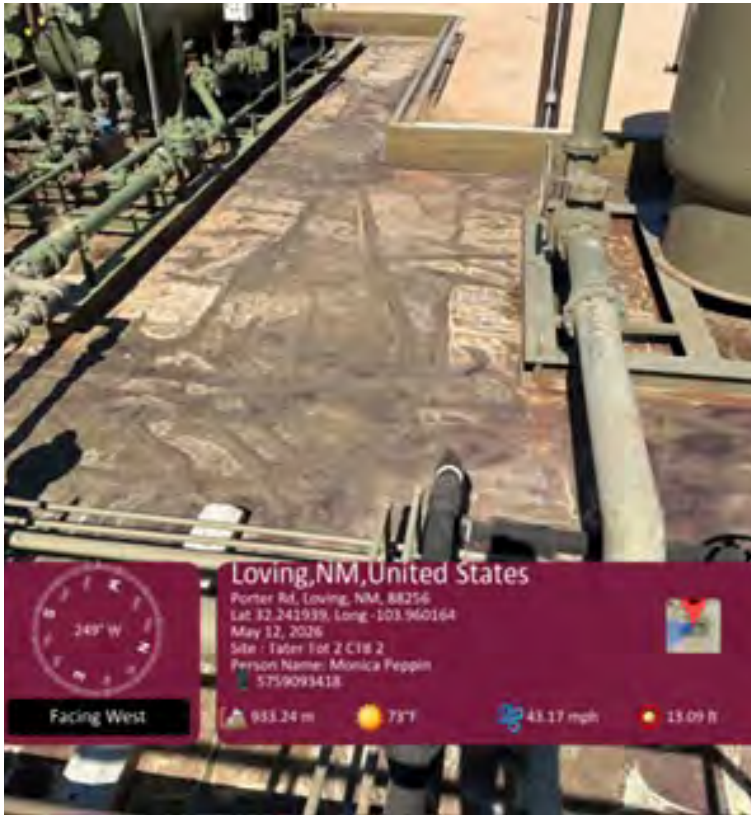
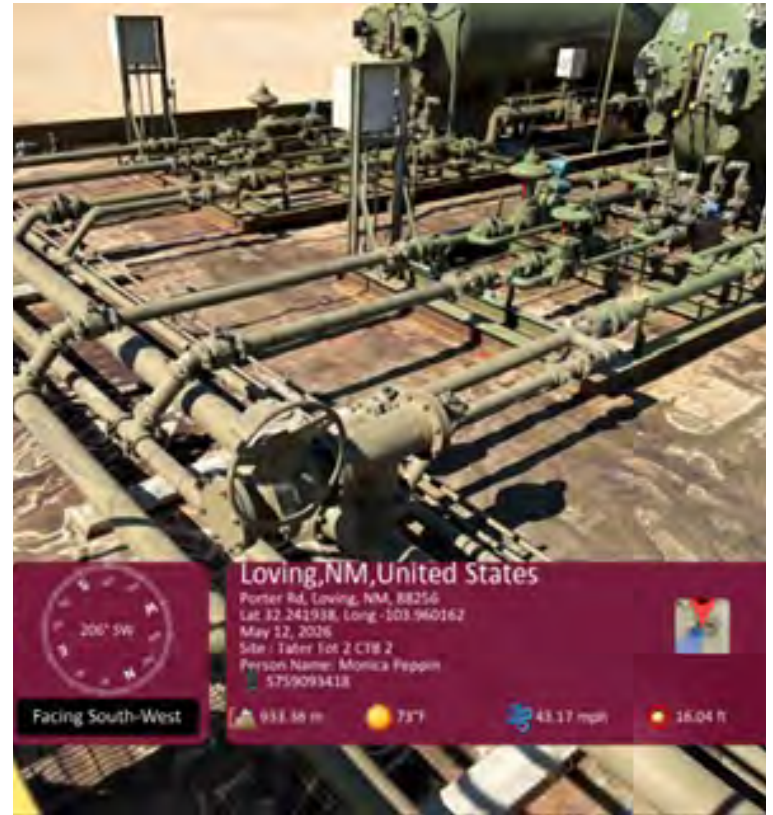
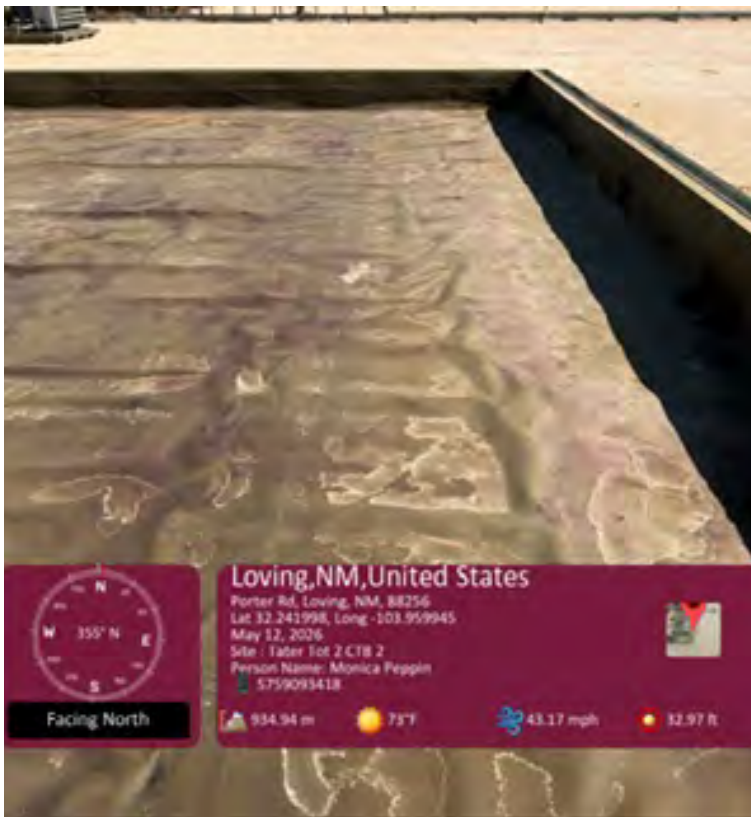
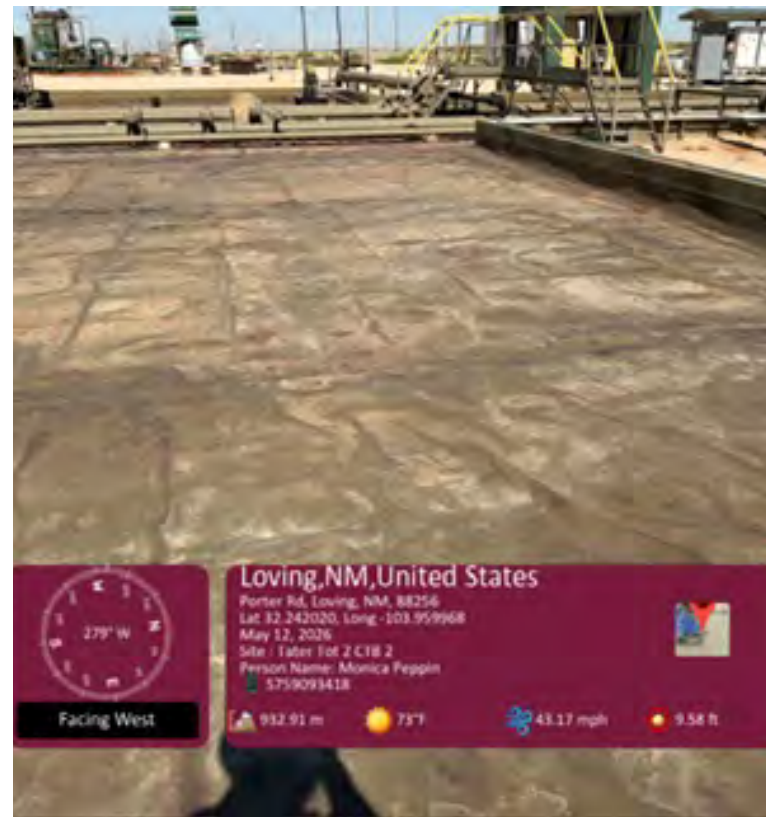
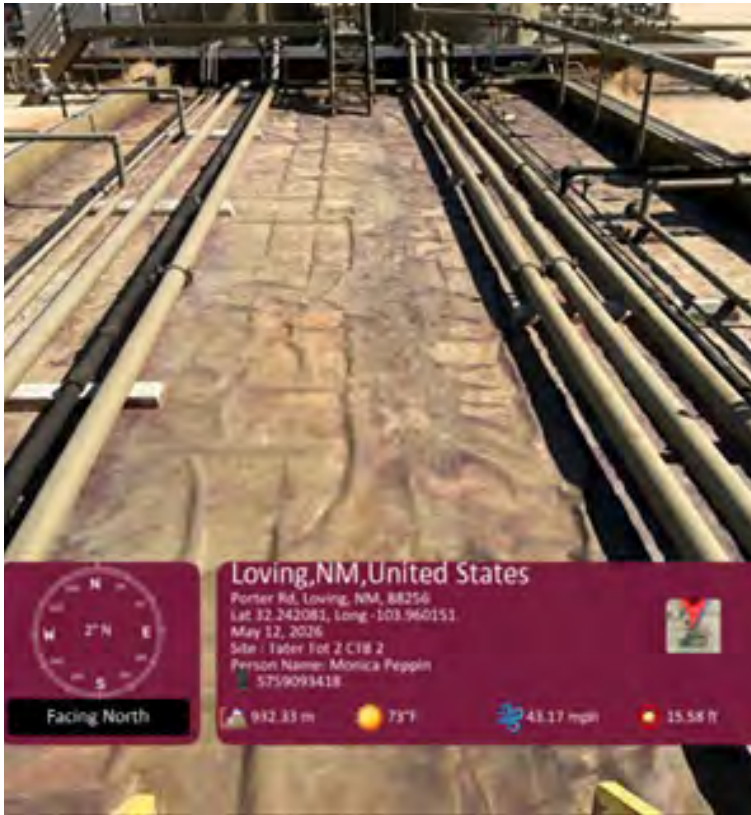
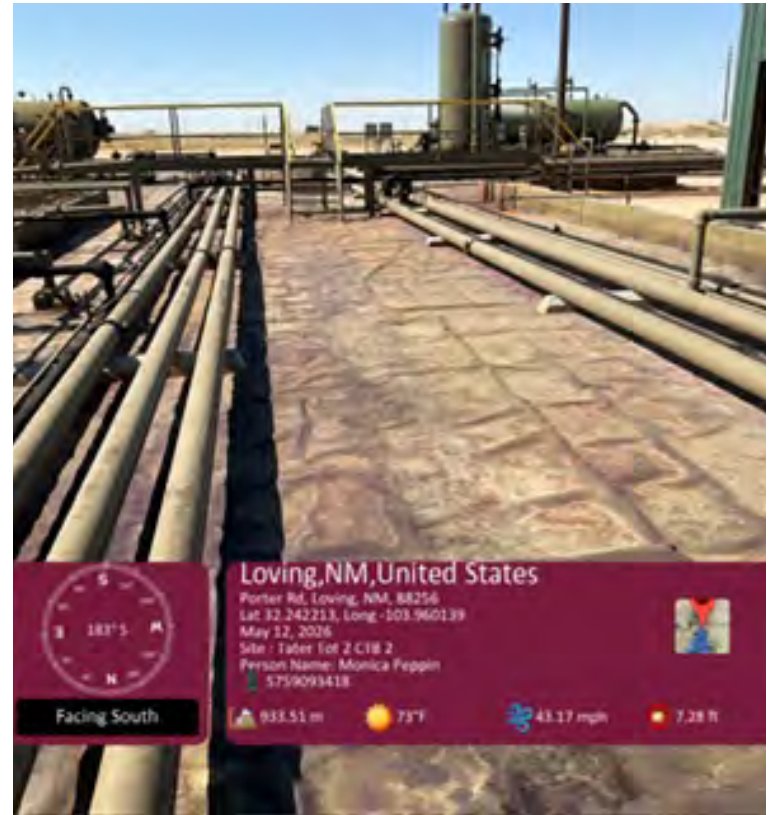
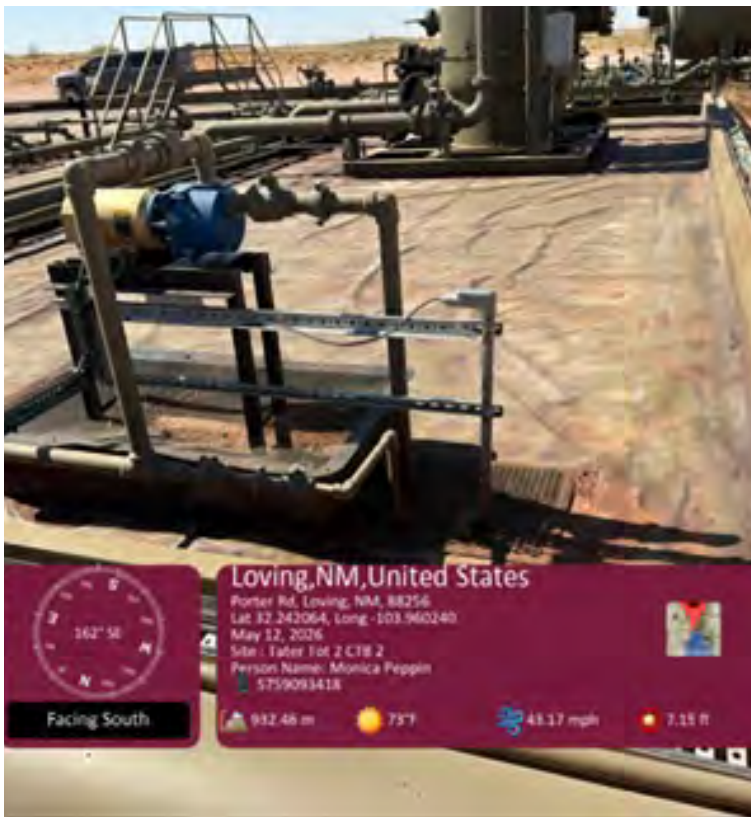
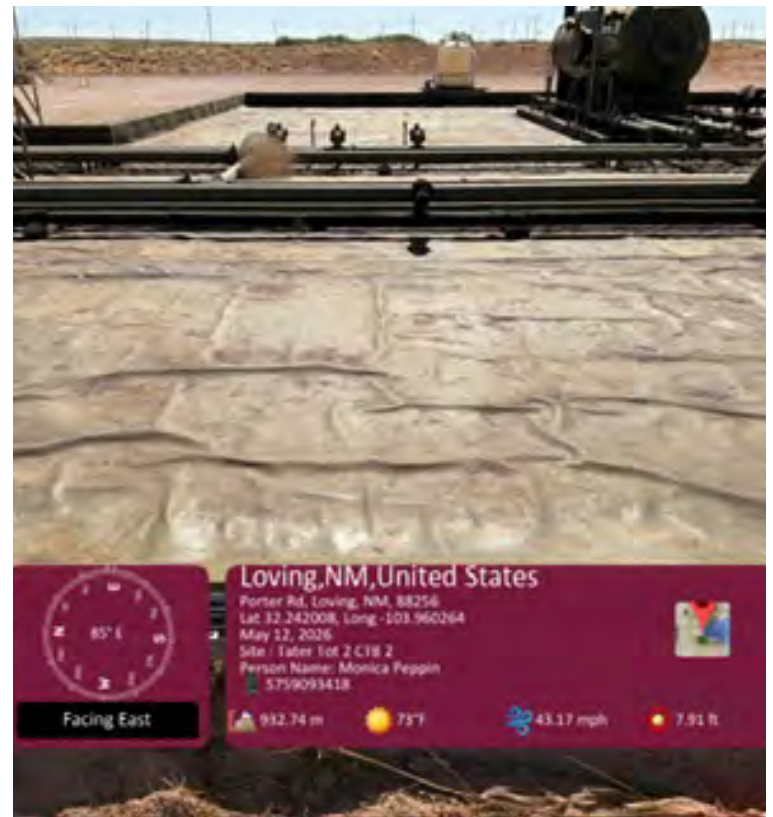
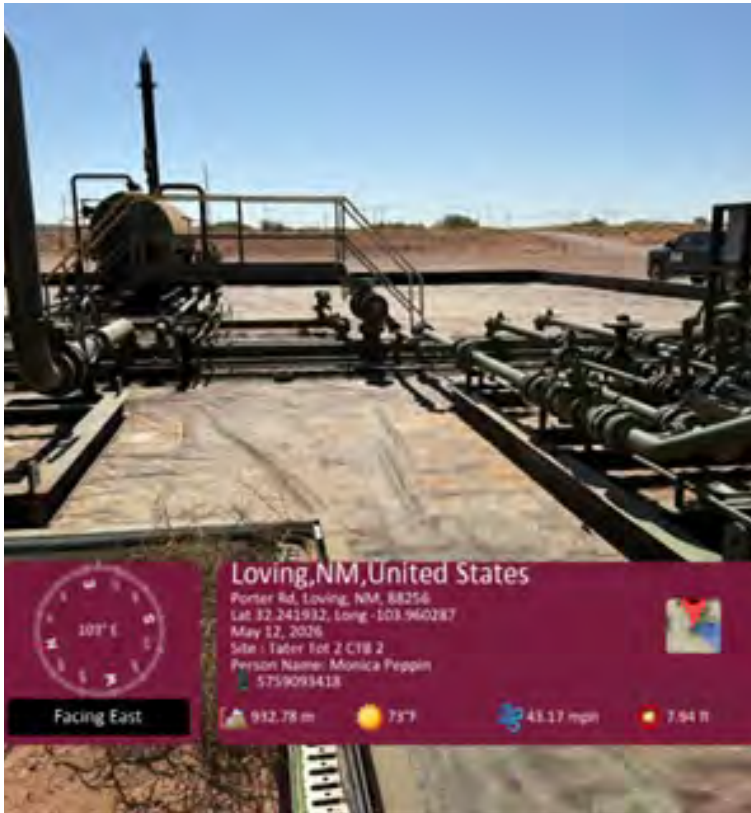
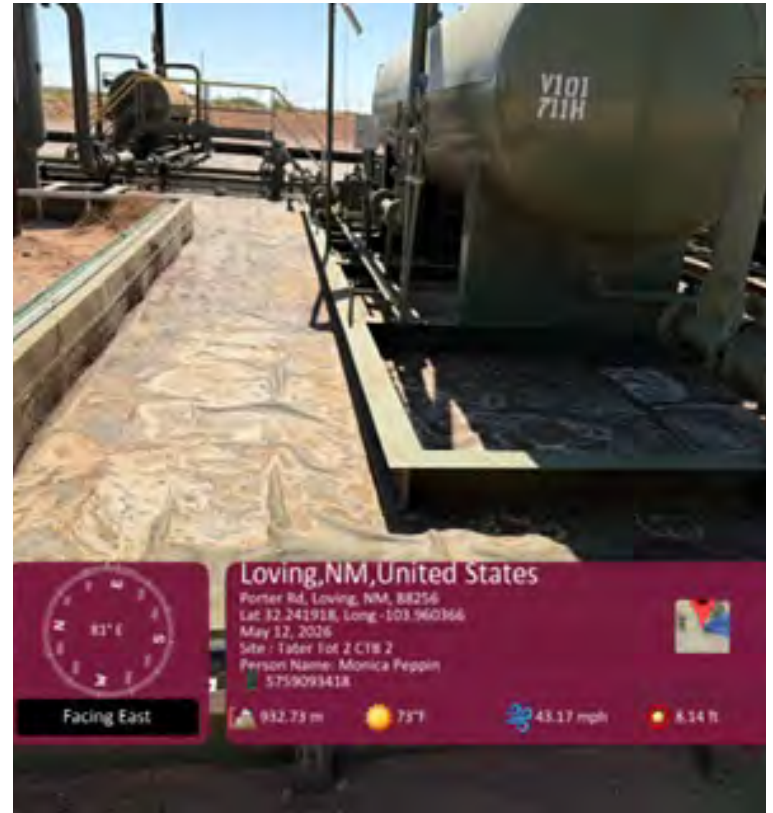
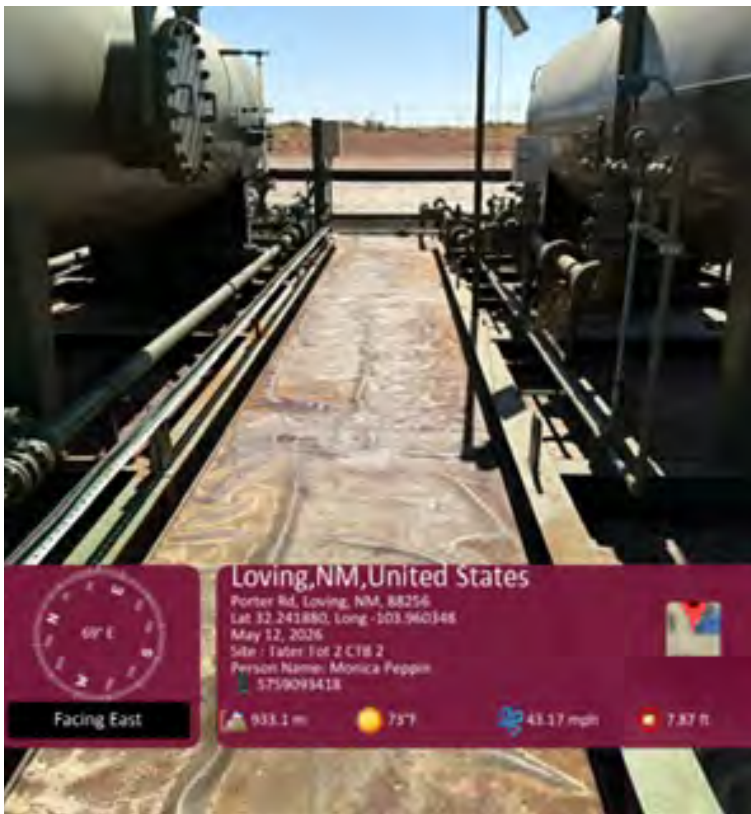
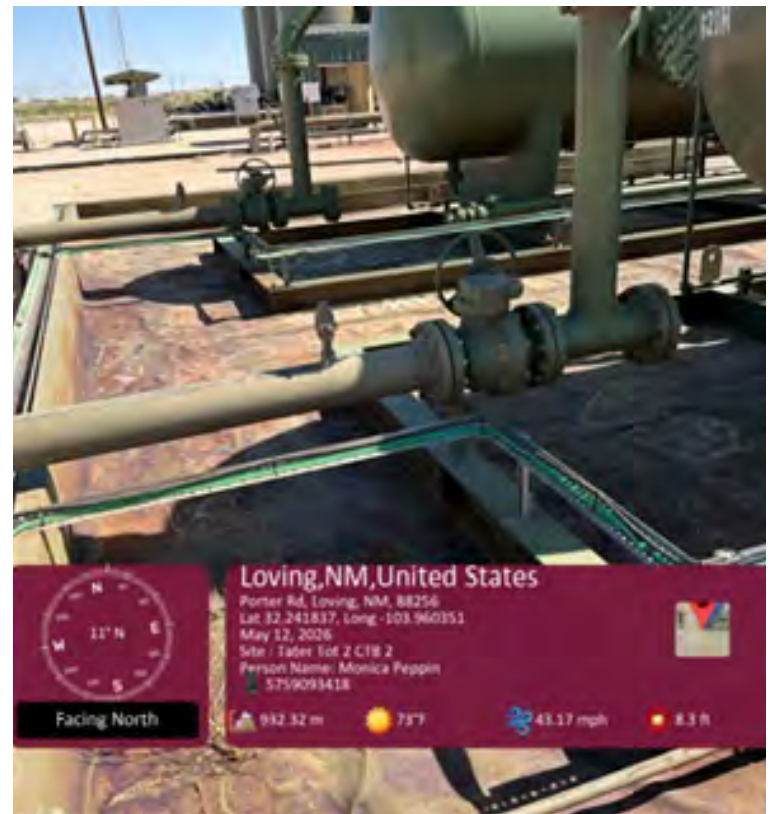
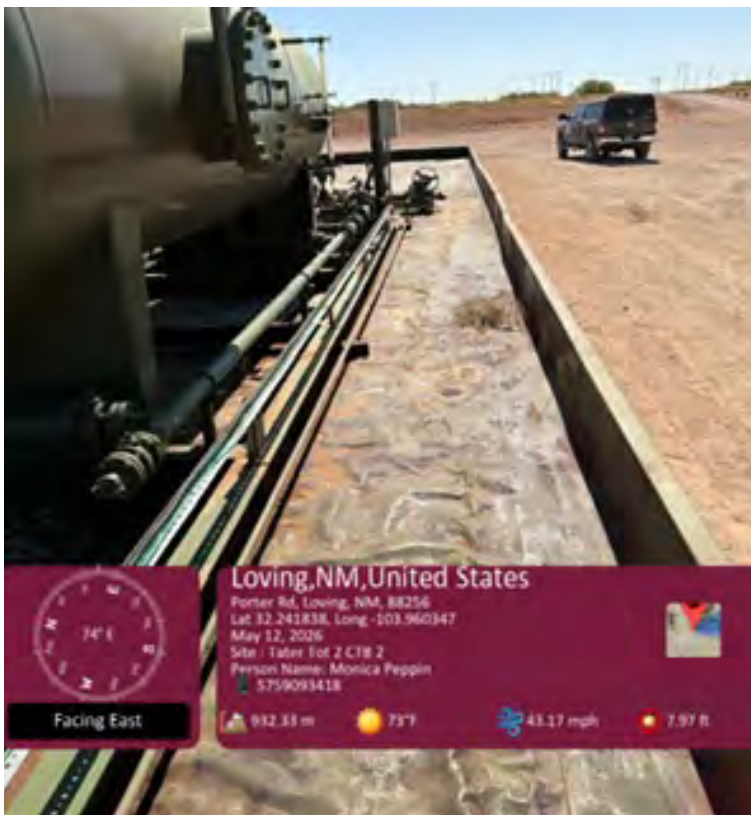
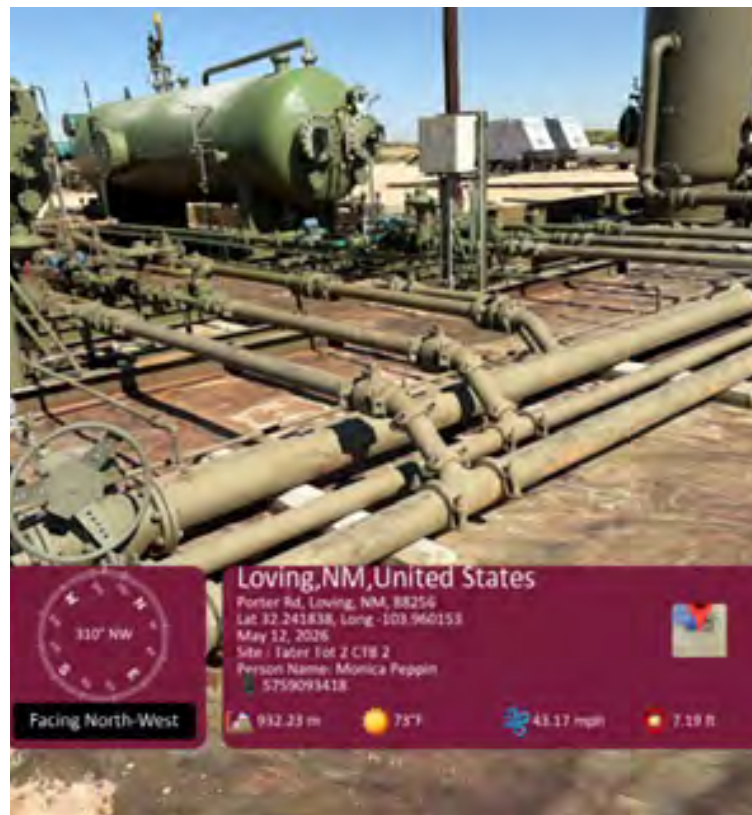
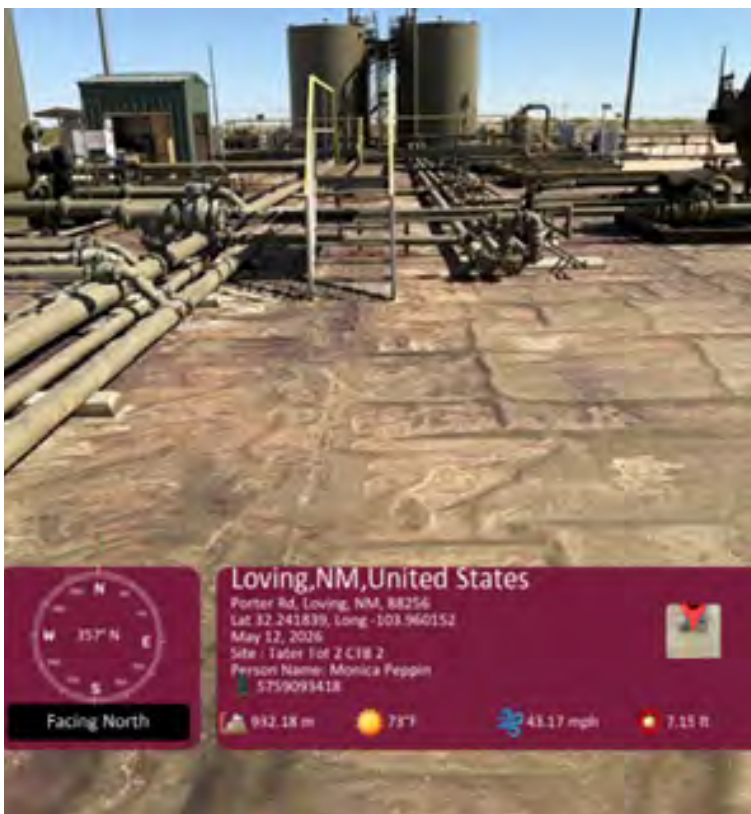
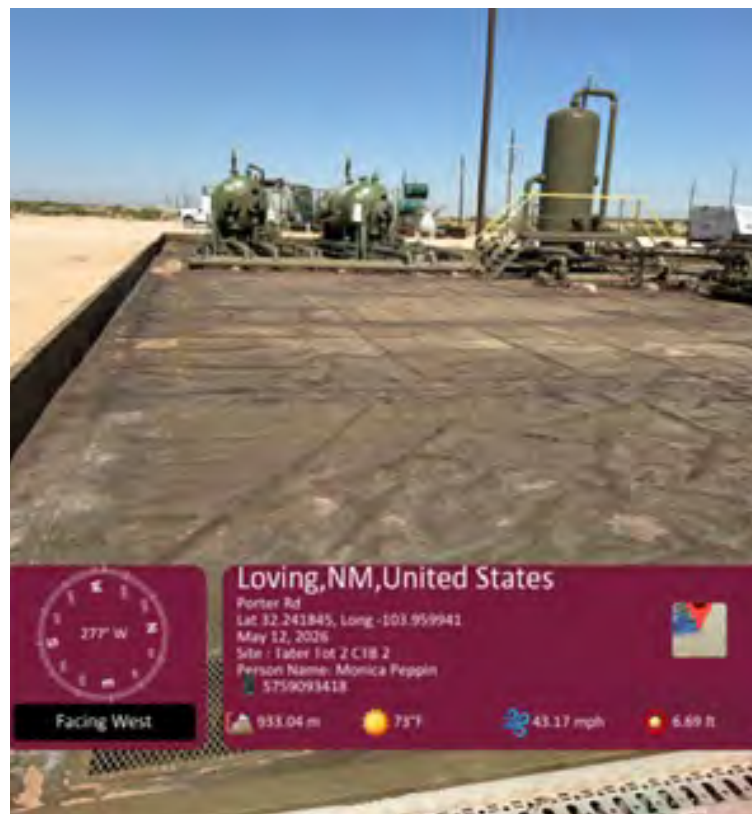
- Observations consisted of the base, walls, and areas where equipment is congested.
- No signs of visible damage including cuts, holes, and UV wear.
- Liner integrity confirmed and passes inspection.
- No further assessment needed.
