SUBJECT: Liner Inspection and Closure Report for Tater Tot 2 CTB 2 – May 8, 2026 and May 12, 2026 Site Visits

Incident IDs: nAPP2606428628 and nAPP2612734857  
Facility API (Name): fAPP2416935463 (TATER TOT 2 CTB 2)  
Facility Location: Unit M of Section 2, Township 24 South, Range 29 East, New Mexico  
Facility GPS Coordinates: 32.2422093, -103.9601062  
Eddy County, New Mexico

# LINER INSPECTION FIELD NOTES & PHOTOLOG REPORT

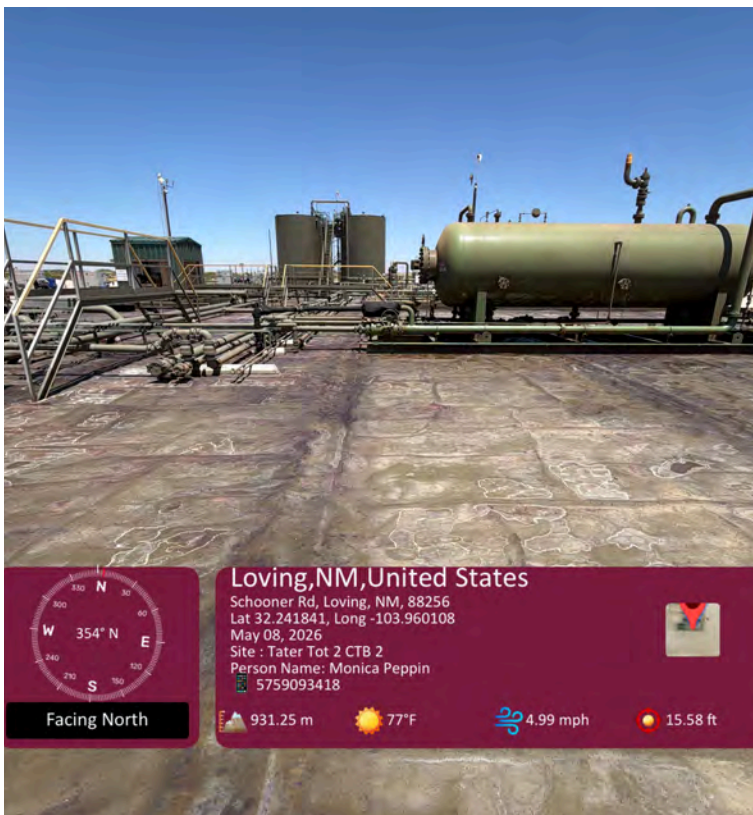
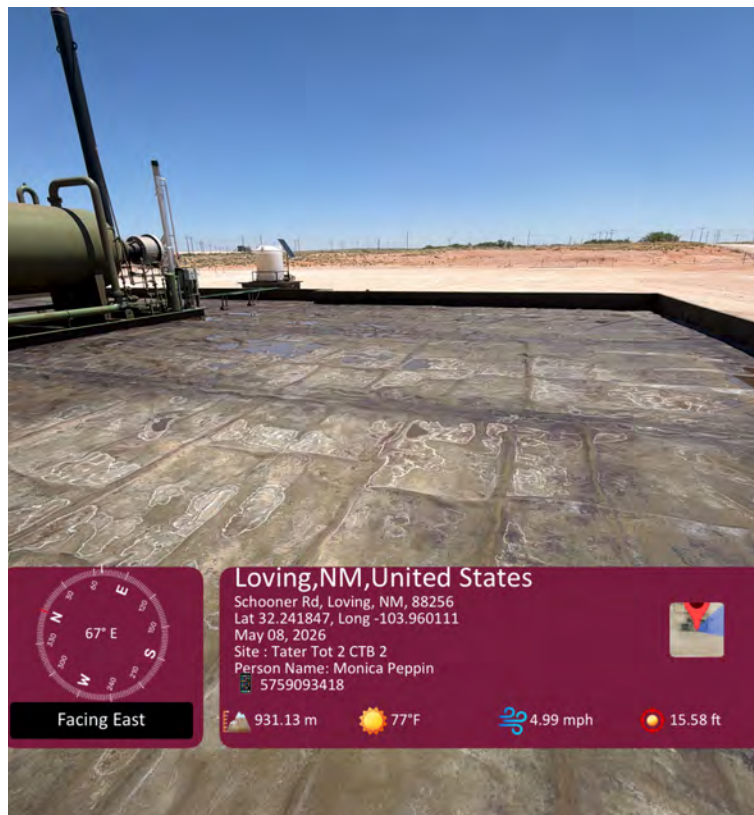
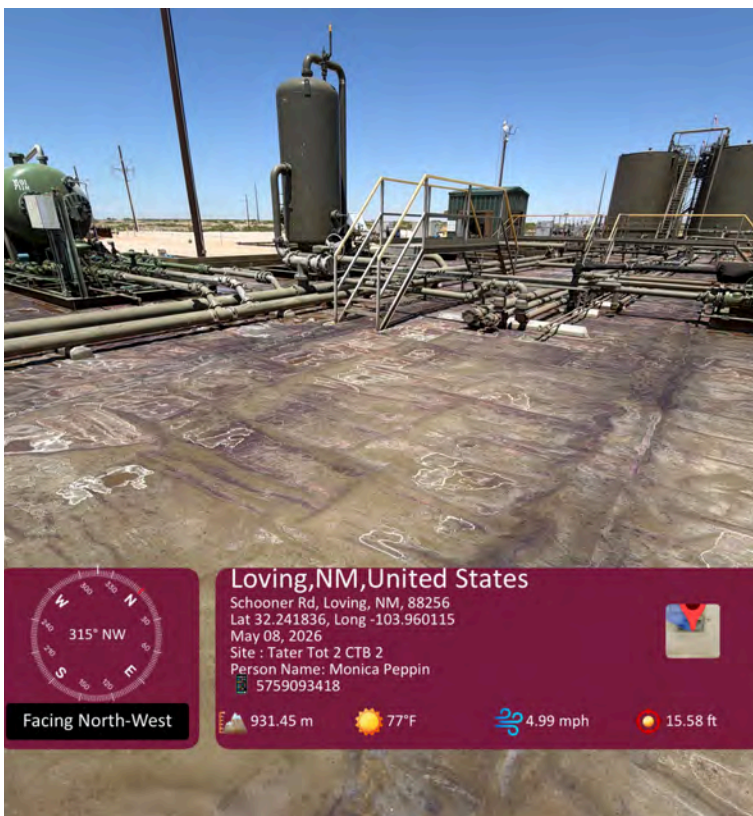
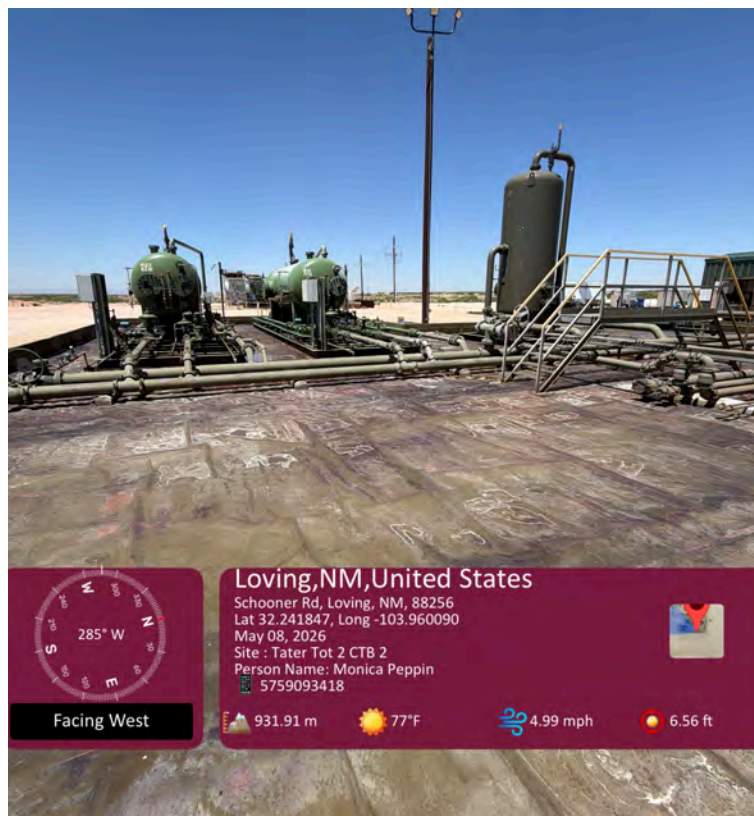
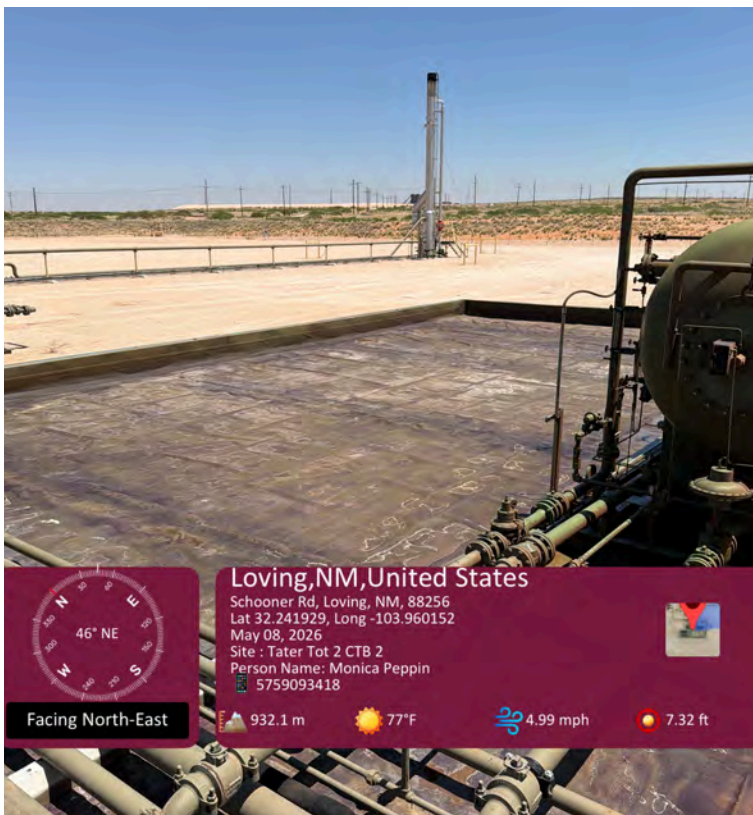
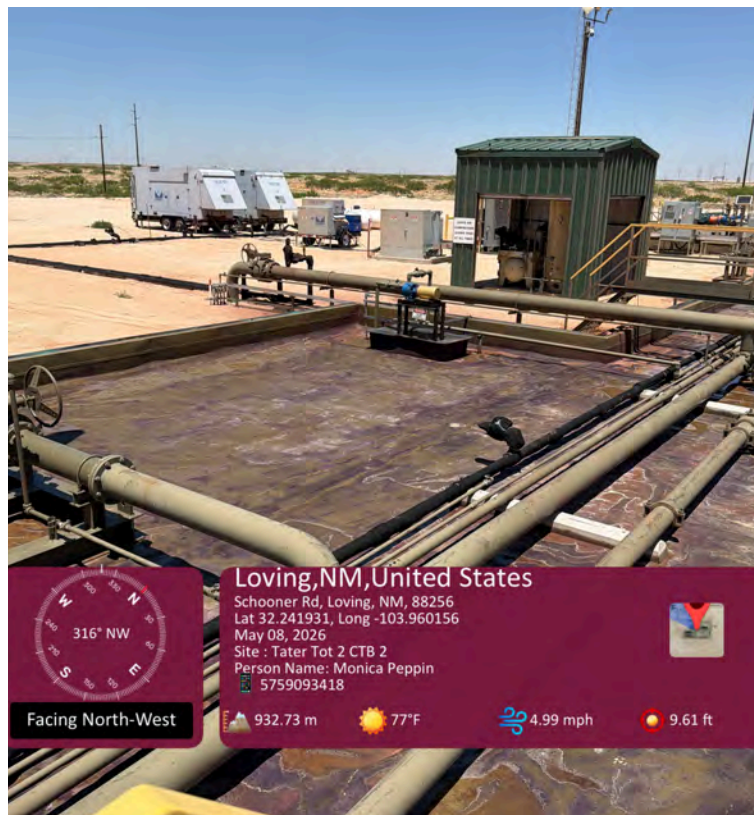
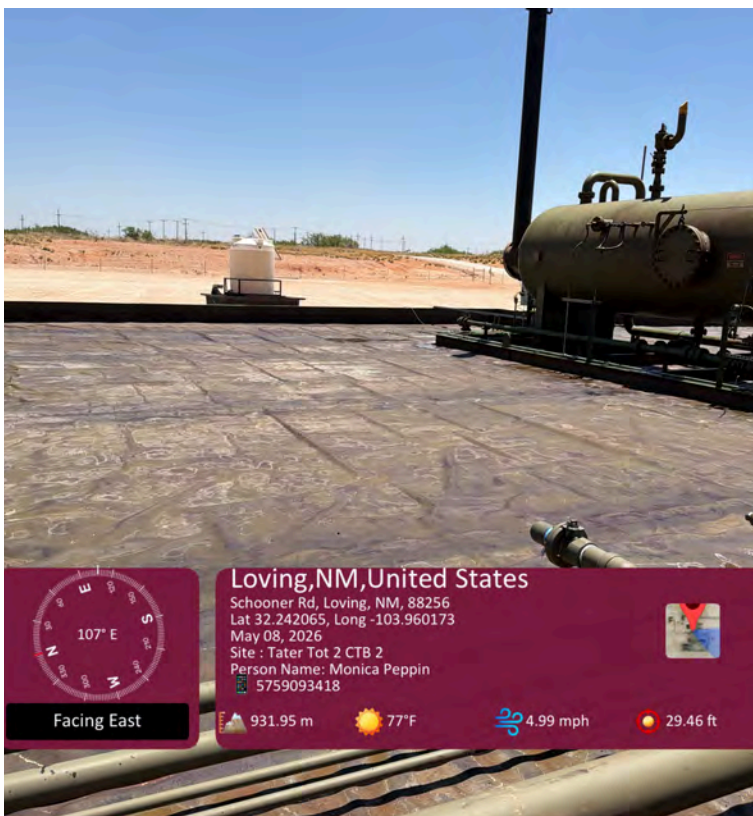
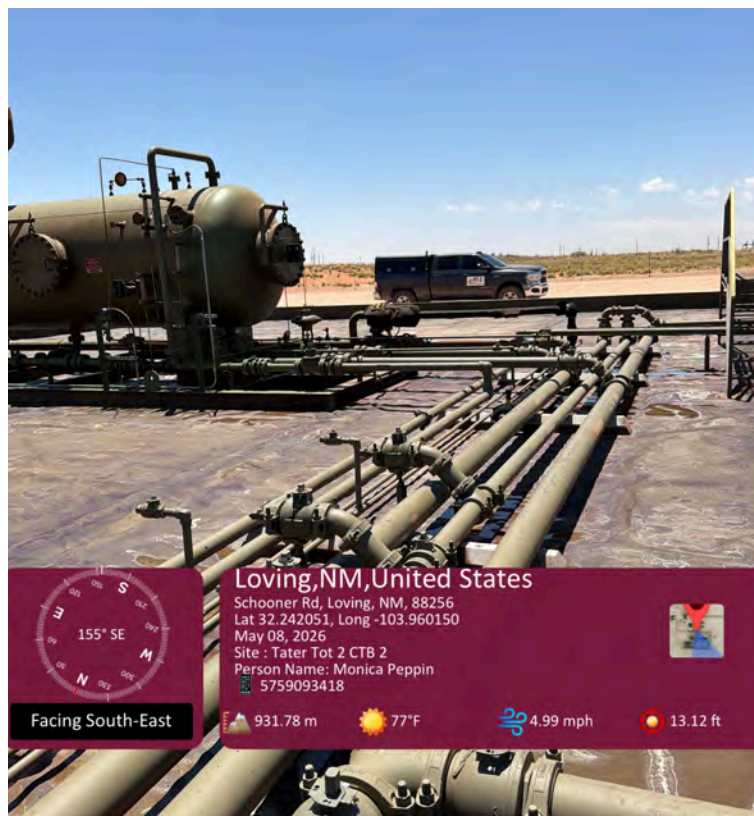
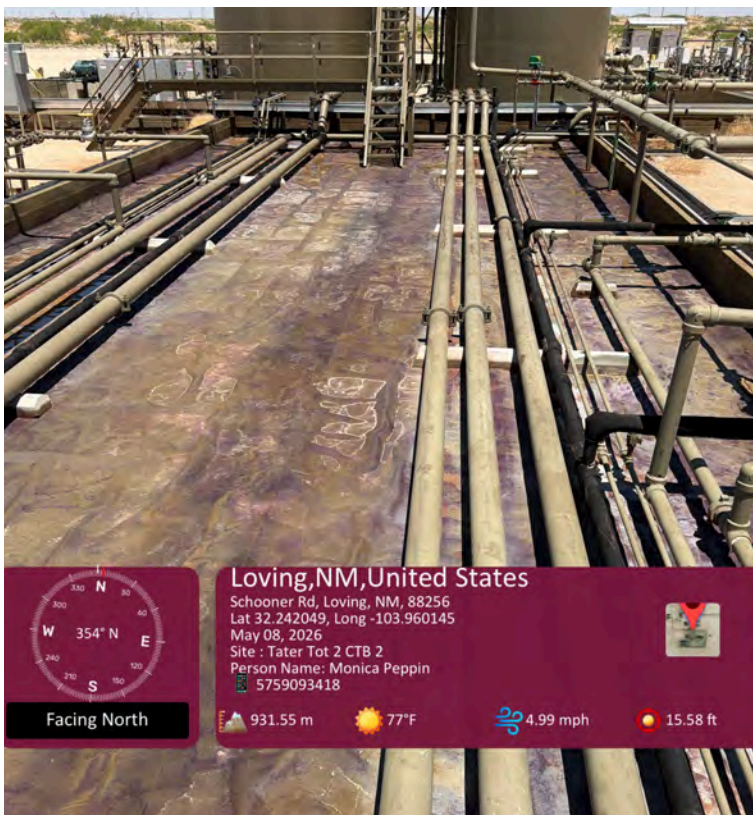
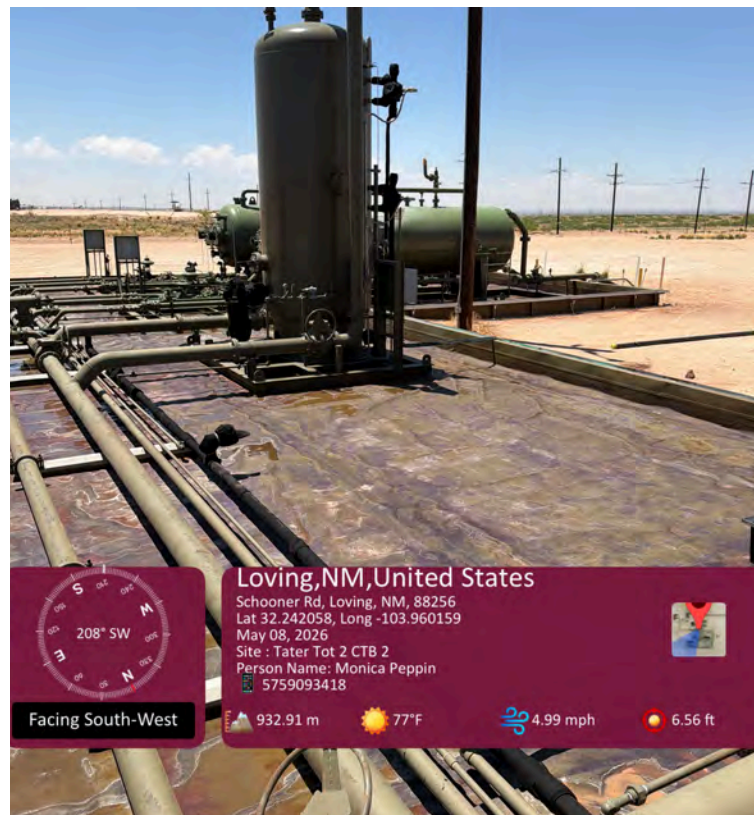
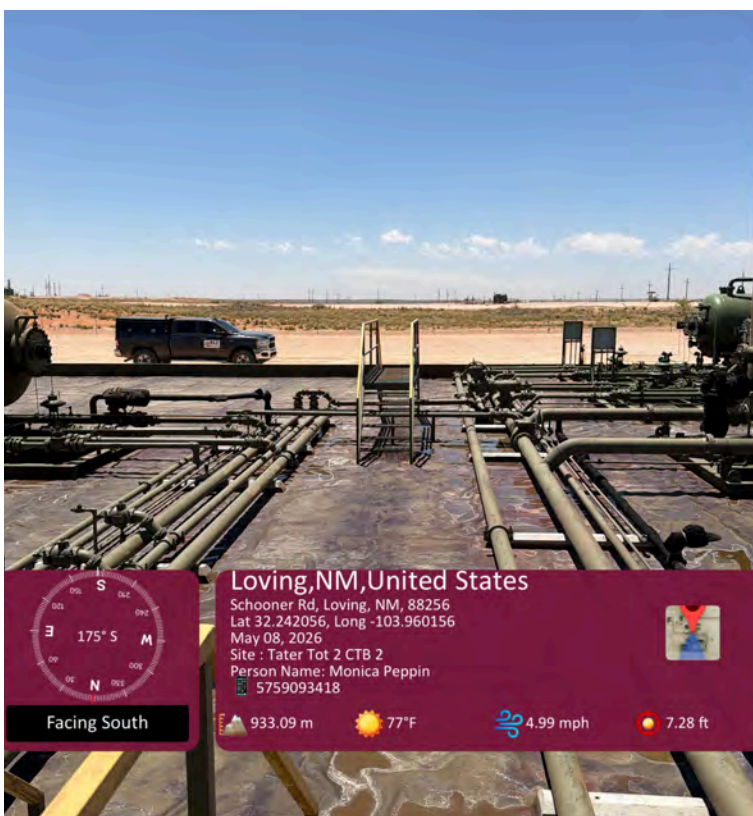
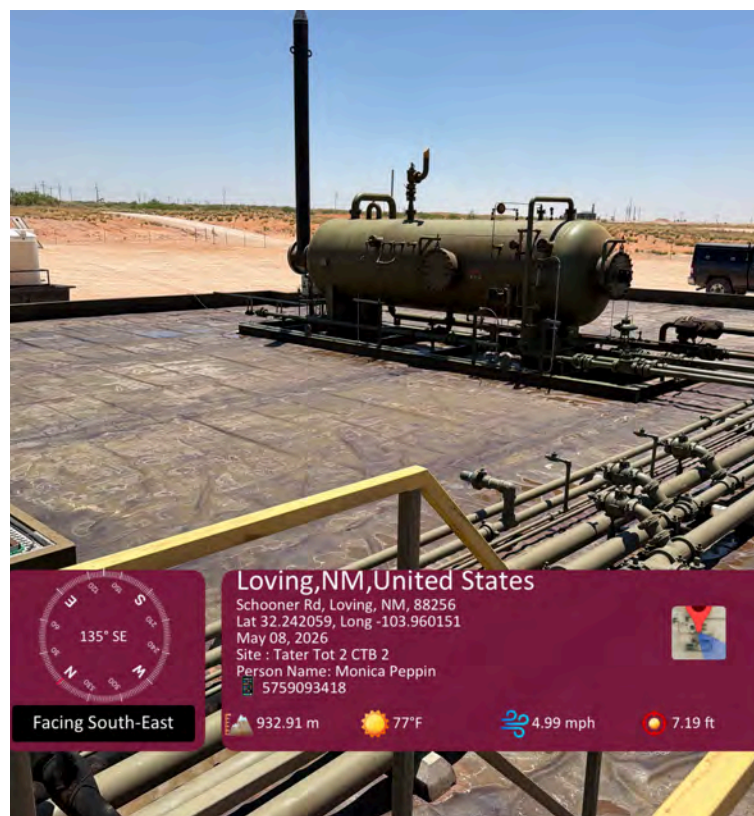
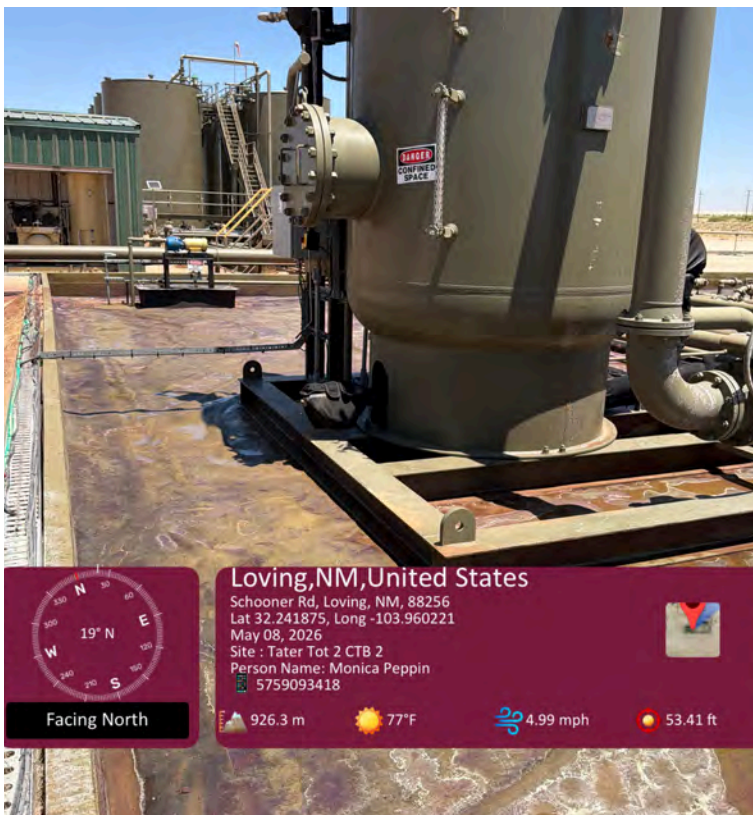
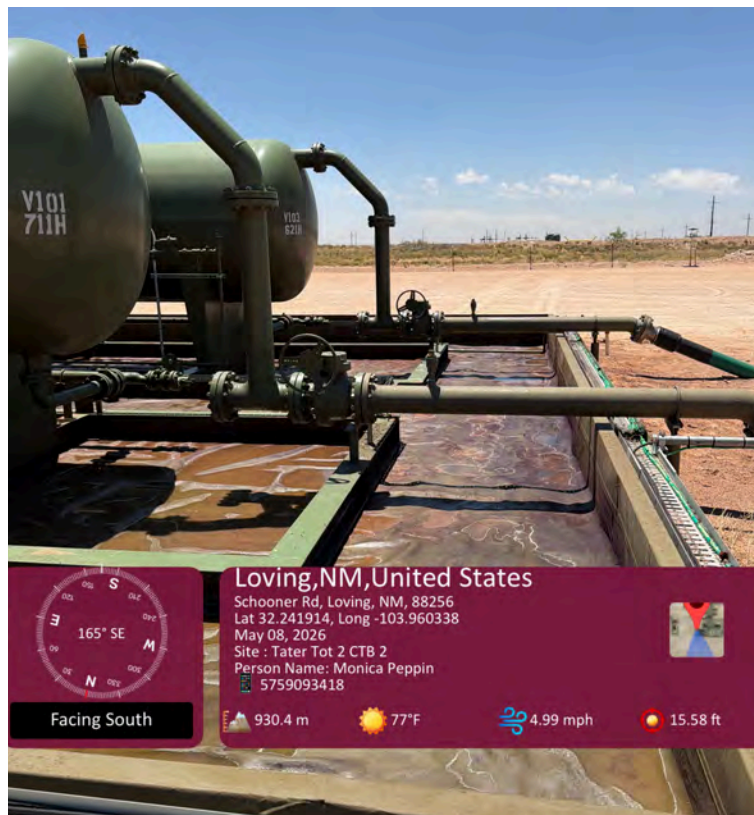
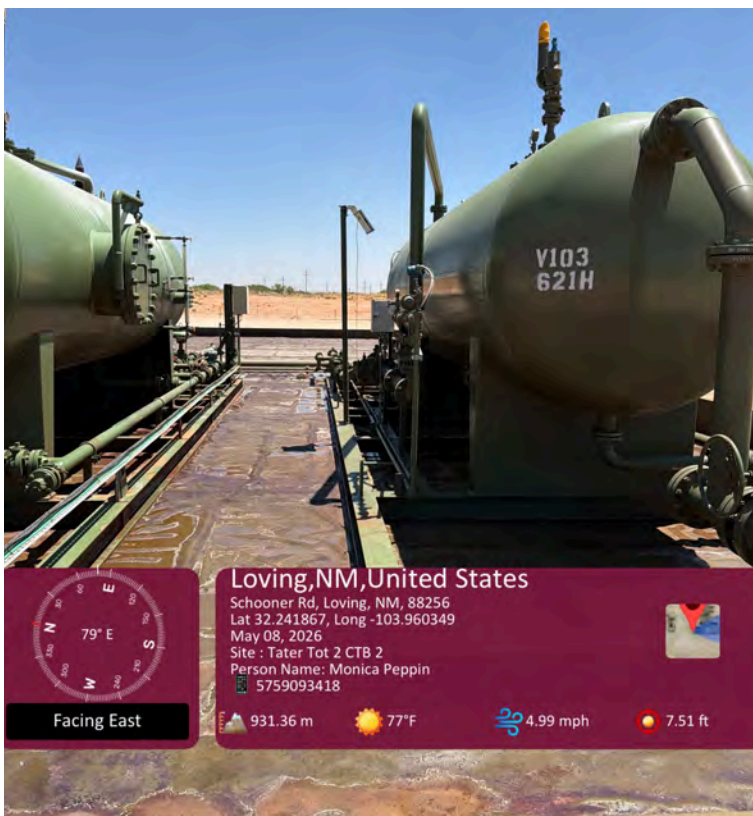
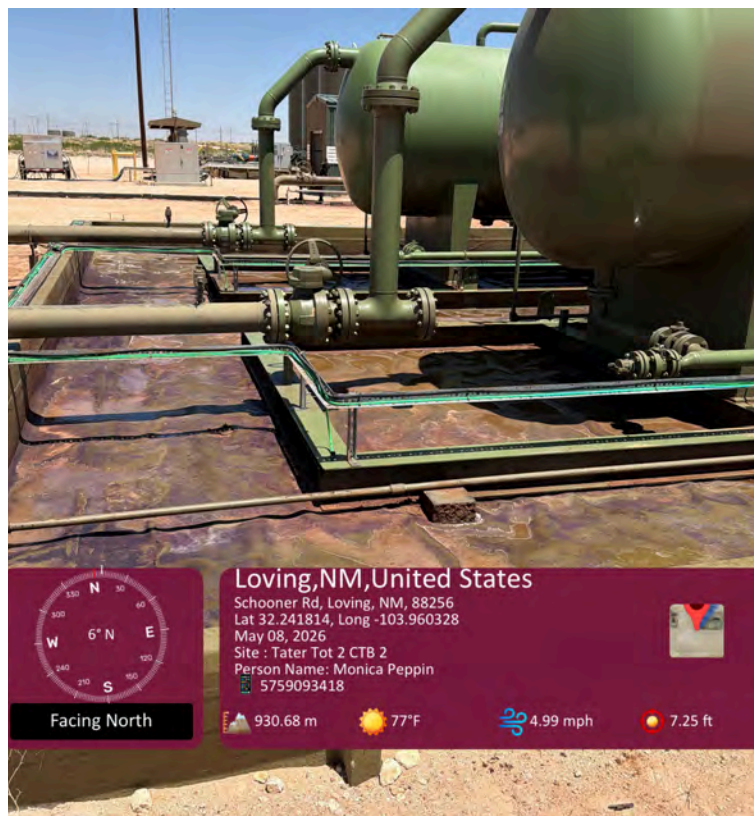
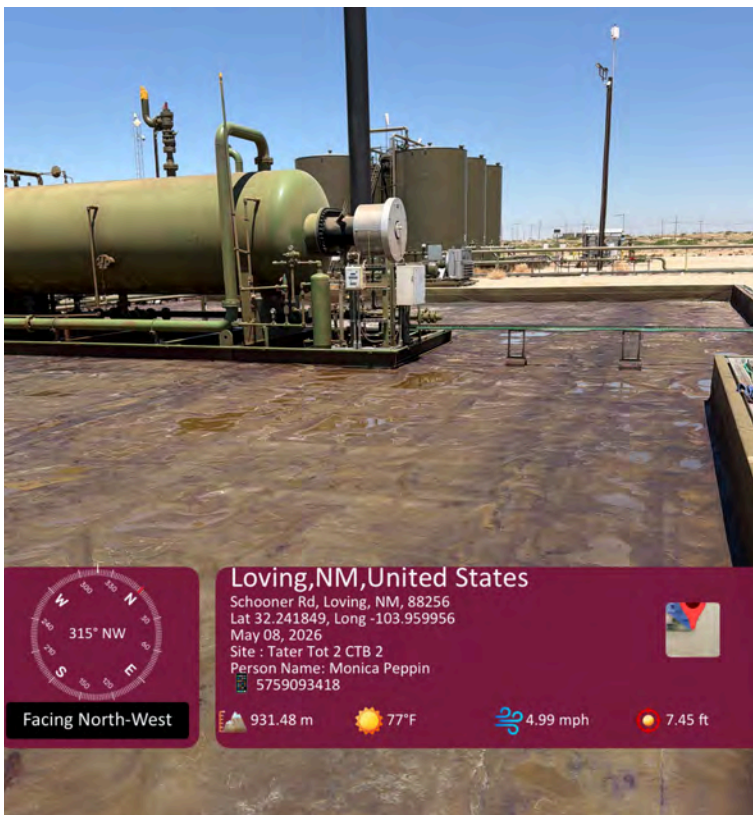
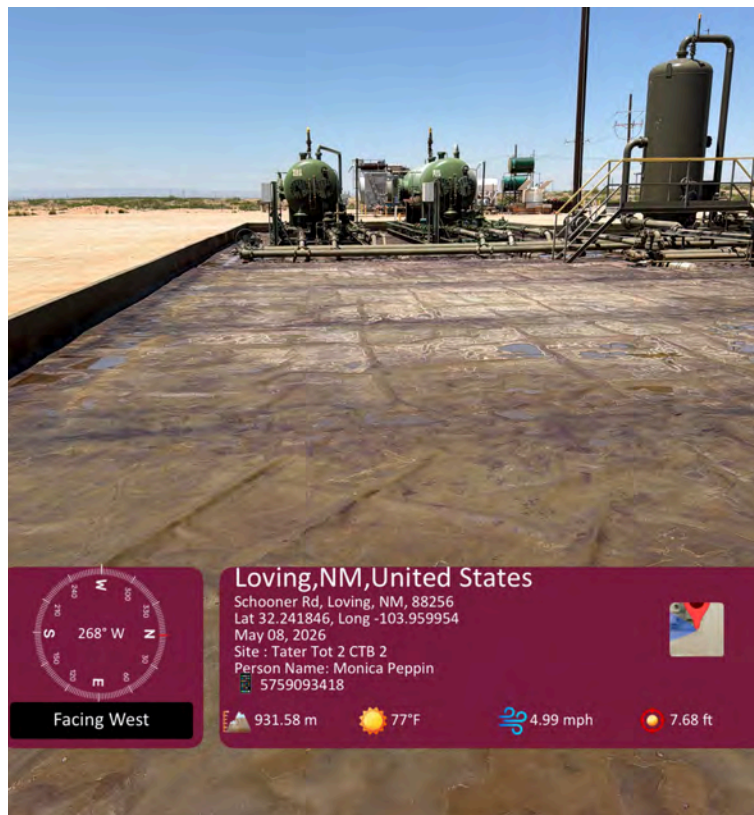
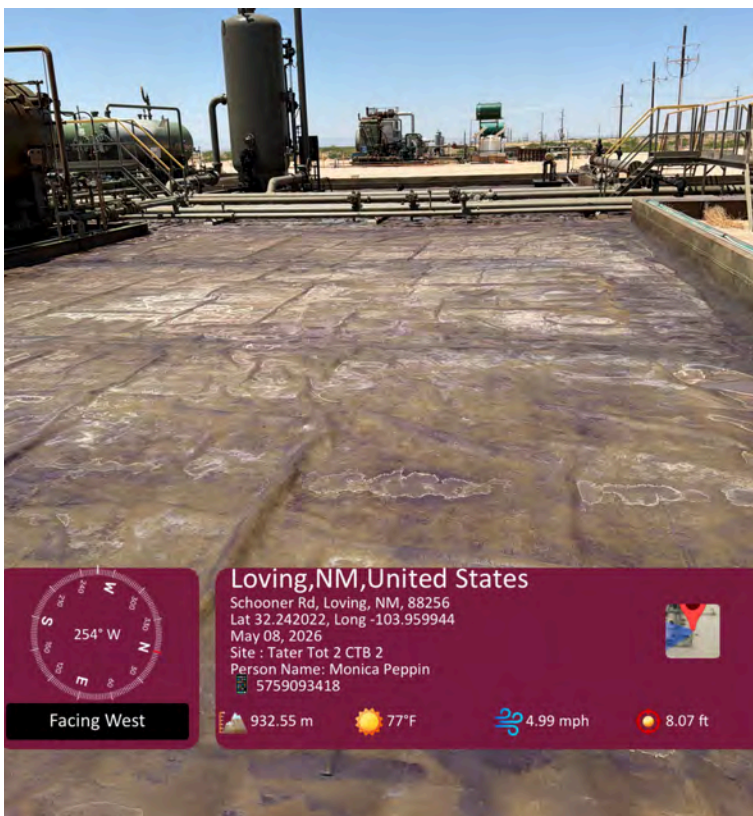
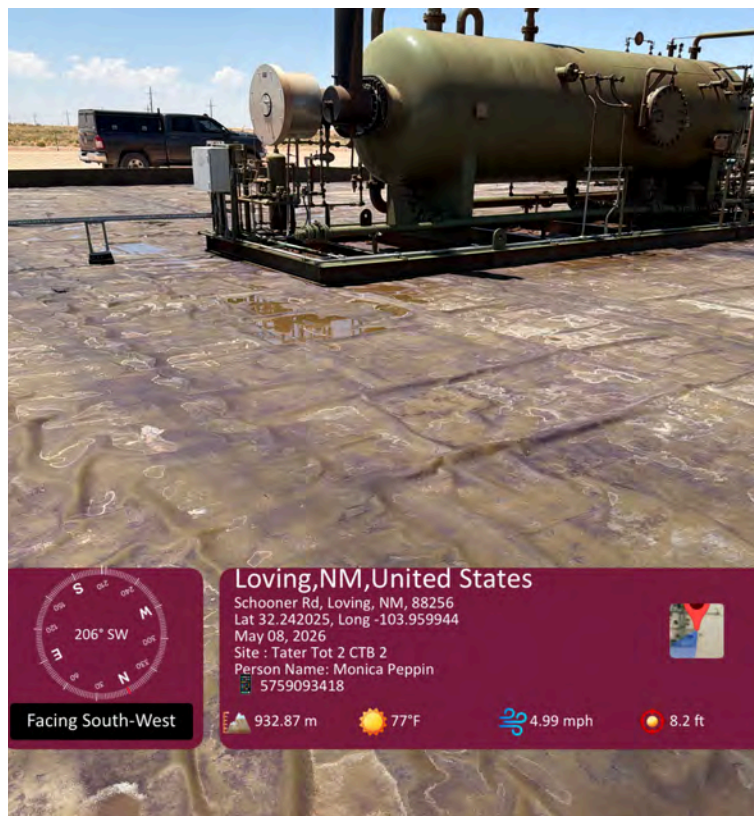
- Observations consisted of the base, walls, and areas where equipment is congested.
- No signs of visible damage including cuts, holes, and UV wear.
- Liner integrity confirmed and passes inspection.
- No further assessment needed.
