SUBJECT: Liner Inspection and Closure Report for Tater Tot 2 CTB 2 – May 8, 2026 and May 12, 2026 Site Visits

Incident IDs: nAPP2606428628 and nAPP2612734857  
Facility API (Name): fAPP2416935463 (TATER TOT 2 CTB 2)  
Facility Location: Unit M of Section 2, Township 24 South, Range 29 East, New Mexico  
Facility GPS Coordinates: 32.2422093, -103.9601062  
Eddy County, New Mexico

# LINER INSPECTION FIELD NOTES & PHOTOLOG REPORT

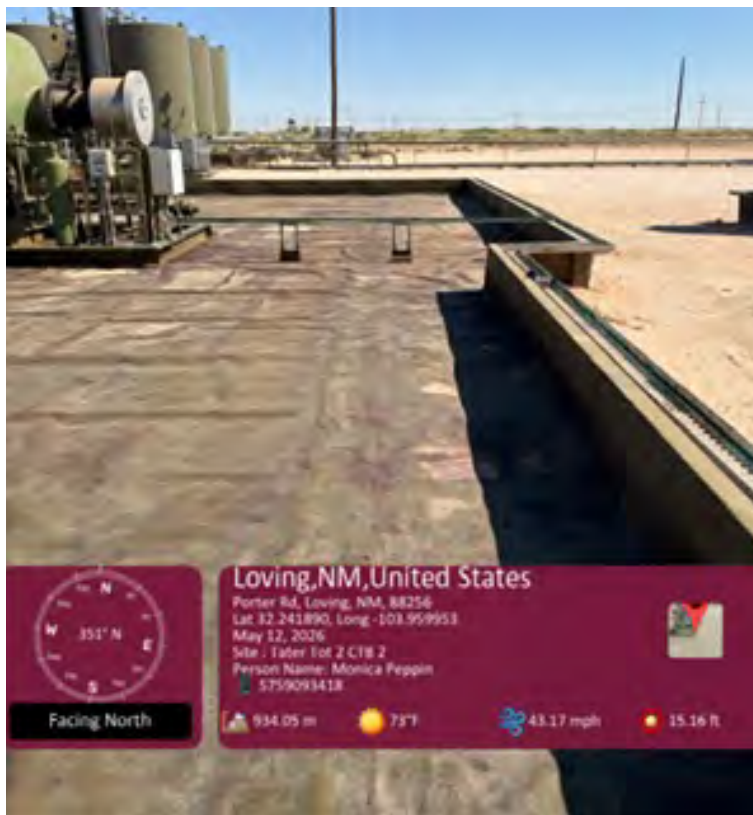
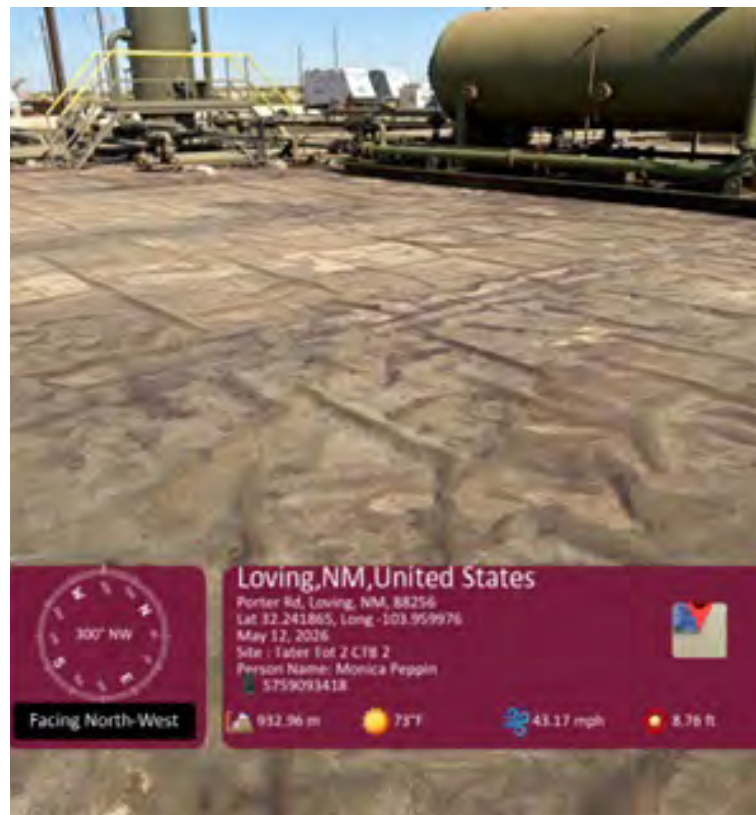
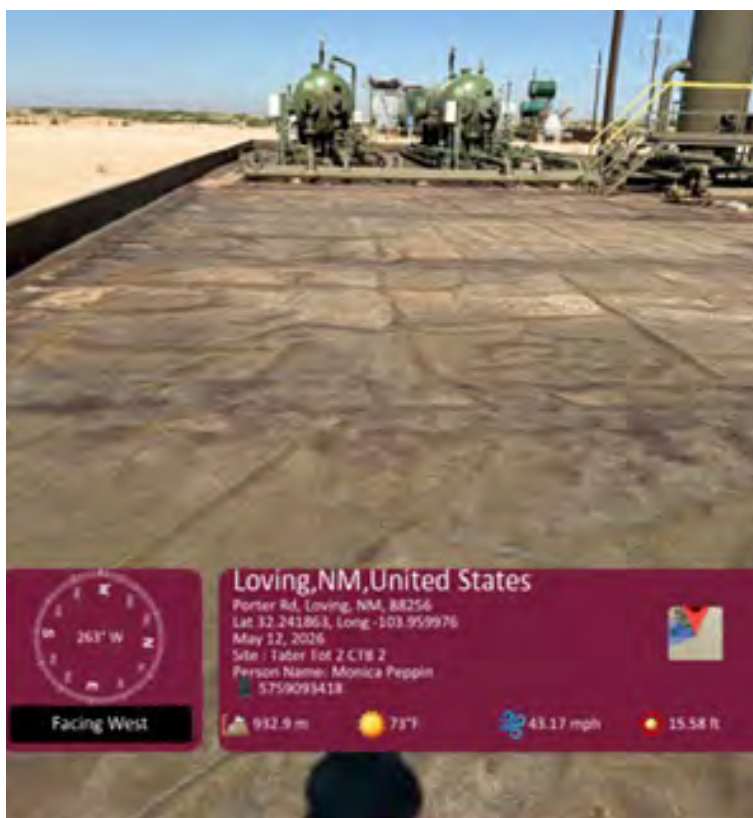
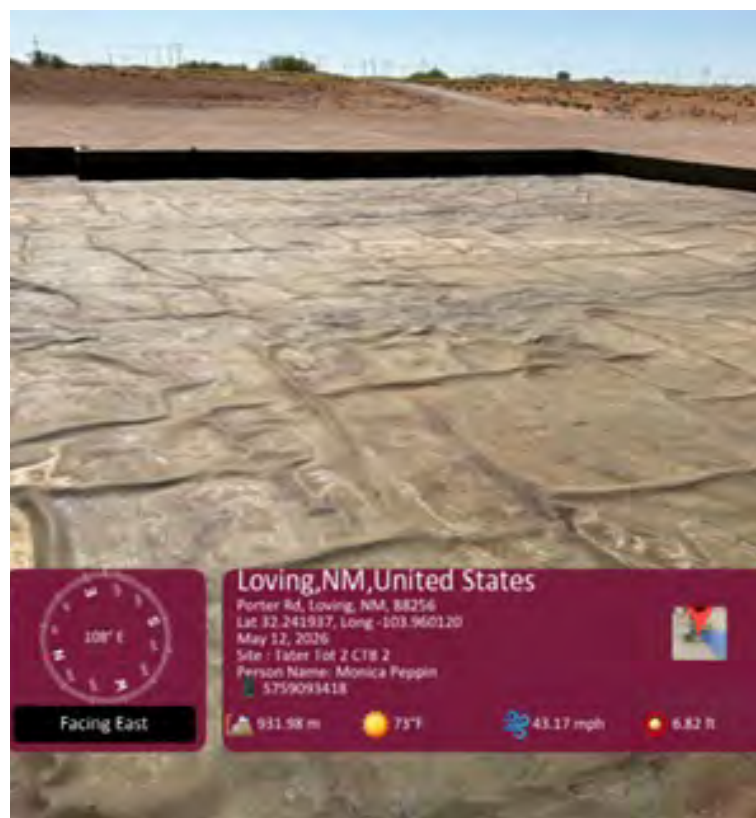
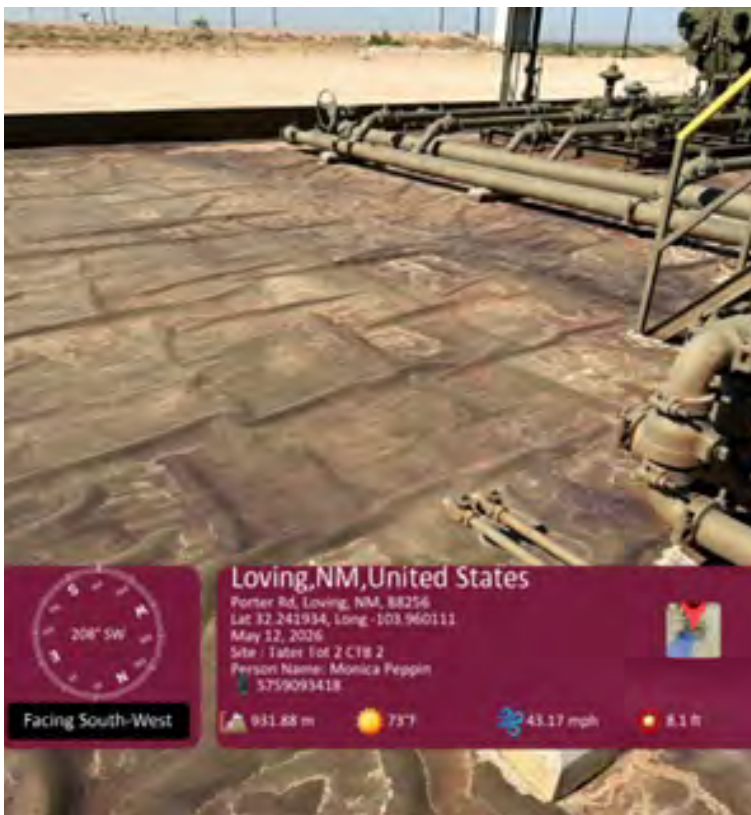
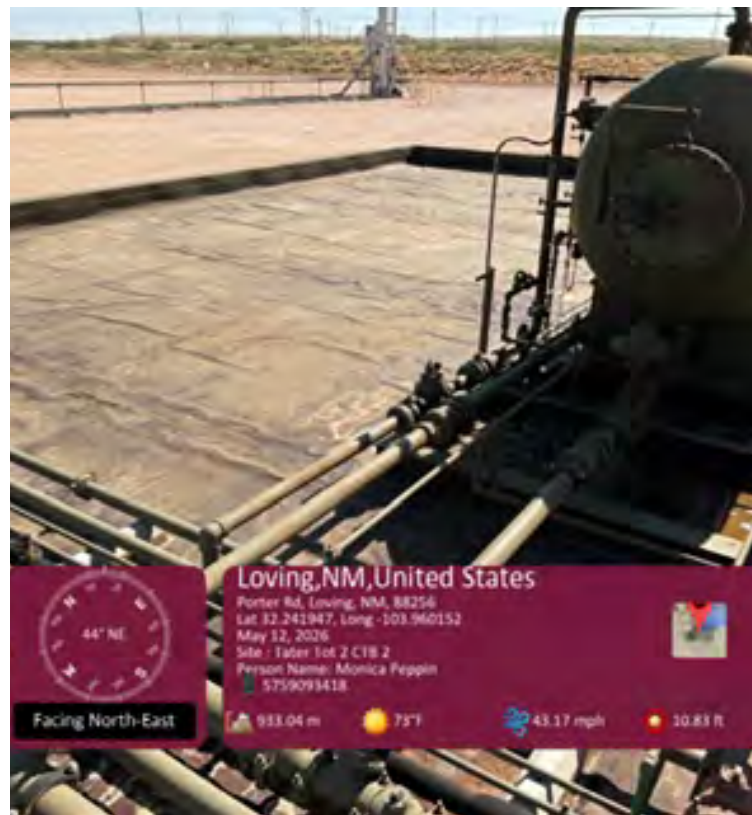
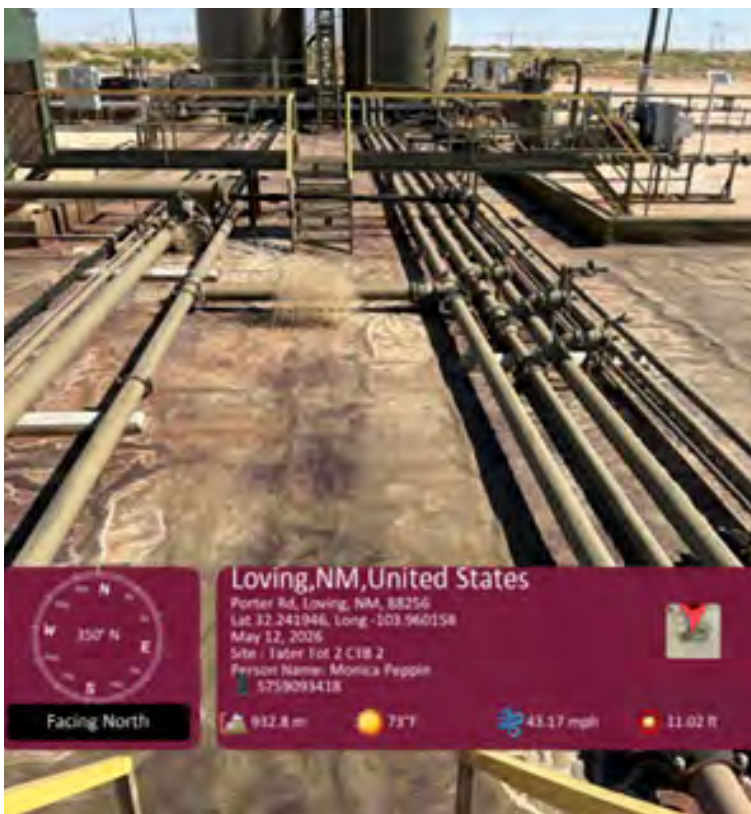
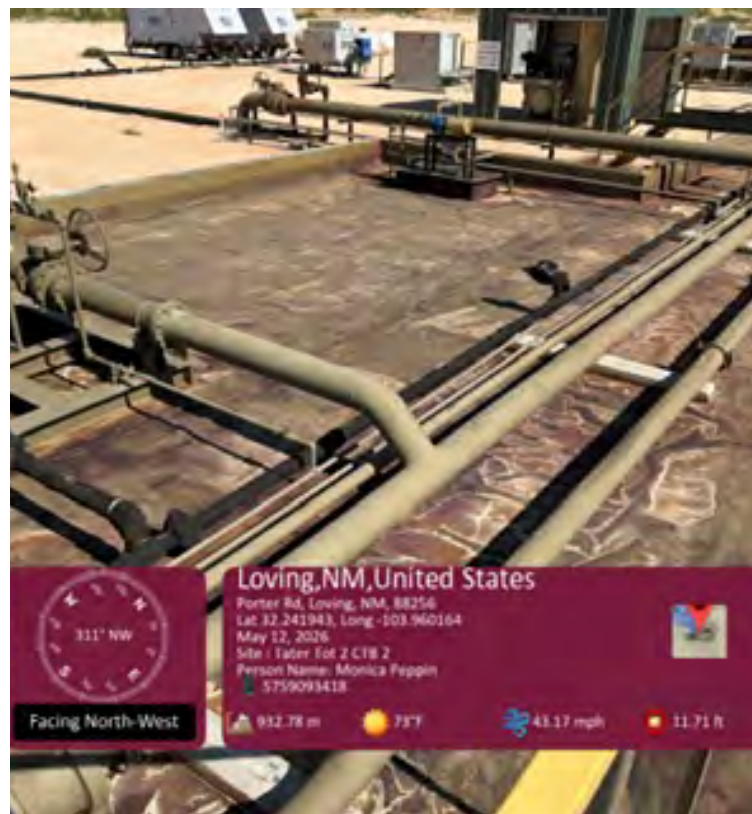
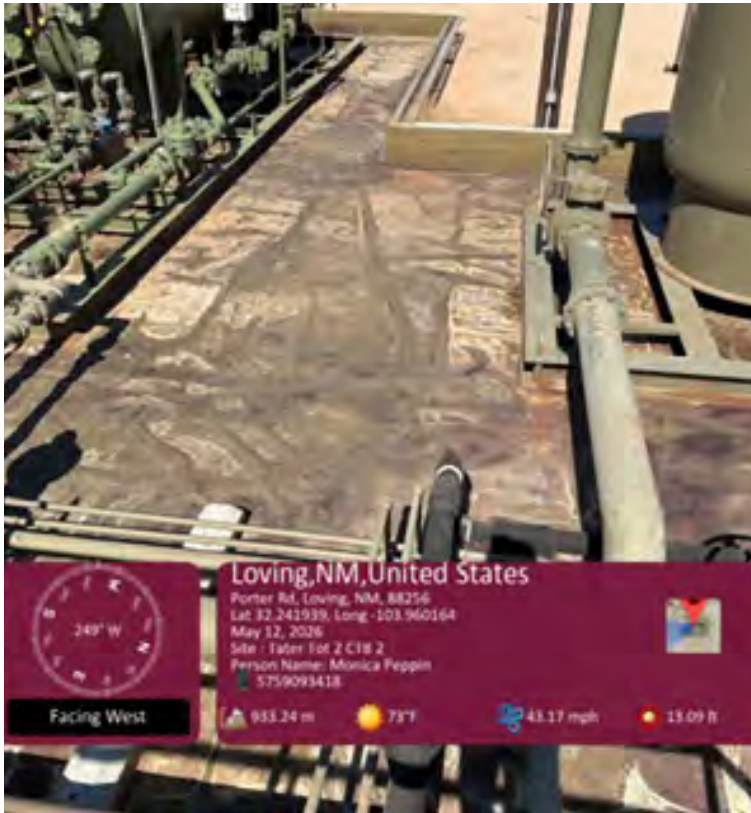
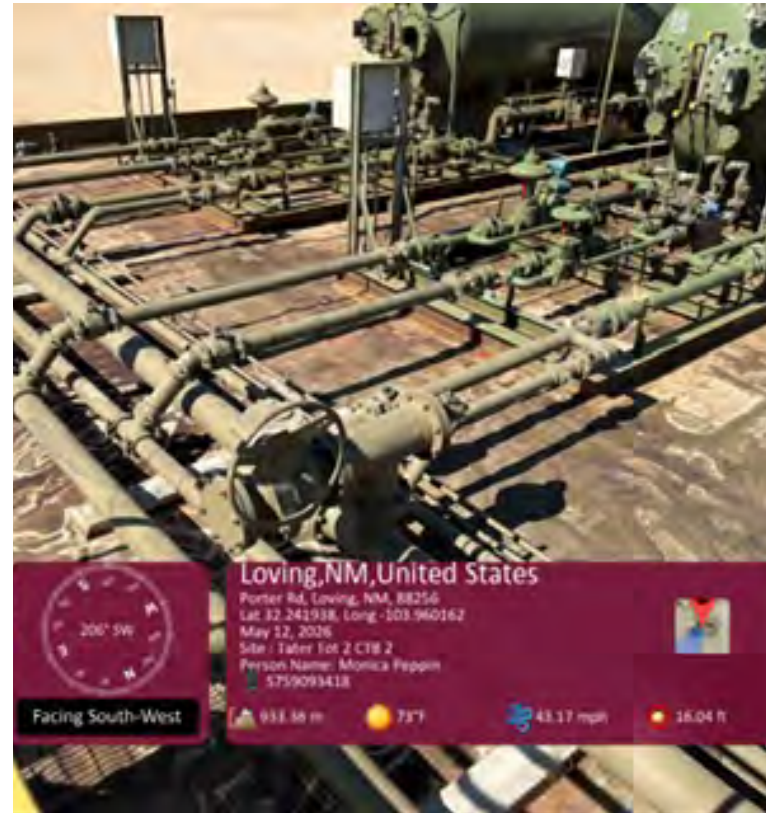
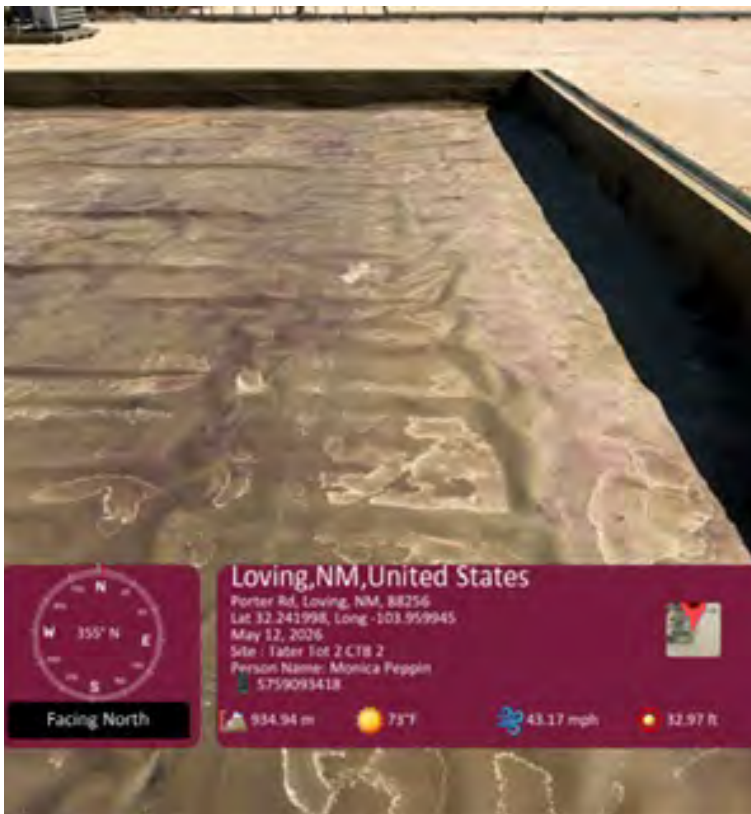
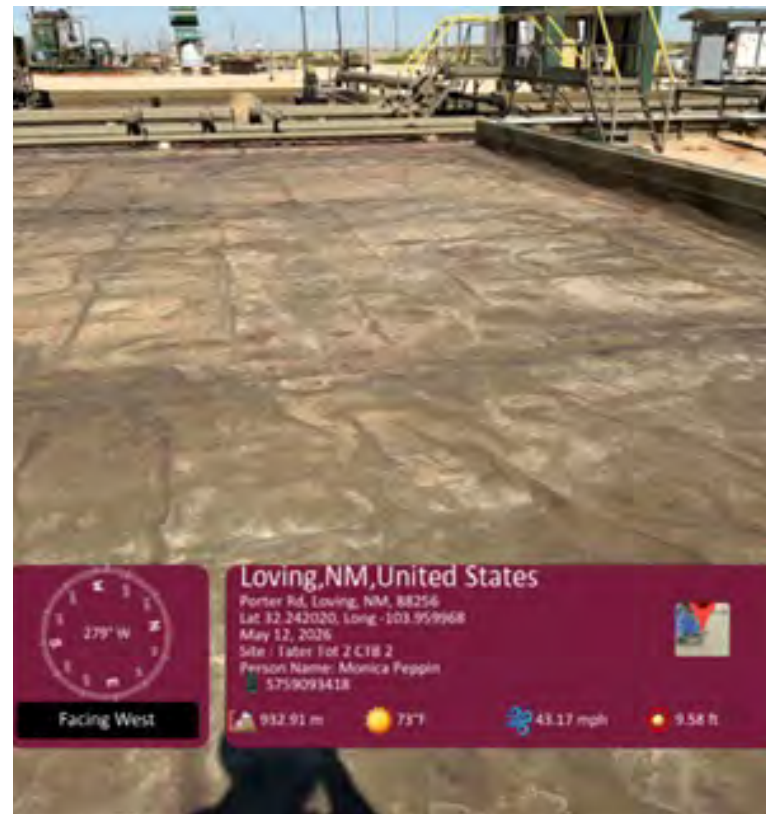
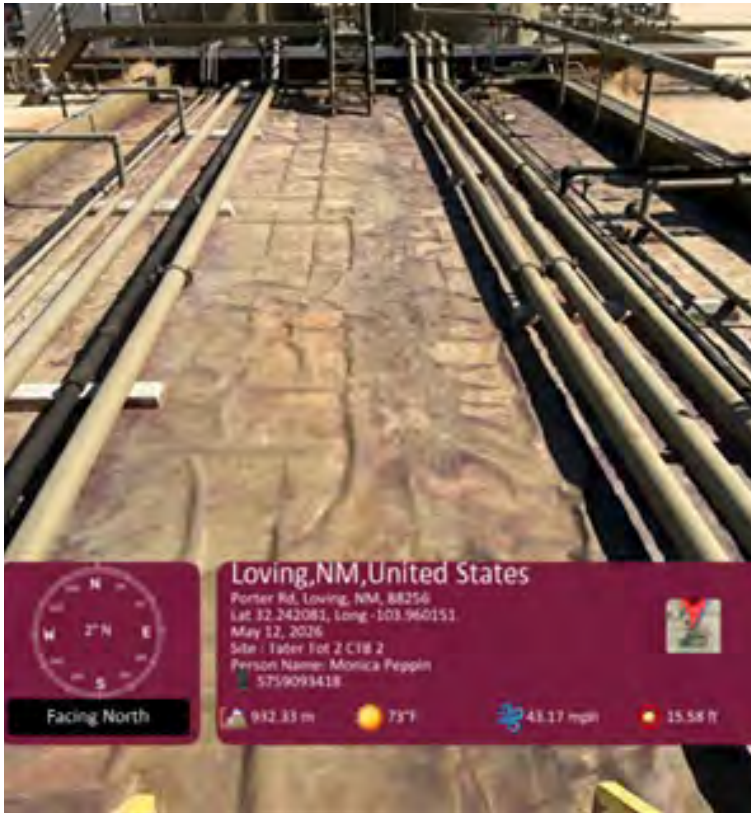
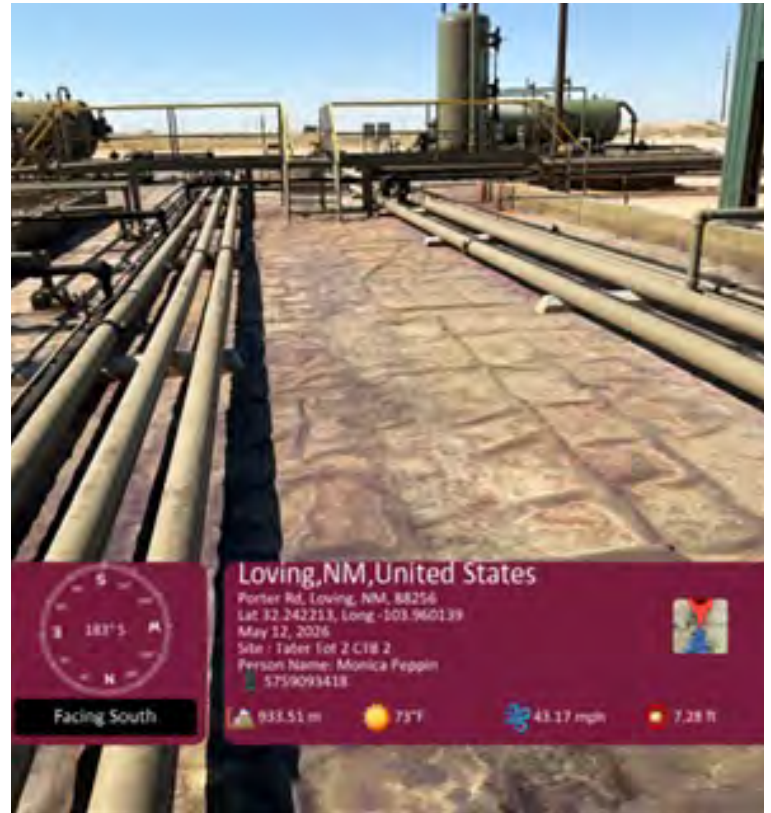
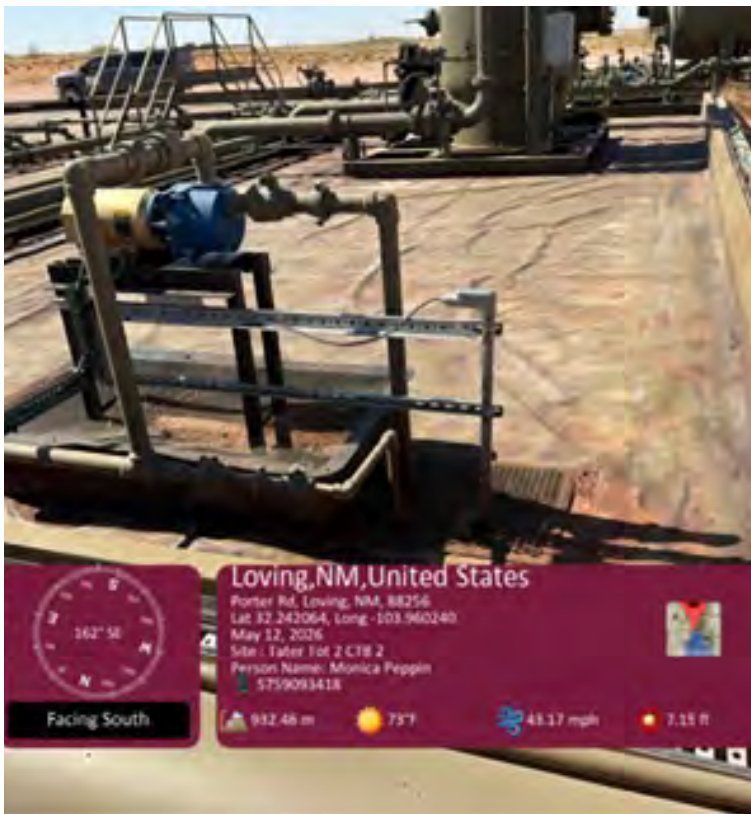
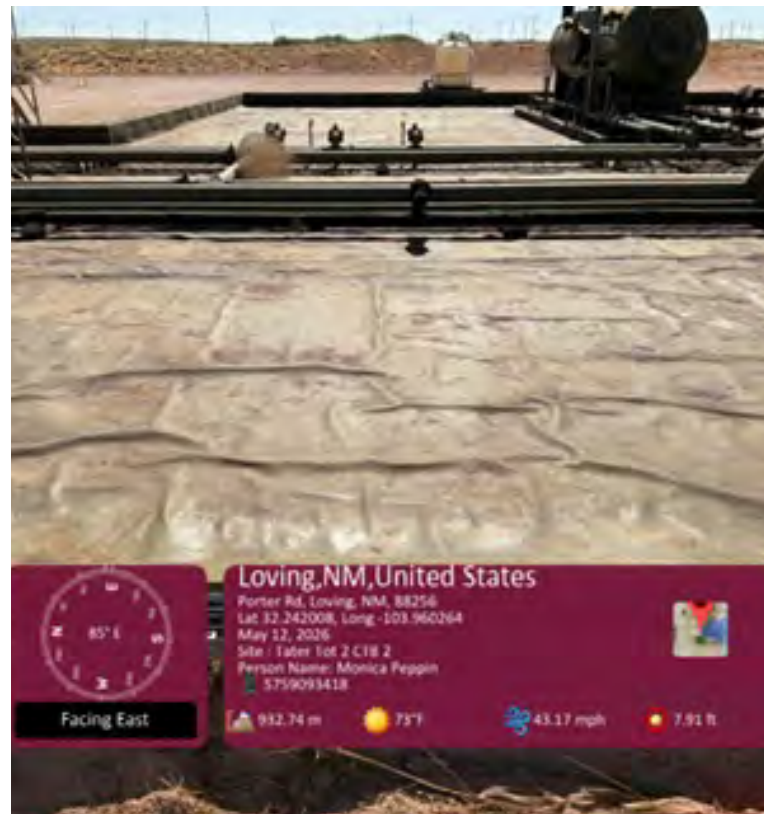
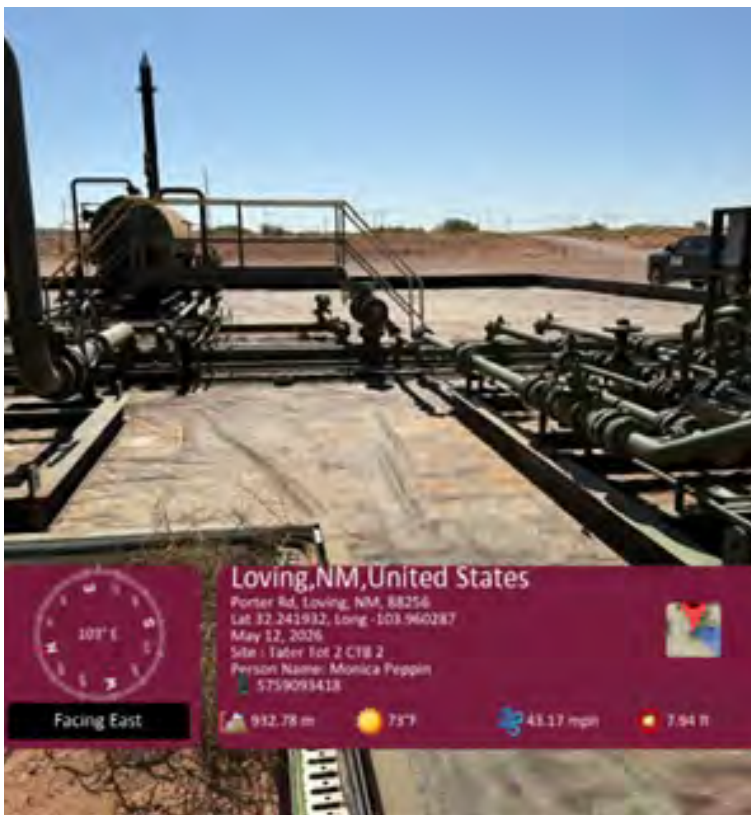
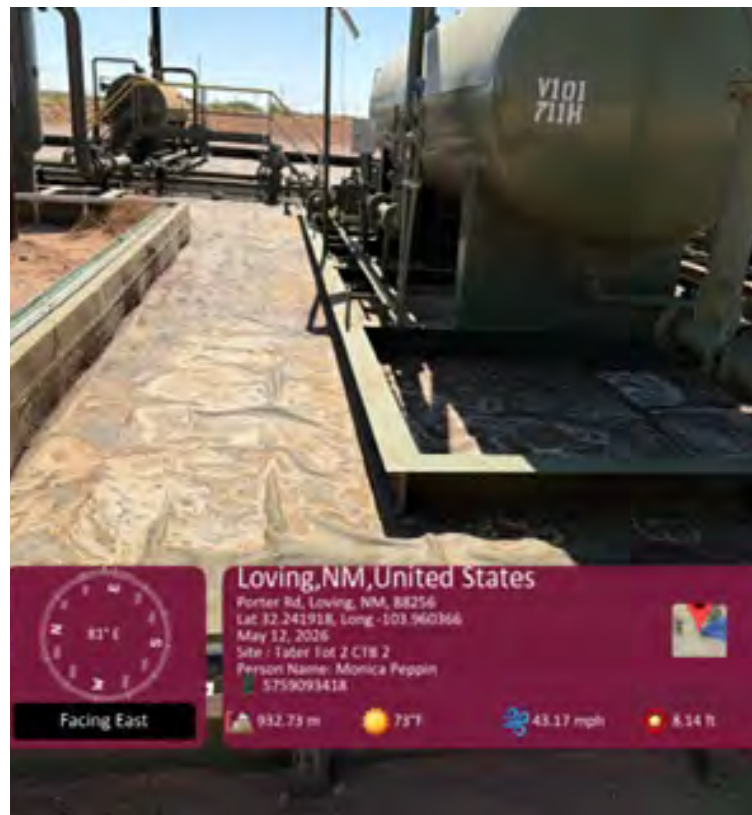
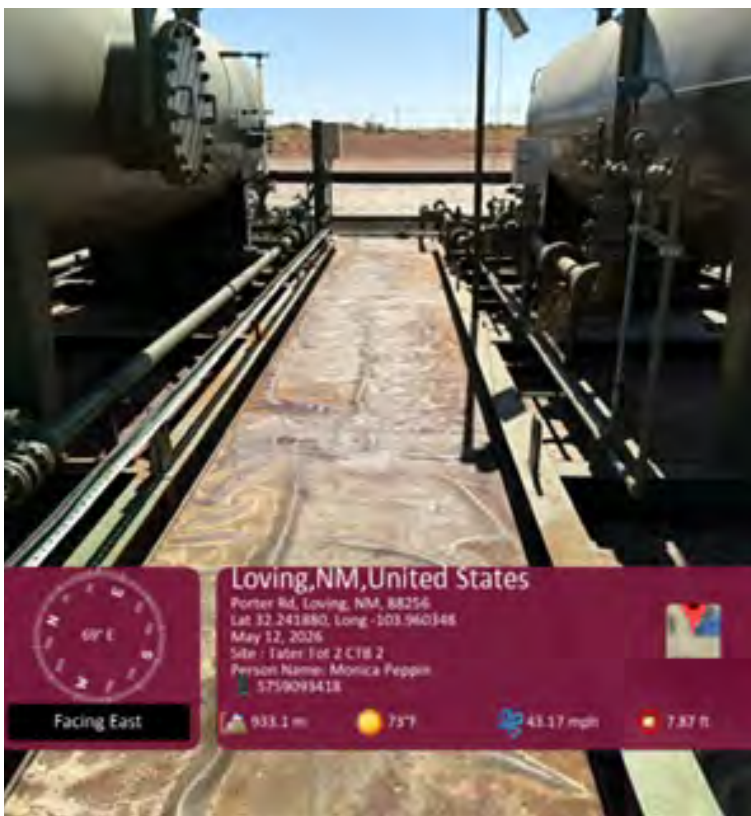
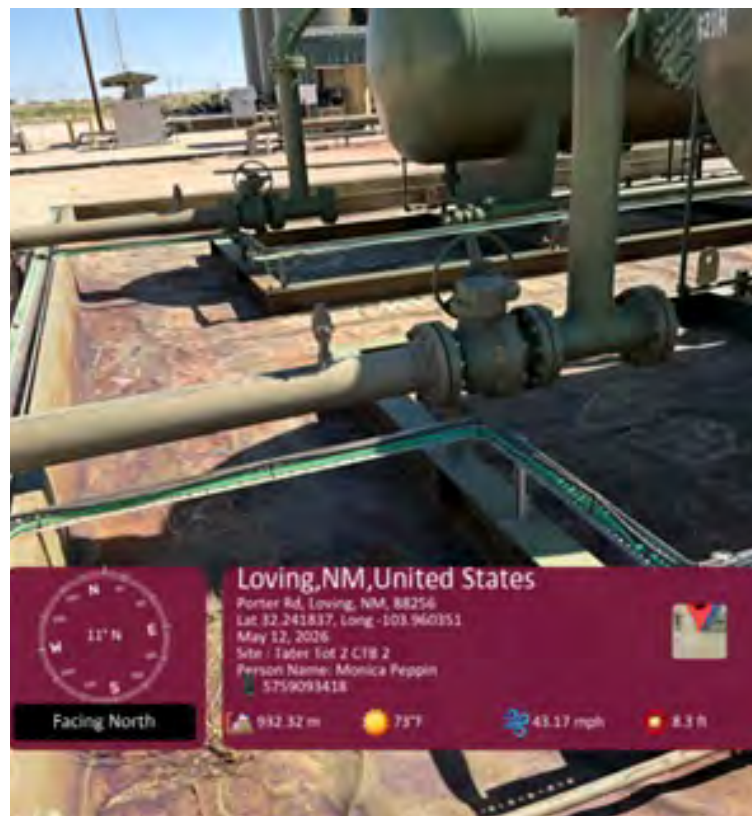
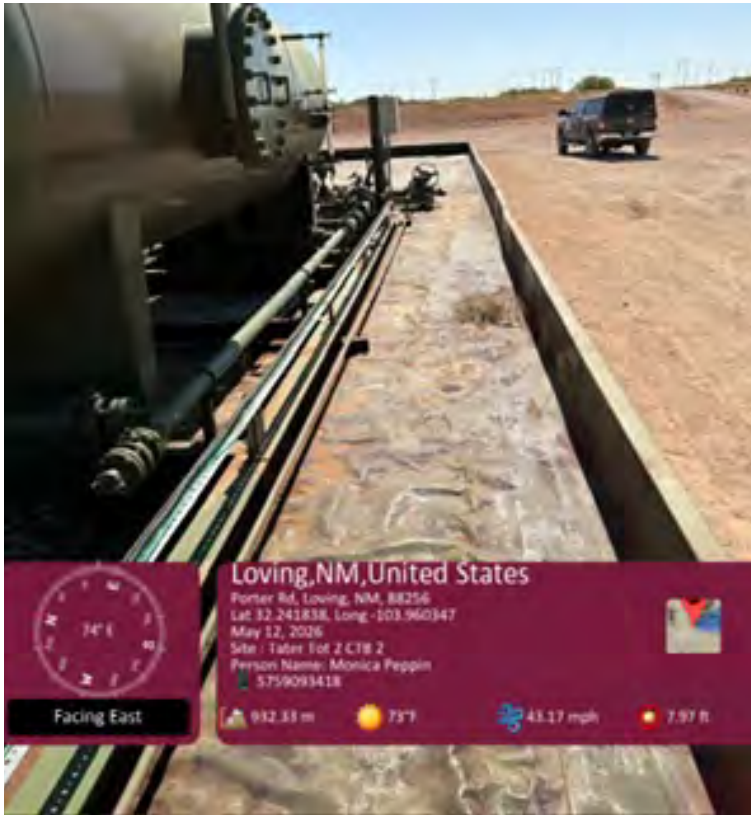
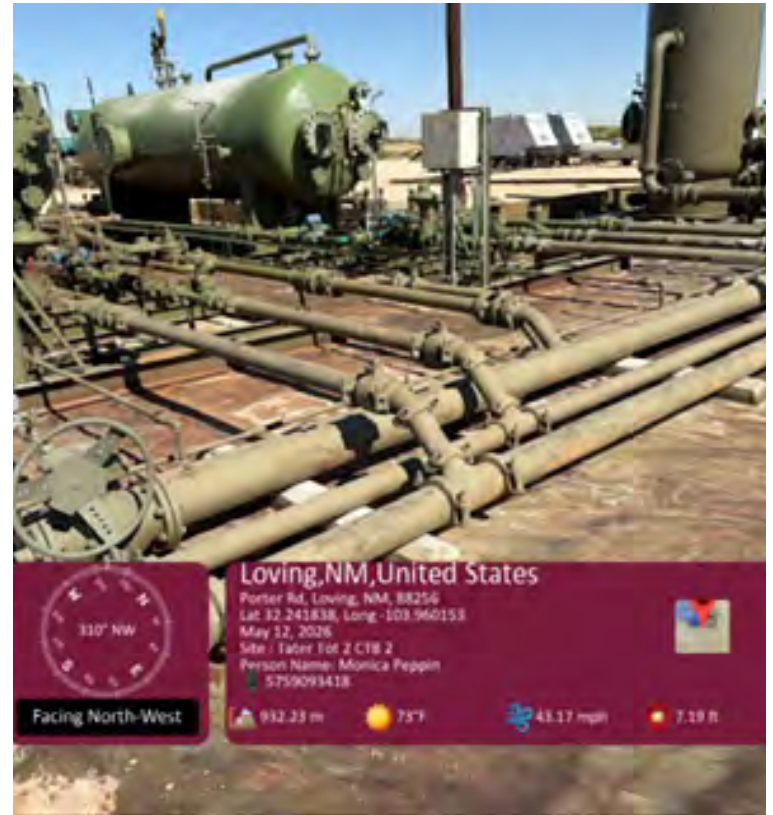
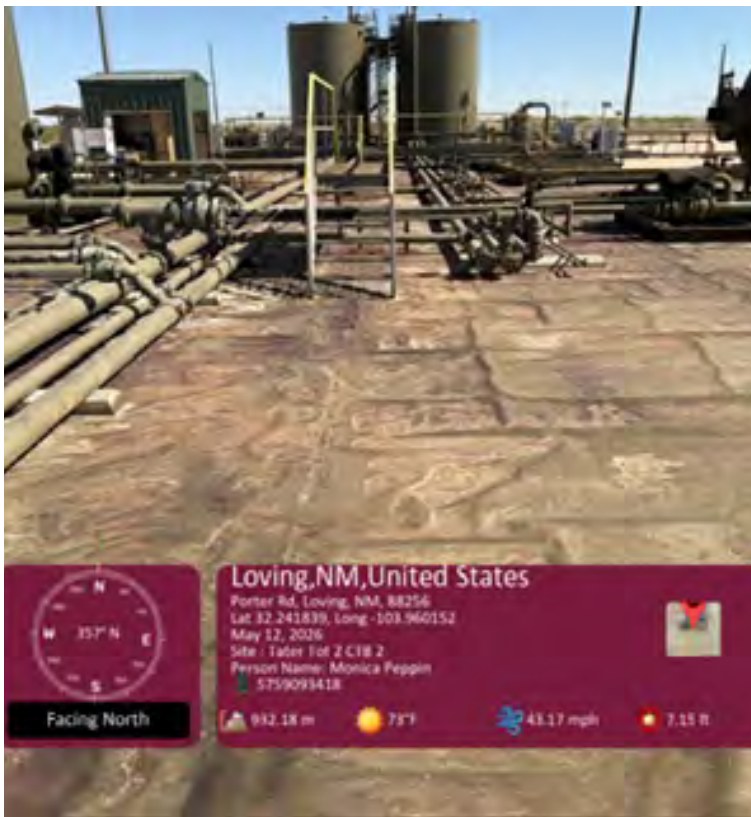
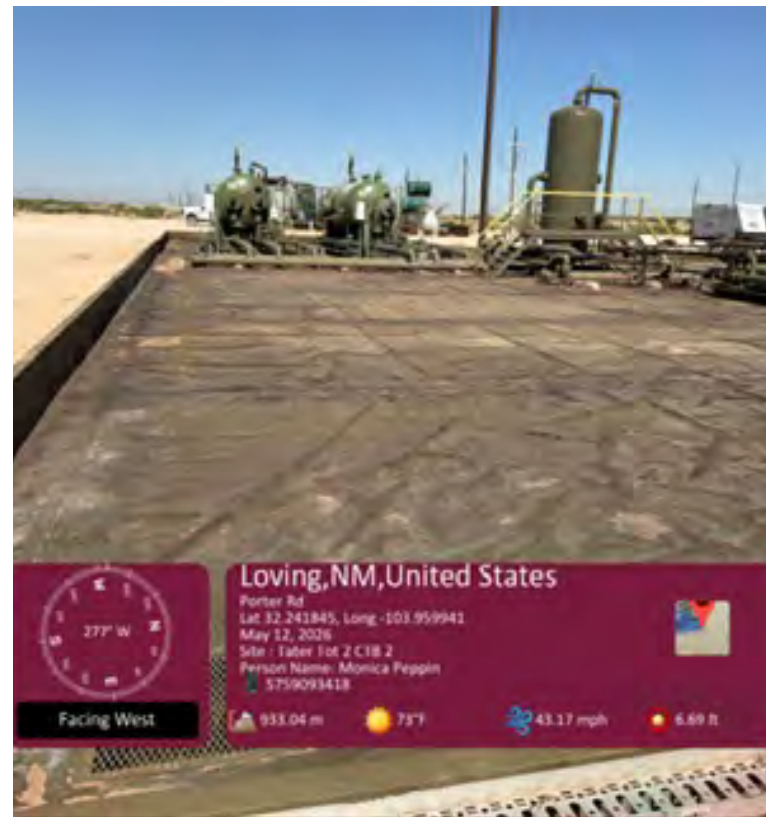
- Observations consisted of the base, walls, and areas where equipment is congested.
- No signs of visible damage including cuts, holes, and UV wear.
- Liner integrity confirmed and passes inspection.
- No further assessment needed.
