Re: Closure Report
Bora Bora 13 CTB 2
Incident Number nAPP2607927390
Incident Number nAPP2609628554
Incident Number nAPP2611730726
Eddy County, New Mexico

Bora Bora 13 CTB 2 Incident Number(s): nAPP2607927390; nAPP2609628554; nAPP2611730726

Closure Report

Liner Integrity Inspection | May 14, 2026 | Photos 1-20 (chronological)

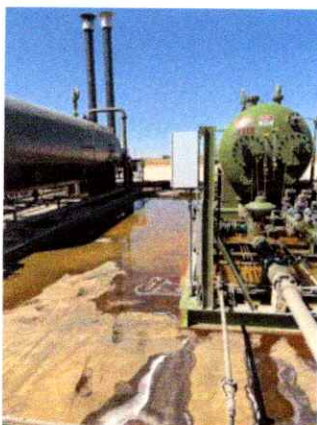
Photo 4 of 5 - Spill Condition on Skid Deck

Pooling observed across full deck surface.
Green pressure vessel with confined space labeling visible at right.
Black horizontal tanks visible in background.

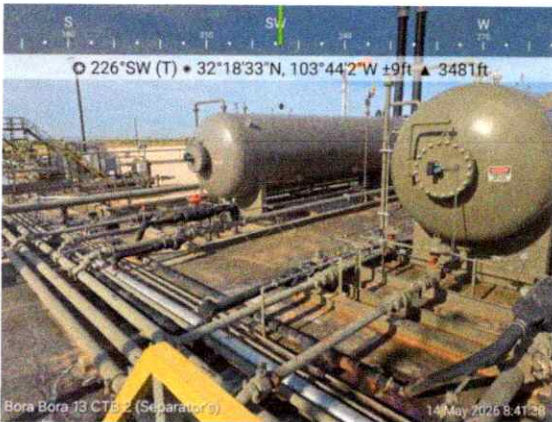
Photo 10 of 20

Description: Southwest view showing horizontal inlet separator and process vessel (confined space placard visible). Pipe rack and manifold in foreground. Liner surface inspected along west equipment and no breaches, tears, punctures, uplift, or other indications of compromised liner integrity were found.

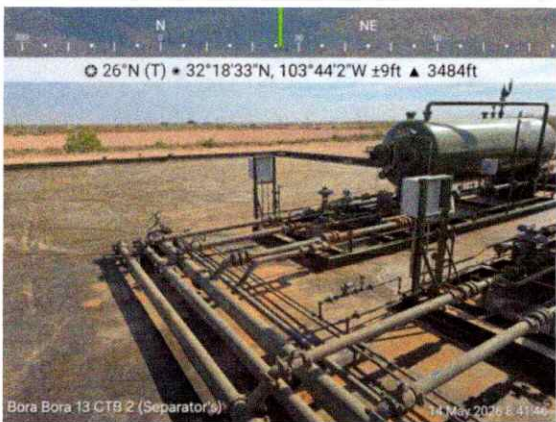
Photo 11 of 20

Description: North-facing view of northeast corner of green separator skid. Single separator vessel and inlet/outlet piping manifold. The secondary containment liner along the equipment perimeter was inspected and determined to be intact, with no evidence of breaches, tears, punctures, uplift, seam separation, or other conditions indicative of compromised liner integrity.

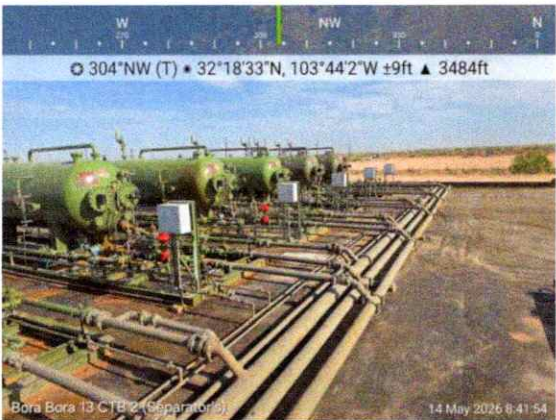
Photo 12 of 20

Description: Northwest overview of the green separator battery depicting all vessels, piping, and instrument enclosures. Inspection of the liner surface identified no tears, seam failures, or compromised penetration integrity.

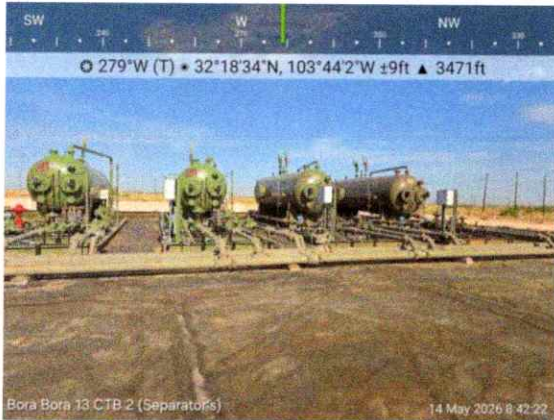
Photo 13 of 20

Description: West-facing view of green separator vessels Y106, Y108, Y110, and Y112 on the process skid, including the inlet manifold and outlet piping. Inspection of the liner surface identified no tears, seam failures, or compromised penetration integrity.

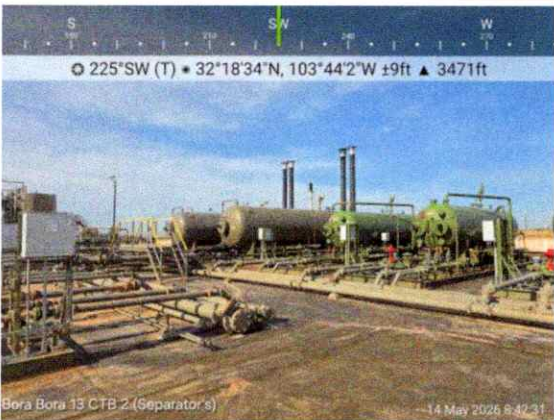
Photo 14 of 20

Description: Horizontal inlet separator and vertical separator vessels with combustor stack assemblies and yellow safety access platform. The liner was inspected along the west and south berms and found to be intact, with no observed tears, seam failures, or compromised penetration integrity.

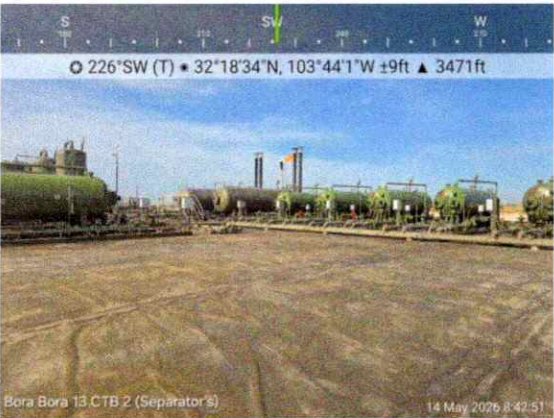
Photo 15 of 20

Description: Overview of the full lateral extent of the green separator battery with the active combustor flare visible at center. Inspection of the liner surface identified no tears, seam failures, or compromised penetration integrity.

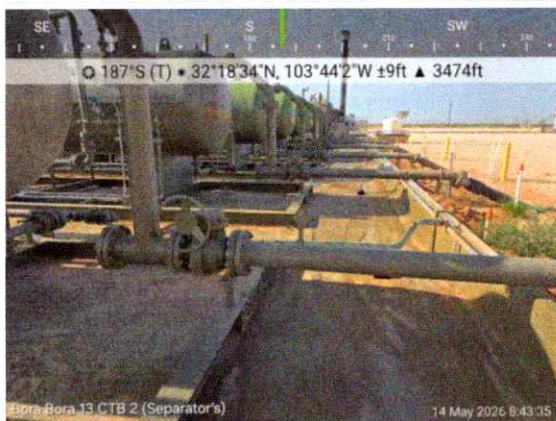
Photo 18 of 20

Description: South-facing view showing the gate valve, flanged connections, and associated piping along the east side of the green separator skid. The liner at the equipment base and adjacent containment berm was inspected and confirmed to be intact, with no observed breaches, tears, seam failures, uplift, or other anomalies indicative of compromised liner integrity.
