Our Ref.: 12679157-NMOCD-2

May 29, 2026

Closure Report
Devon Energy Production Company, LP
Arena Roja 28 CTB 2
Unit Letter B, Section 28, T26S, R35E
Lea County, New Mexico
(32.0186376, -103.3724479)

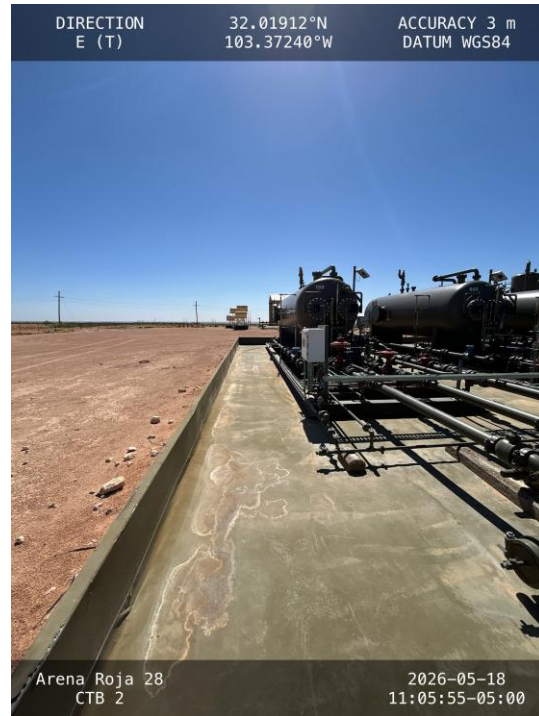
Photo 2 View of northern side containment area towards east.

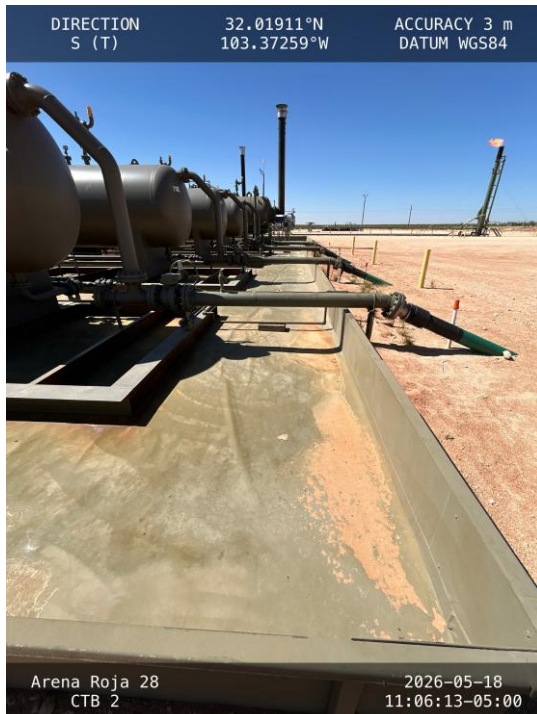
Photo 3 View of west side secondary containment towards south.

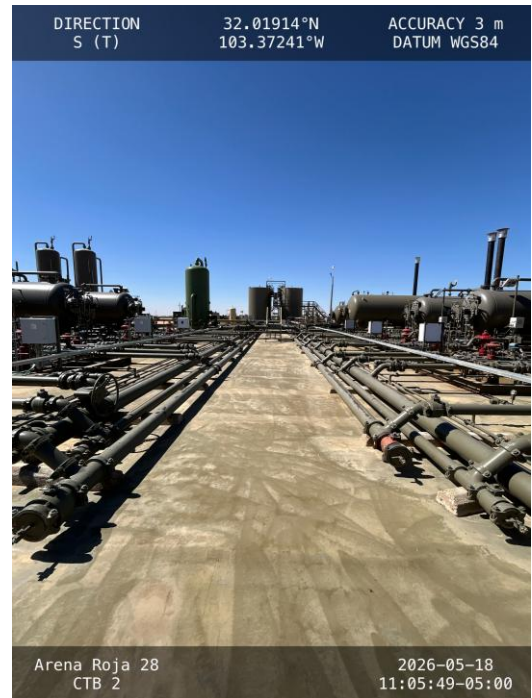
Photo 4 View of central portion of containment area towards south.

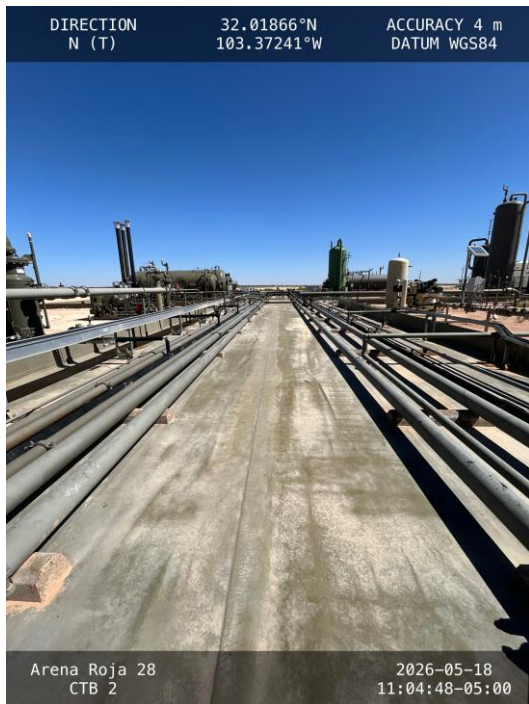
Photo 5 View of central portion of containment area towards north.

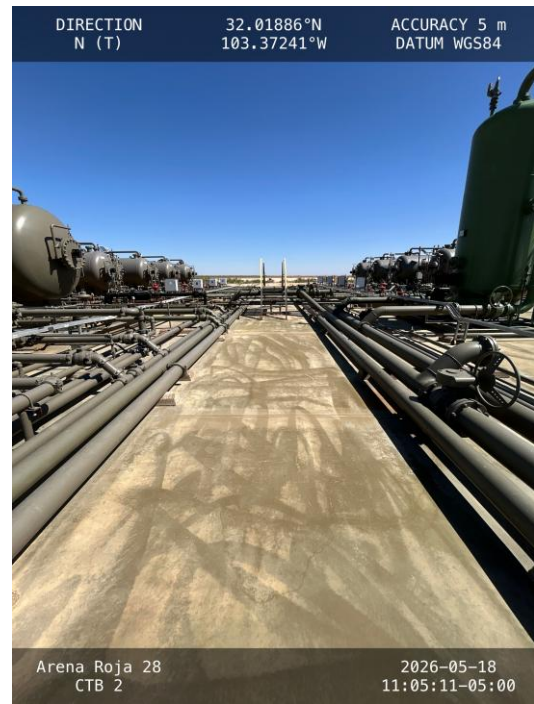
Photo 6 View of central portion of containment area towards north.

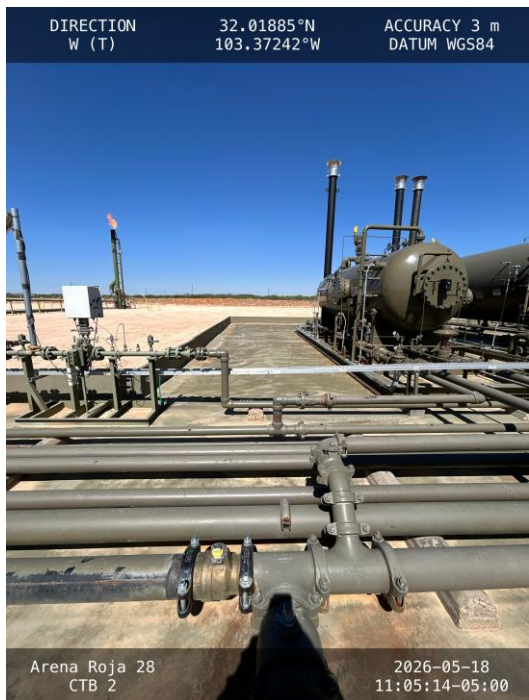
Photo 7 View of south side of containment towards west.

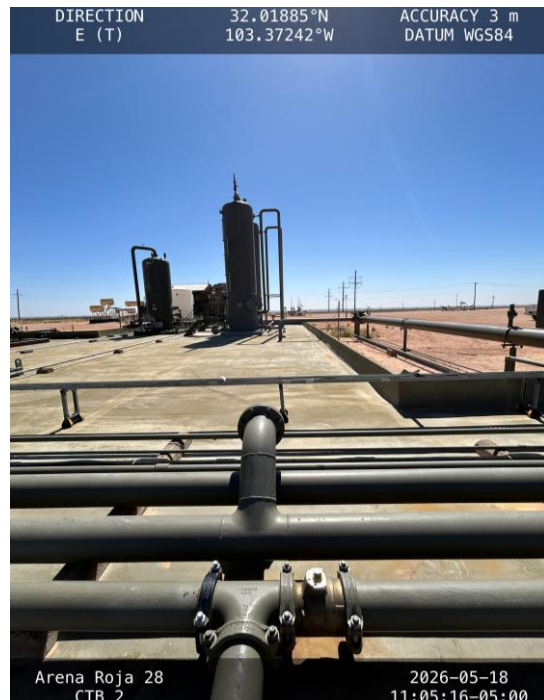
Photo 8 View of south side of containment towards east.

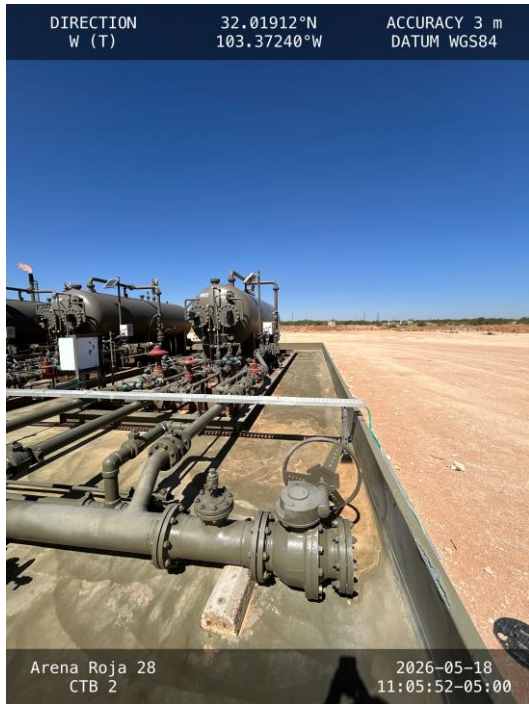
Photo 9 View of north side of secondary containment towards west.

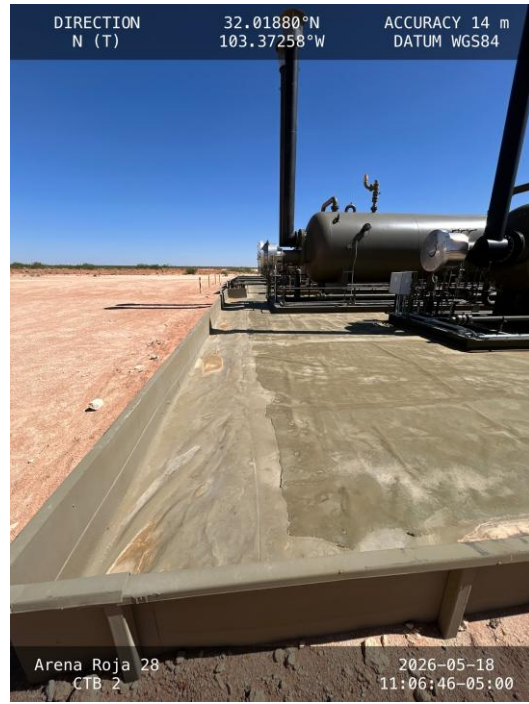
Photo 10 View of west side of secondary containment towards north.

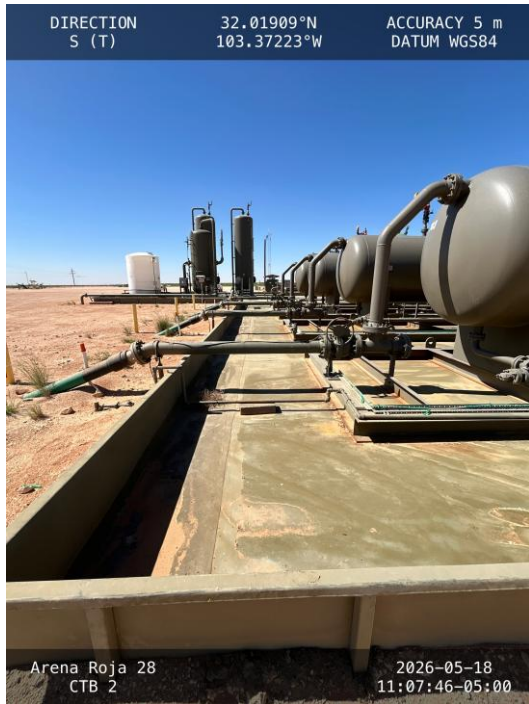
Photo 11 View of east side of secondary containment areas towards south.

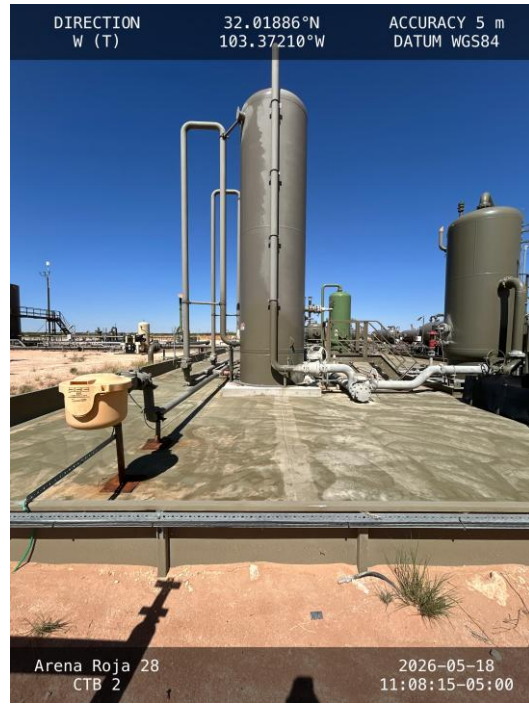
Photo 12 View of east side of secondary containment towards west.

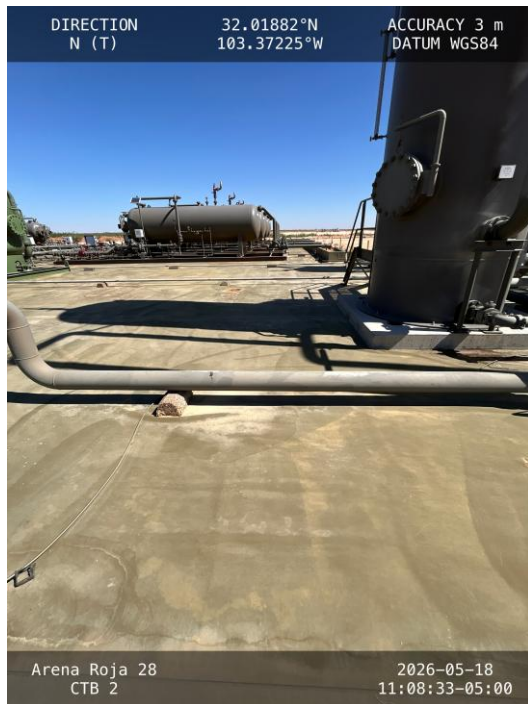
Photo 13 View of east side of secondary containment towards north.
