Re: Closure Report  
Bora Bora 13 CTB 2  
Incident Number nAPP2607927390  
Incident Number nAPP2609628554  
Incident Number nAPP2611730726  
Eddy County, New Mexico

**Bora Bora 13 CTB 2 Incident Number(s): nAPP2607927390; nAPP2609628554; nAPP2611730726**

**Closure Report**

Liner Integrity Inspection | May 14, 2026 | Photos 1-20 (chronological)

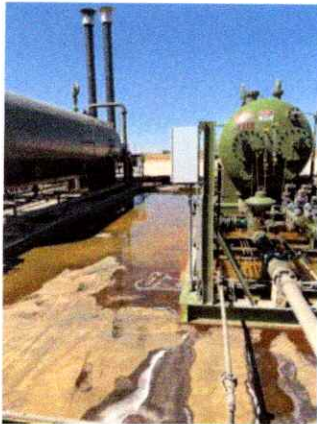
**Photo 4 of 5 - Spill Condition on Skid Deck**

Pooling observed across full deck surface.

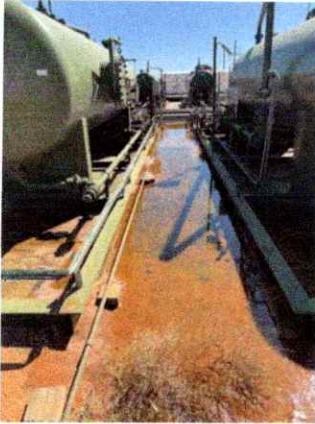
**Photo 4 of 5 - Fluid Pooling Between Vessel Rows**

**Fluid:** Pooling visible along full corridor length

Produced water accumulation observed between vessel skid structures. Spill appears confined between vessel rows.

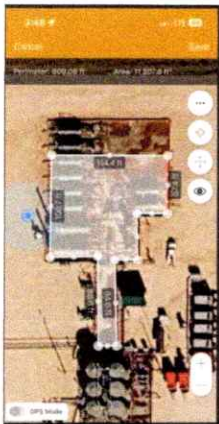
**Photo 2 of 5 - Aerial Spill Area Measurement**

Largest spill of the three incidents documented.

Aerial view shows extensive spill polygon across full pipeline skid area.

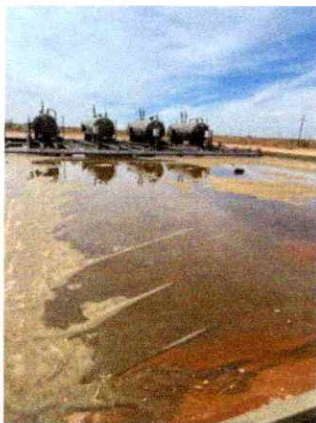
**Photo 4 of 5 - Skid Deck Fluid Accumulation**

**Fluid:** Pooling covers full visible deck surface

Produced water with sheen visible across the skid deck.  
Multiple green horizontal pressure vessels with confined space labeling visible.  
Horizontal heater treaters in background.

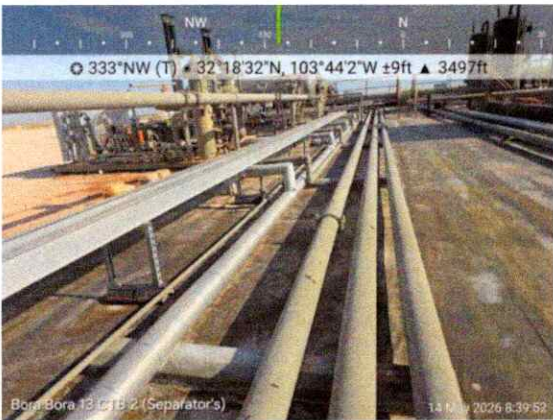
Photo 2 of 20

Description: Northwest-facing view along pipe rack corridor between containment sections. Galvanized cable tray and Dura-Blok pipe supports on skid deck. Liner surface and deck interface evaluated no breach or uplift observed. Residual salt staining visible on liner.

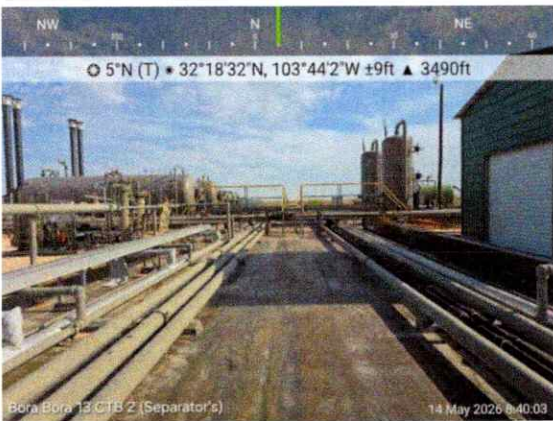
Photo 3 of 20

Description: North-facing corridor view between black process vessel skid (left) and green building (right). Multi-line pipe rack runs full length of containment. Liner surface dry; no breach or uplift observed. Residual salt staining visible on liner. residue marks from prior release events visible.

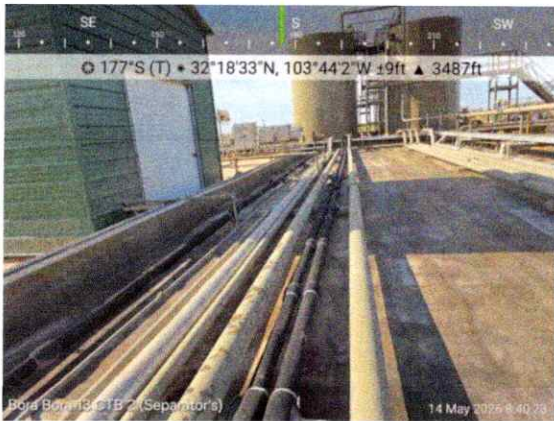
Photo 4 of 20

Description: South-facing view along east edge of containment adjacent to green building. Multi-diameter pipe bundle exits containment. Inspection of the liner surface and east berm interface identified no breaches, tears, punctures, uplift, or other indications of compromised liner integrity.

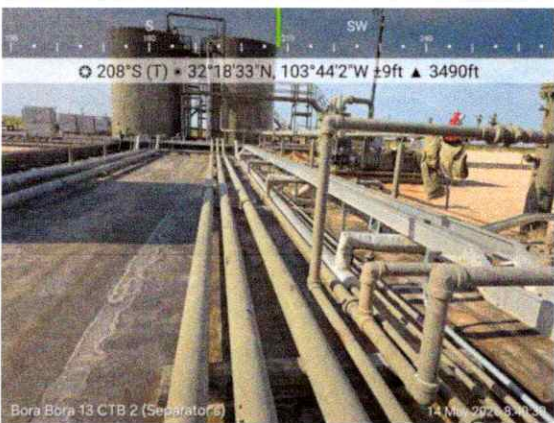
Photo 5 of 20

Description: South-southwest view showing large storage tank beyond containment berm. Pipe rack and liner surface in foreground. Inspection of the liner surface interface identified no breaches, tears, punctures, uplift, or other indications of compromised liner integrity.

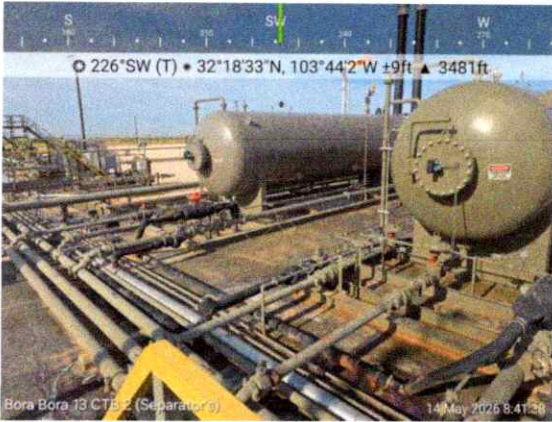
Photo 10 of 20

Description: Southwest view showing horizontal inlet separator and process vessel (confined space placard visible). Pipe rack and manifold in foreground. Liner surface inspected along west equipment and no breaches, tears, punctures, uplift, or other indications of compromised liner integrity were found.

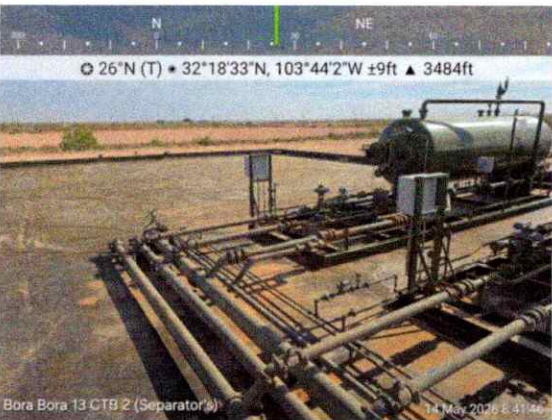
Photo 11 of 20

Description: North-facing view of northeast corner of green separator skid. Single separator vessel and inlet/outlet piping manifold. The secondary containment liner along the equipment perimeter was inspected and determined to be intact, with no evidence of breaches, tears, punctures, uplift, seam separation, or other conditions indicative of compromised liner integrity.

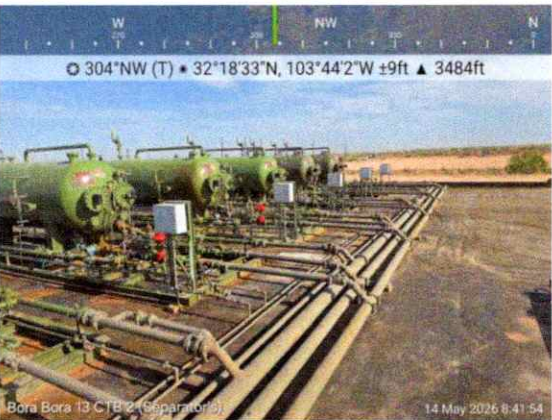
Photo 12 of 20

Description: Northwest overview of the green separator battery depicting all vessels, piping, and instrument enclosures. Inspection of the liner surface identified no tears, seam failures, or compromised penetration integrity.

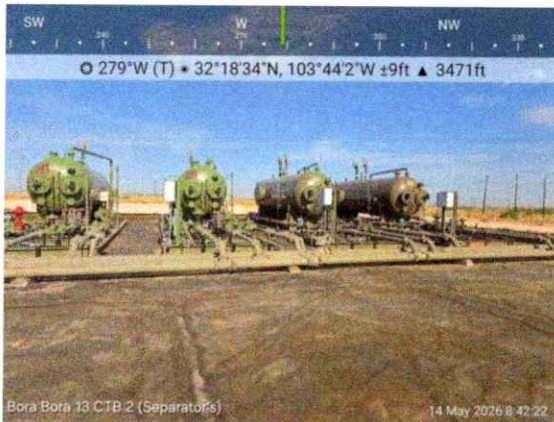
Photo 13 of 20

Description: West-facing view of green separator vessels Y106, Y108, Y110, and Y112 on the process skid, including the inlet manifold and outlet piping. Inspection of the liner surface identified no tears, seam failures, or compromised penetration integrity.

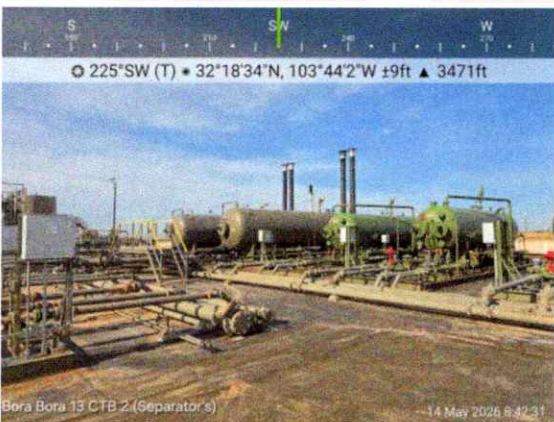
Photo 14 of 20

Description: Horizontal inlet separator and vertical separator vessels with combustor stack assemblies and yellow safety access platform. The liner was inspected along the west and south berms and found to be intact, with no observed tears, seam failures, or compromised penetration integrity.

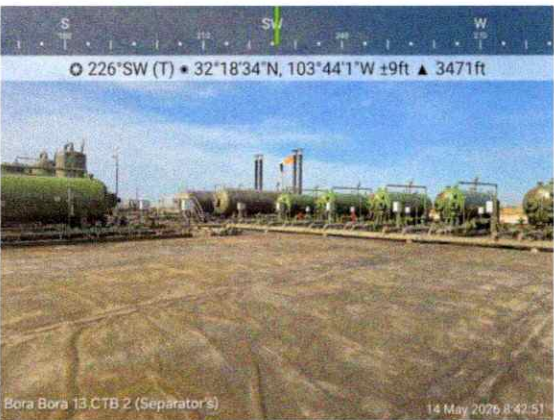
Photo 15 of 20

Description: Overview of the full lateral extent of the green separator battery with the active combustor flare visible at center. Inspection of the liner surface identified no tears, seam failures, or compromised penetration integrity.

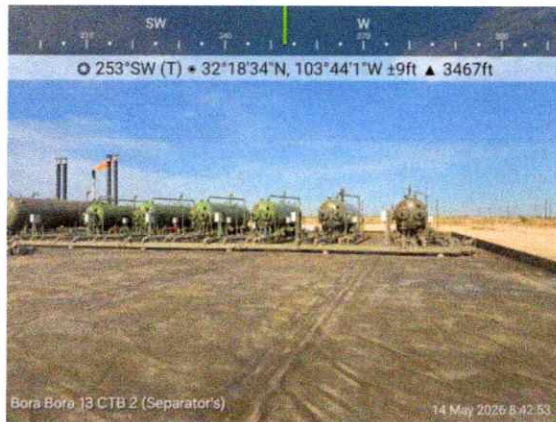
Photo 16 of 20

Description: View of the separator vessels on the process skid with the active flare visible in the background. The skid perimeter and containment interface are shown. Inspection of the liner along the skid edge identified no damage, breaches, uplift, or other indications of compromised liner integrity.

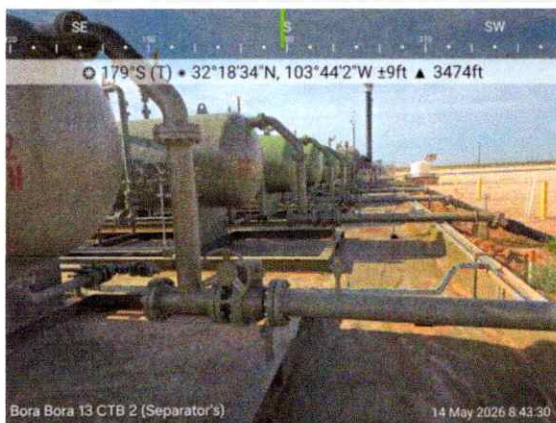
Photo 17 of 20

Description: South-facing view along the east side of the green separator skid showing Vessel Y110 outlet connections and gate valve in the foreground. Inspection of the liner surface identified no tears, seam failures, or compromised penetration integrity.

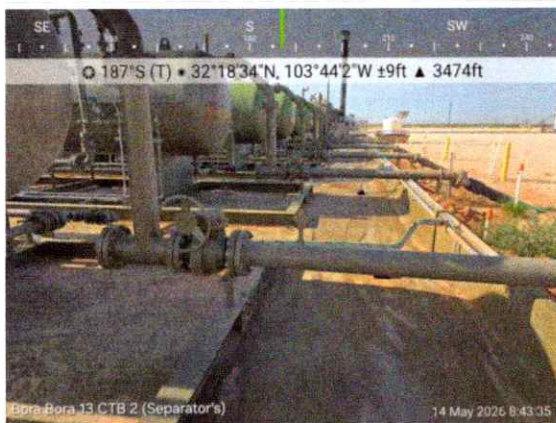
Photo 18 of 20

Description: South-facing view showing the gate valve, flanged connections, and associated piping along the east side of the green separator skid. The liner at the equipment base and adjacent containment berm was inspected and confirmed to be intact, with no observed breaches, tears, seam failures, uplift, or other anomalies indicative of compromised liner integrity.

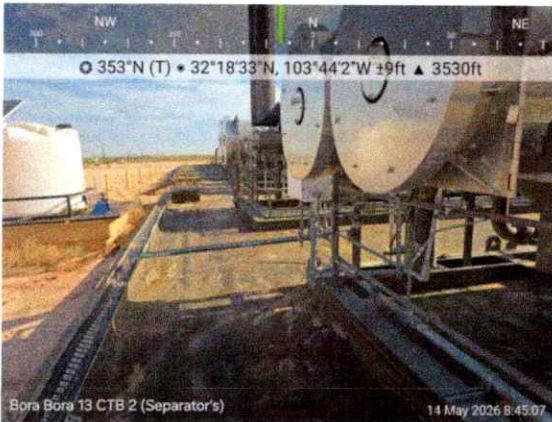
Photo 19 of 20

Description: North-facing view along the lined secondary containment berm. Inspection of the interior liner surface and berm edge along the full visible length identified no punctures, seam separations, uplift, or other liner integrity concerns.

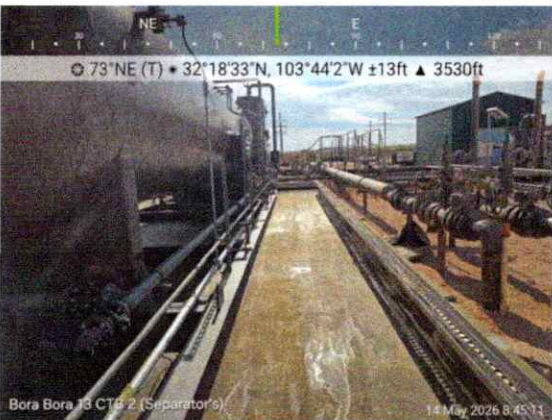
Photo 20 of 20

Description: Northeast-facing view along the lined equipment corridor between the separator vessels and process piping. The liner surface exhibits residual salt crystallization consistent with the previous produced water release; however, no standing fluid or evidence of active leakage was observed. The liner surface, equipment interfaces, and visible containment features were inspected and found to be intact, with no observed tears, punctures, seam separations, uplift, or other indications of compromised liner integrity."
