Bradley 8  
Fee 3H TB  
Incident ID nAPP2609828726

PREPARED BY:  
PIMA ENVIRONMENTAL SERVICES, LLC

## Liner Inspection and Closure Report

June 23, 2026

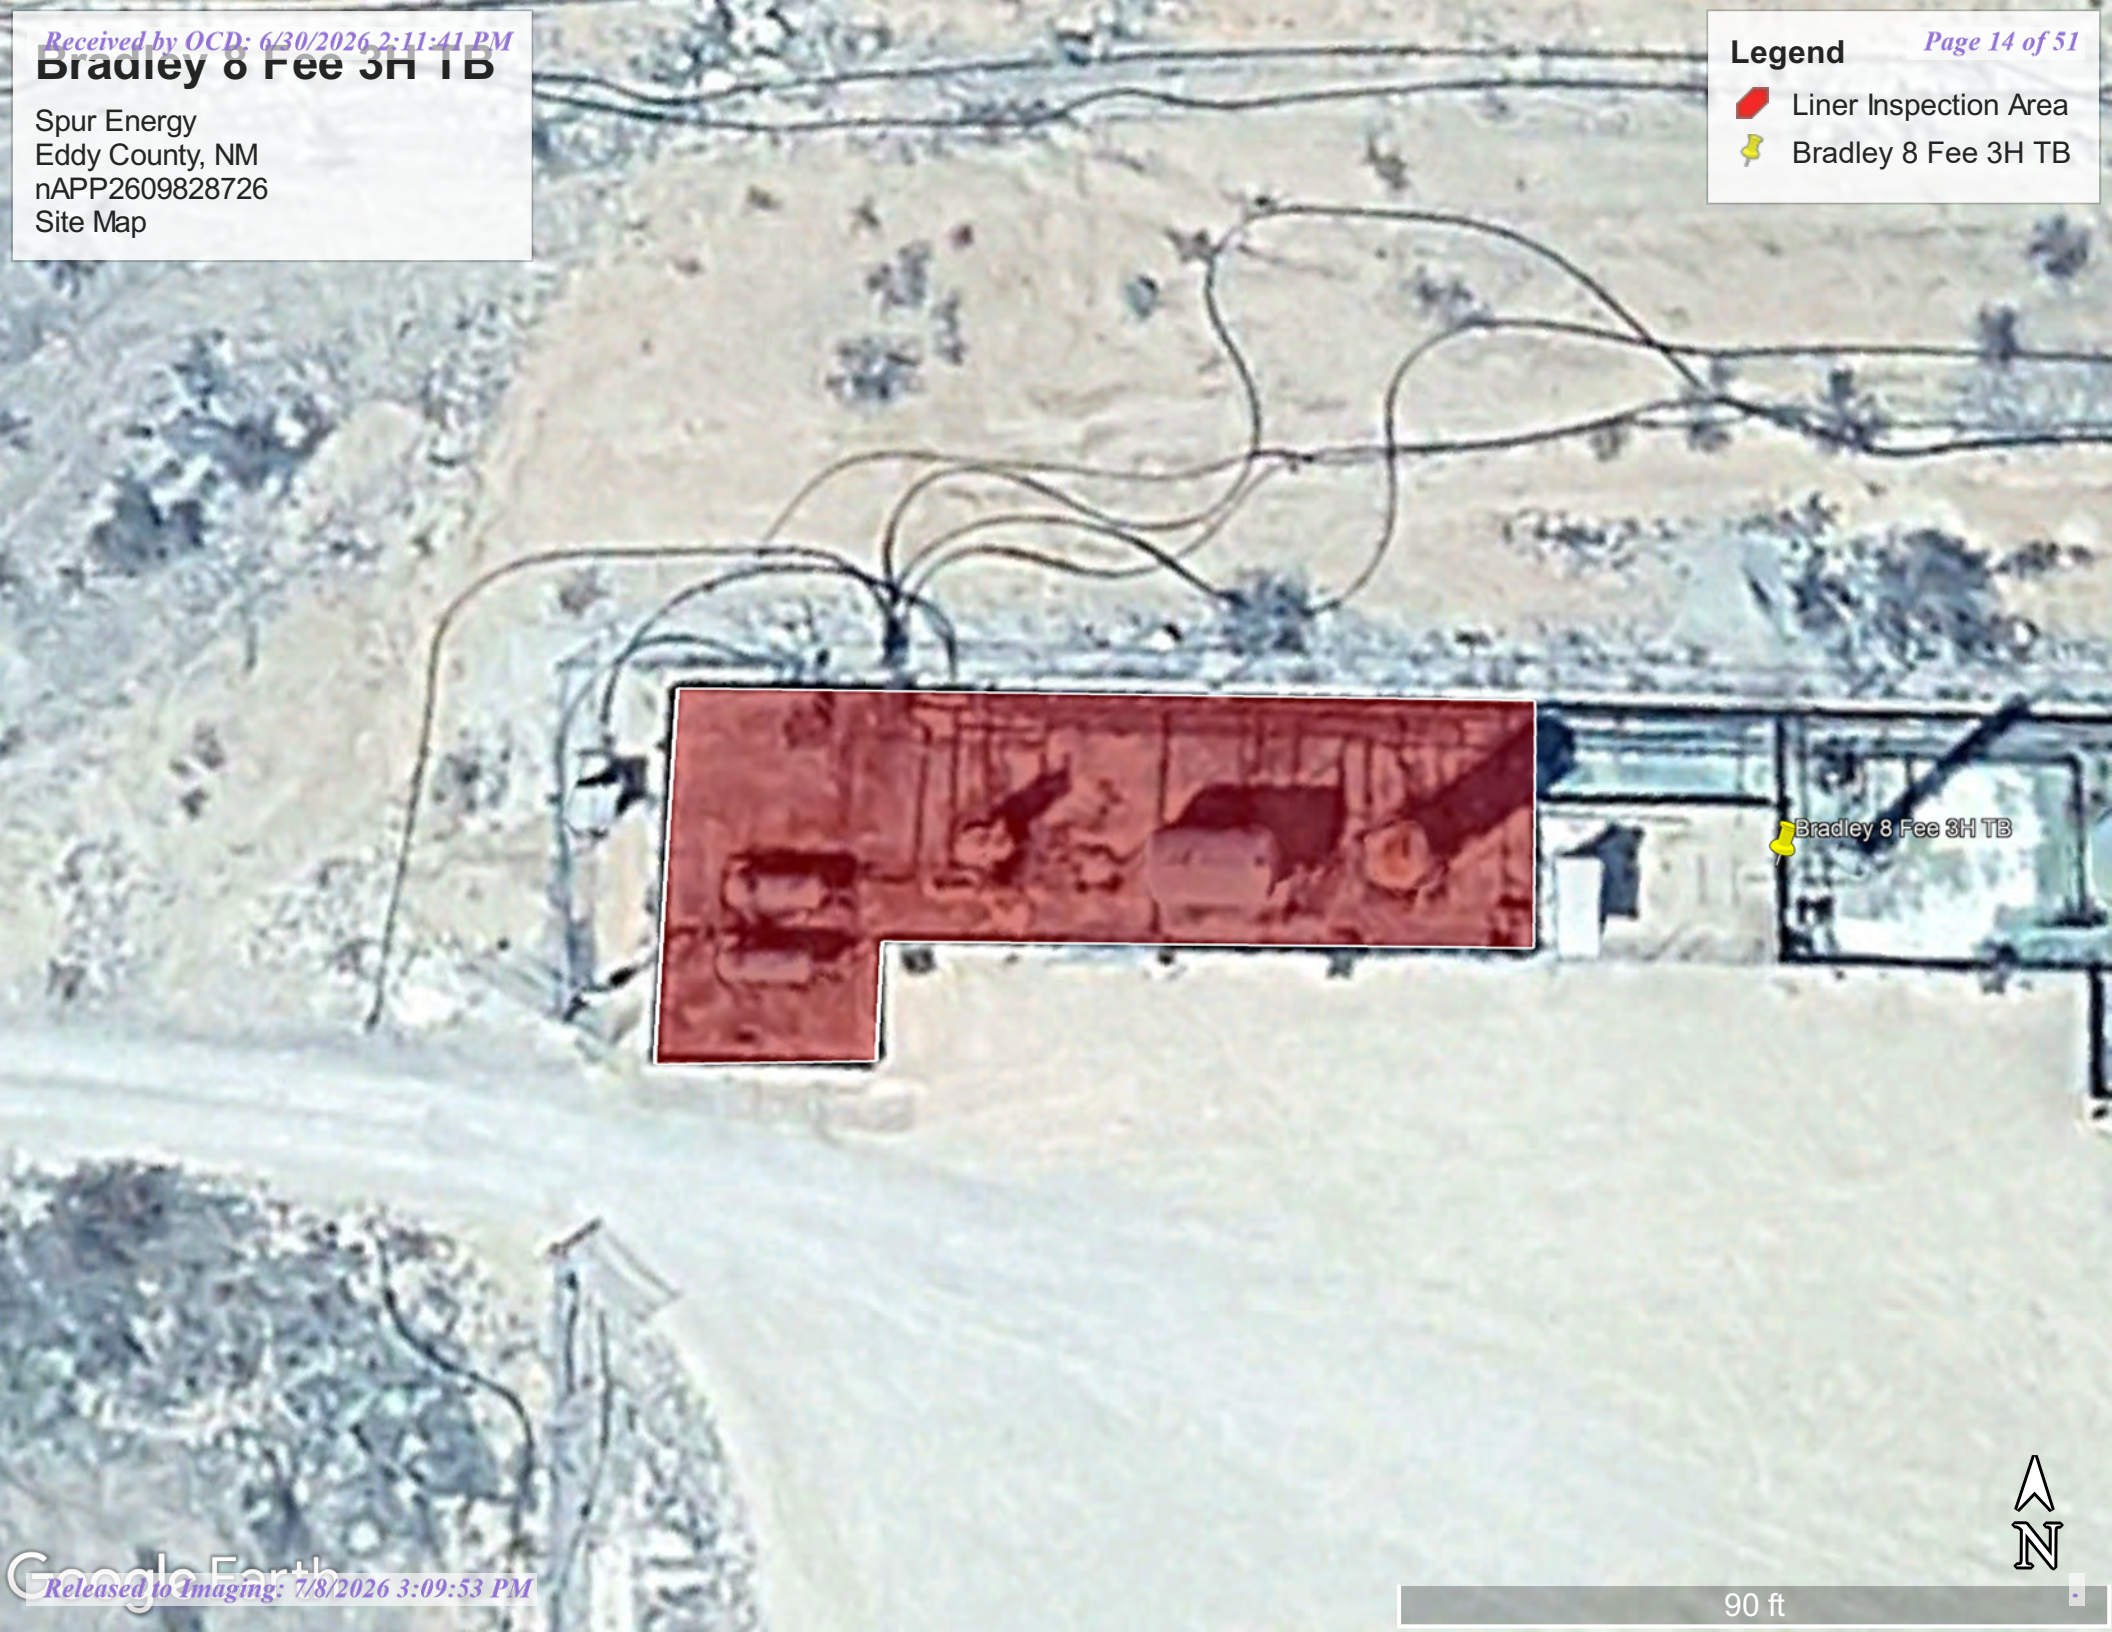
Figure 4- Site Map

**nAPP2609828726:** On April 2, 2026, corrosion of a vessel nipple caused the release of approximately 4 barrels of crude oil and 58 barrels of produced water into the lined containment at the Site. Upon discovery, Spur personnel immediately initiated response and recovery actions to minimize the duration and extent of the release. Vacuum truck operations were mobilized, and all released fluids were successfully recovered from the containment area. Following recovery efforts, the lined containment was inspected and no evidence of fluid migration beyond the containment system was observed. Based on field observations, the secondary containment functioned as designed and effectively prevented impacts to surrounding soils and areas outside the containment. A site map depicting the release location is provided in Figure 4.

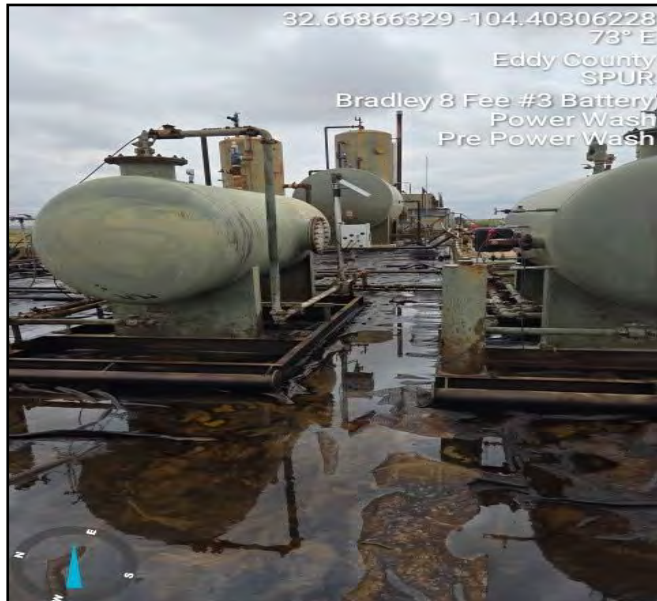
Photograph taken pre powerwash facing east.

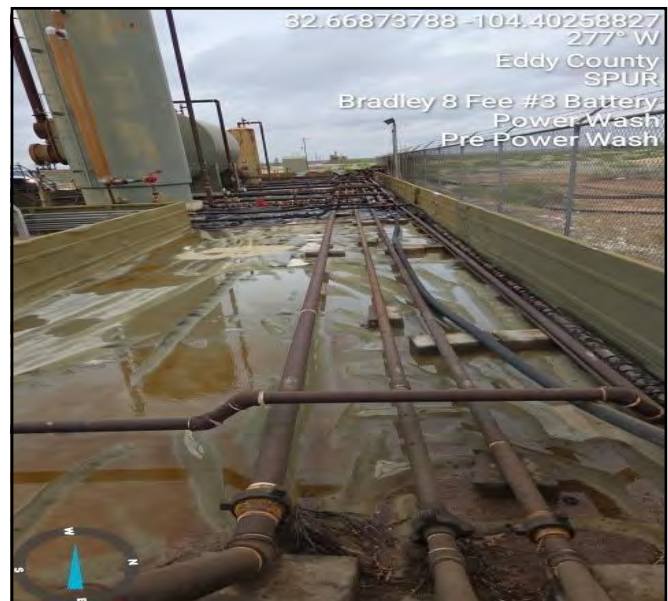
Photograph taken pre powerwash facing west.

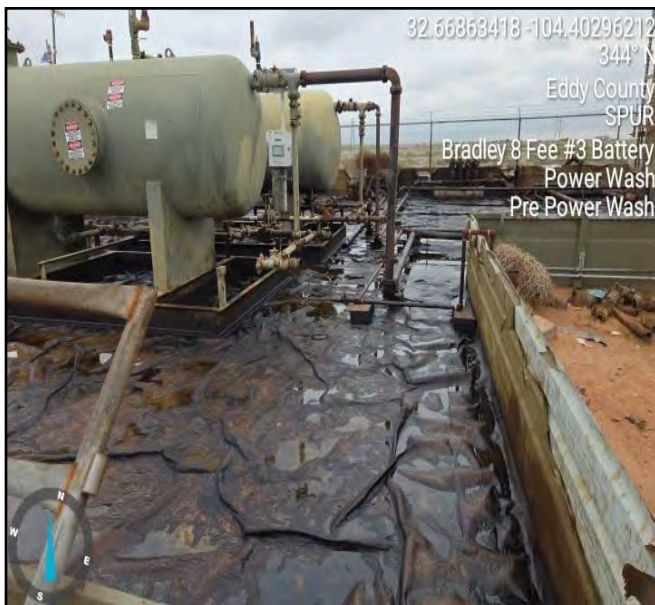
Photograph taken pre powerwash facing north.

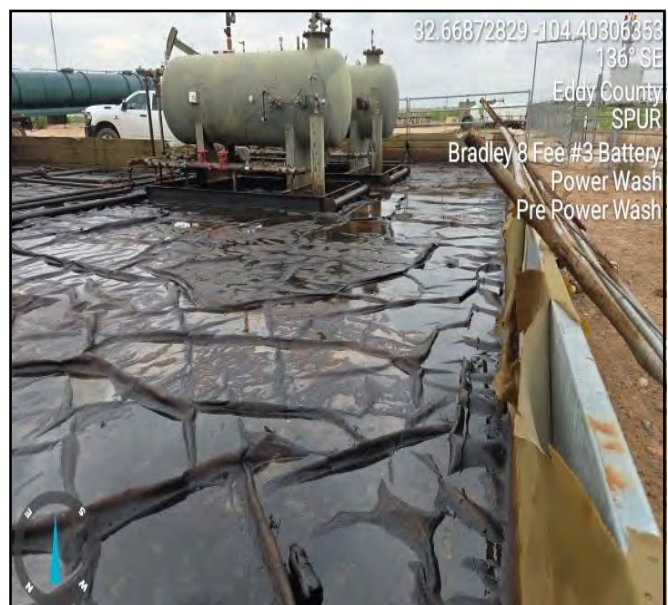
Photograph taken pre powerwash facing southeast.

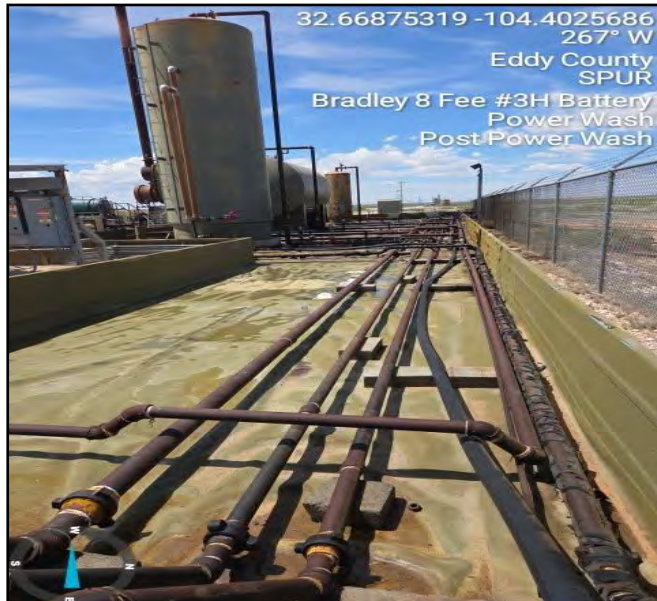
Photograph taken post powerwash facing west.

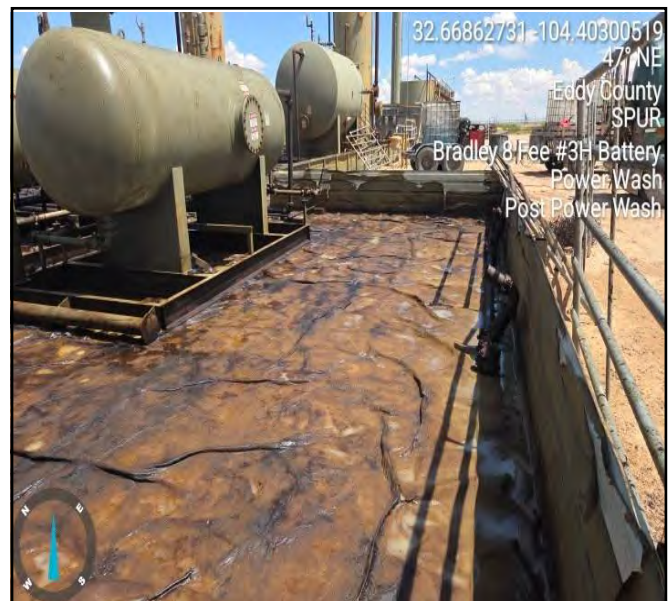
Photograph taken post powerwash facing northeast.

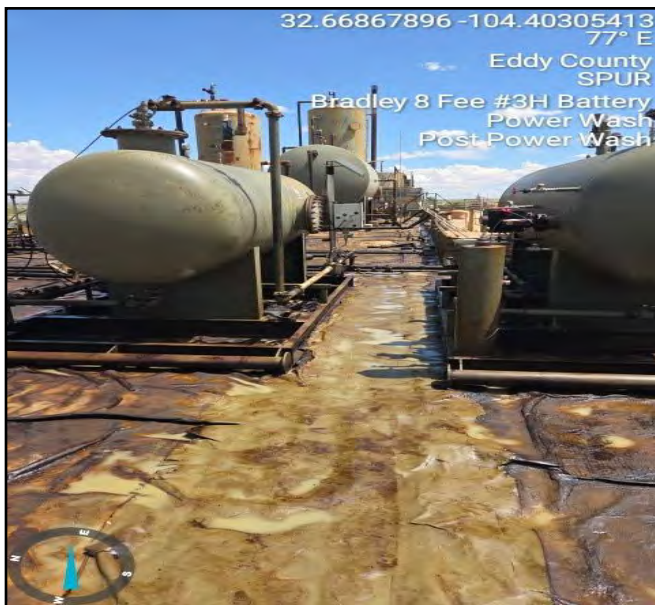
Photograph taken post powerwash facing east.

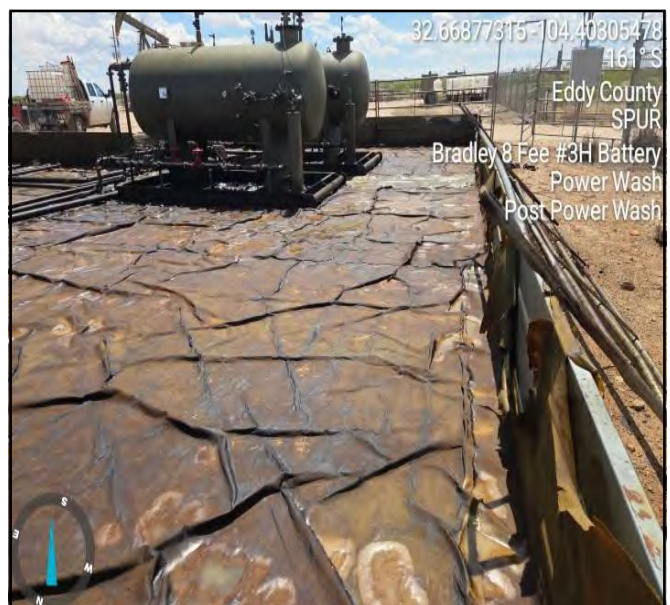
Photograph taken post powerwash facing south.

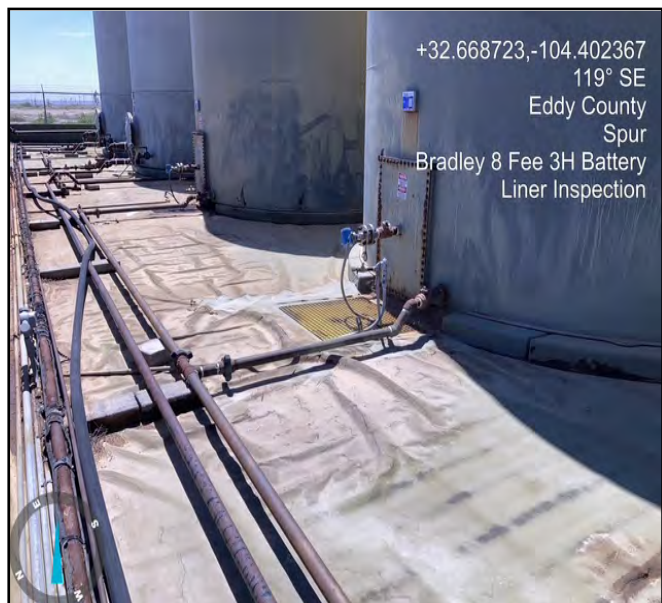
Upon completion of the cleaning activities, the exposed liner was inspected for signs of tears, punctures, seam failures, or other deficiencies that could compromise containment performance. The inspection confirmed that the liner remained intact and functioned as designed, successfully containing all released fluids within the lined containment area. No evidence of fluid migration beyond the

Photograph taken conducting Liner inspection facing southeast.

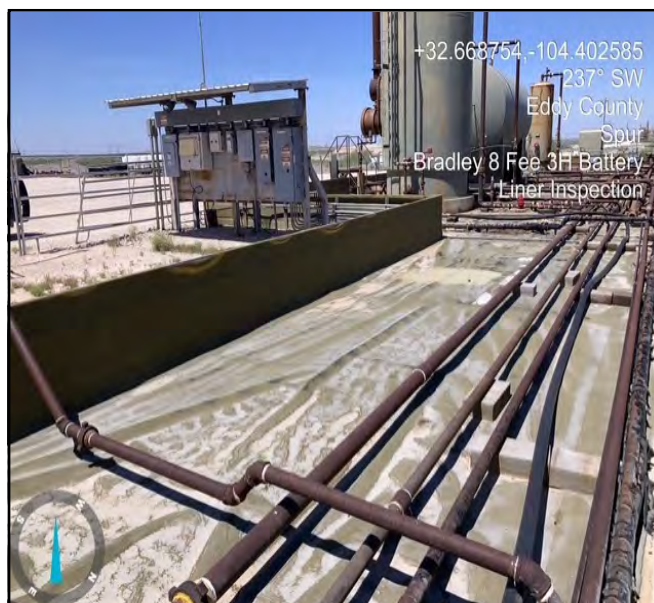
Photograph taken conducting Liner inspection facing southwest.

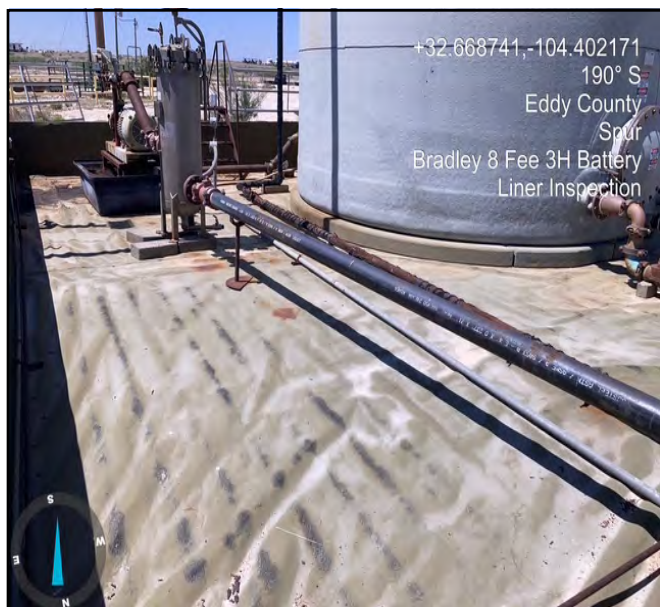
Photograph taken conducting Liner inspection facing south.

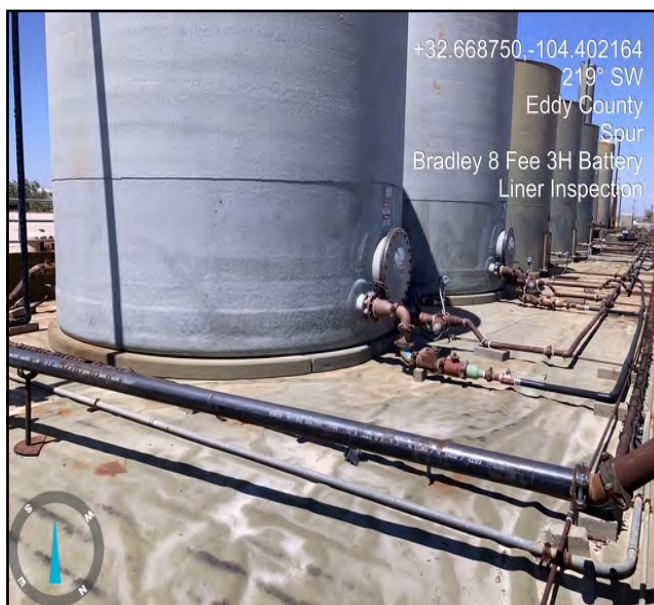
Photograph taken conducting Liner inspection facing southwest.
