Well Name: SAN JUAN 29-6 UNIT	Well Location: T29N / R6W / SEC 28 / NWNW / 36.70068 / -107.47376	County or Parish/State: RIO ARRIBA / NM
Well Number: 58A	Type of Well: CONVENTIONAL GAS WELL	Allottee or Tribe Name:
Lease Number: NMNM03471	Unit or CA Name: SAN JUAN 29-6 UNIT--FR, SAN JUAN 29-6 UNIT--MV	Unit or CA Number: NMNM78416A, NMNM78416E
US Well Number: 3003921262	Well Status: Producing Gas Well	Operator: HILCORP ENERGY COMPANY

Subsequent Report

Type of Action: Workover Operations

San Juan 29-6 Unit 58A
30-039-21262
Dual to Commingle SR

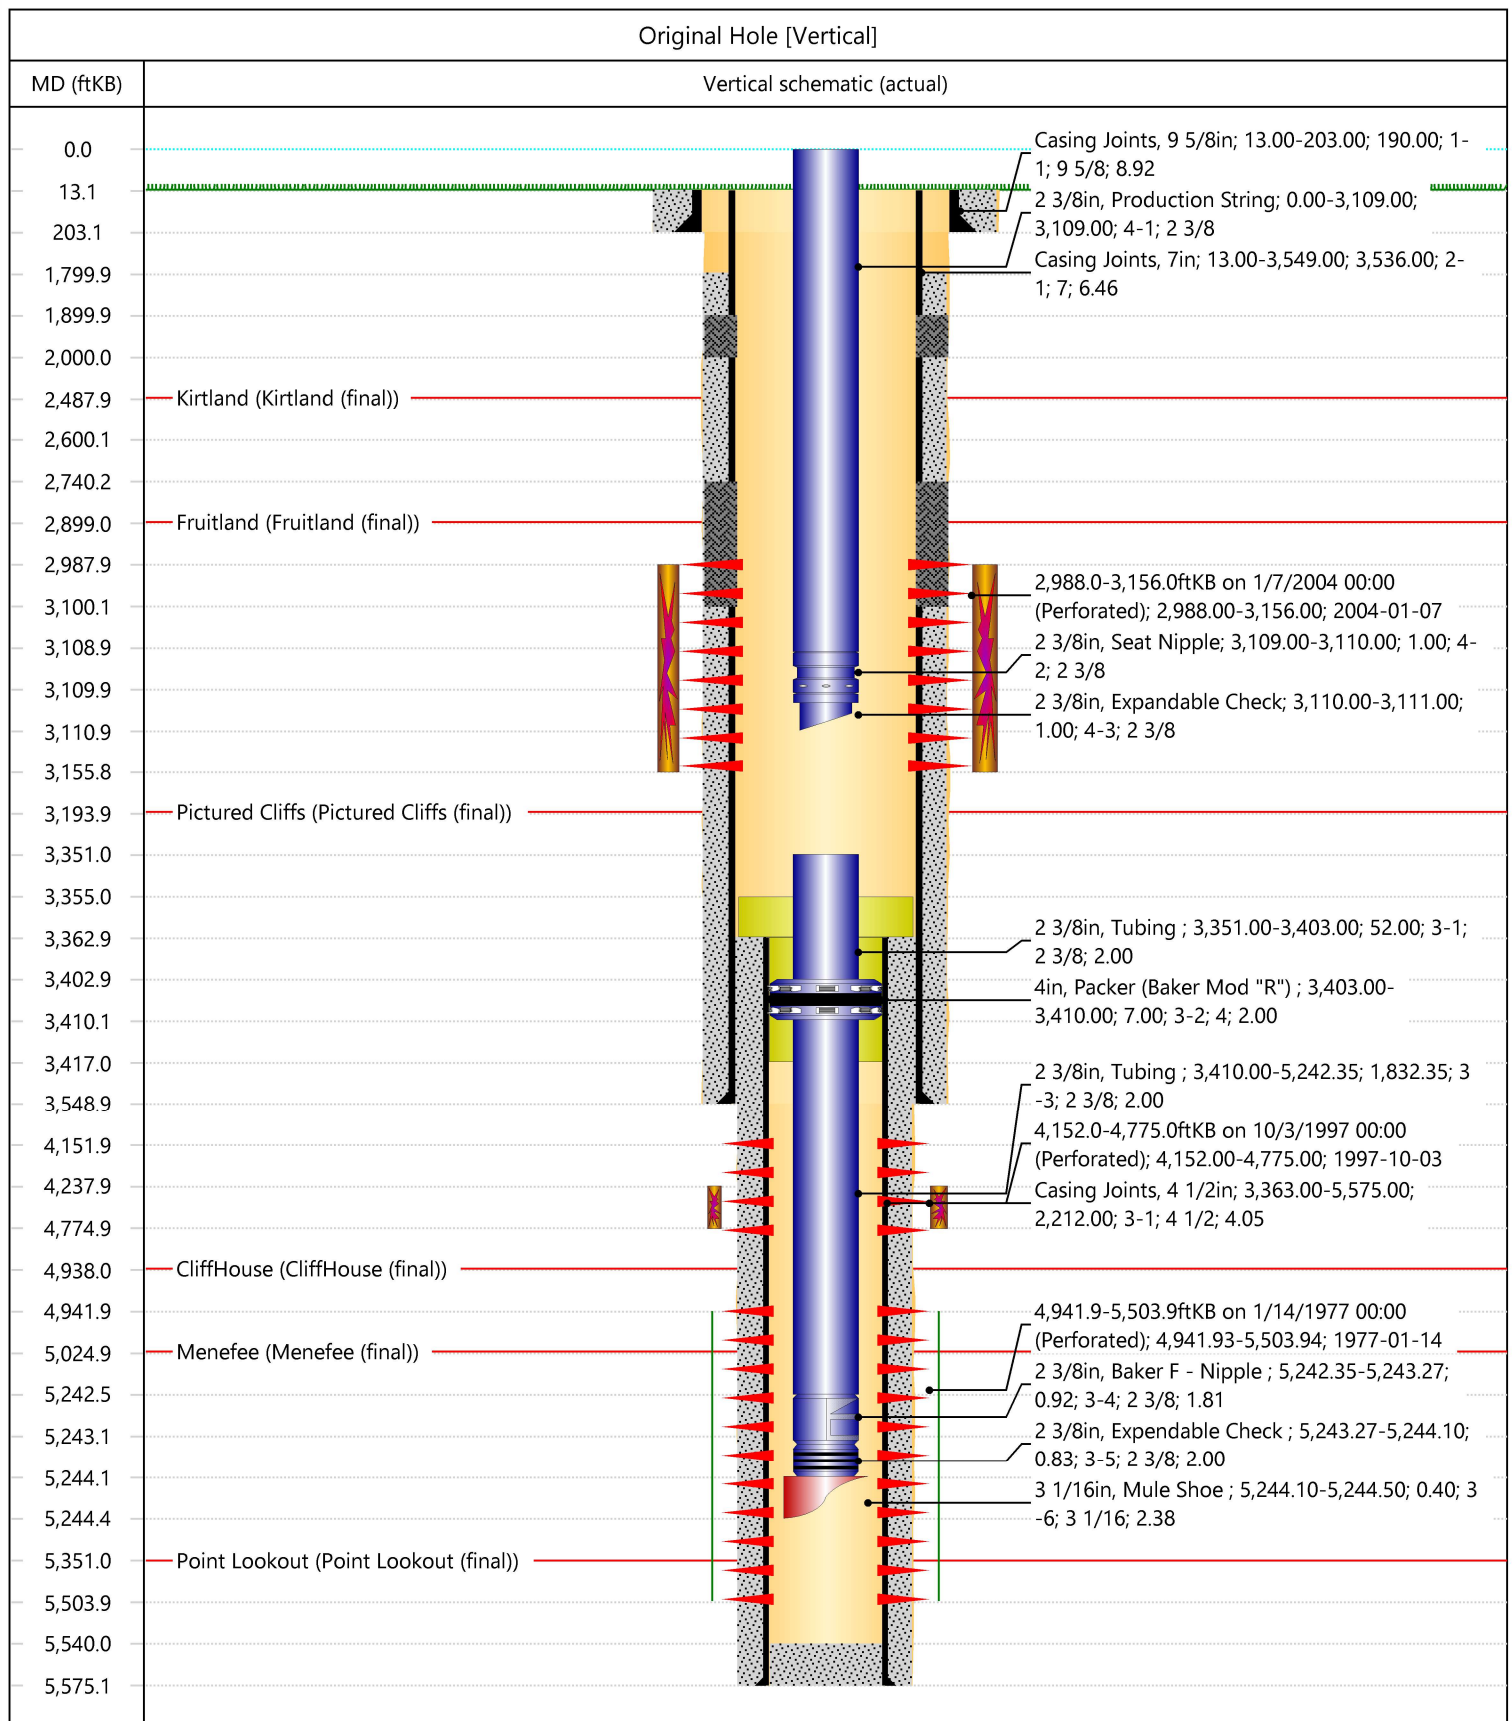
Current Schematic

This well is now producing as a Mesaverde/Fruitland Coal commingle.

8/31/22 - (SITP-100, SICP – 140, SIBP-0). BDW. Work tbg. Attempt to pull fish @ 3351'. No movement. Circ air mist. TOH, LD overshot. **Received permission from Kenny Rennick/BLM & Monica Kuehling/OCD to leave fish in the hole and produce the well as is (MV/FC commingle).** TIH w/ 77 jts of 2 3/8", 4.7#, J-55 tbg and land @ 3111' (SN @ 3109'). ND BOP, NU WH. PT tbg to 500 psi. Good Test. RDMO.
