Report Type: Work Plan

Site:	Harper State # 10					
Company:	COG Operating LLC					
Section, Township and Range	Unit P	Sec 16	T17S	R30E		
Lease Number:	API-30-015-34870					
County:	Eddy County					
GPS:	32.82907° N			103.96906° W		
Surface Owner:	State					
Mineral Owner:						
Directions:	In Loco Hills, from the intersection of Goat Roper Rd and Hwy 82, travel north on Goat Roper Rd for 0.7m, turn right and travel 0.5m, turn right and travel 0.2m to site.

Re: Work Plan for the COG Operating LLC., Harper State # 10 Flow Line, Unit P, Section 16, Township 17 South, Range 30 East, Eddy County, New Mexico.

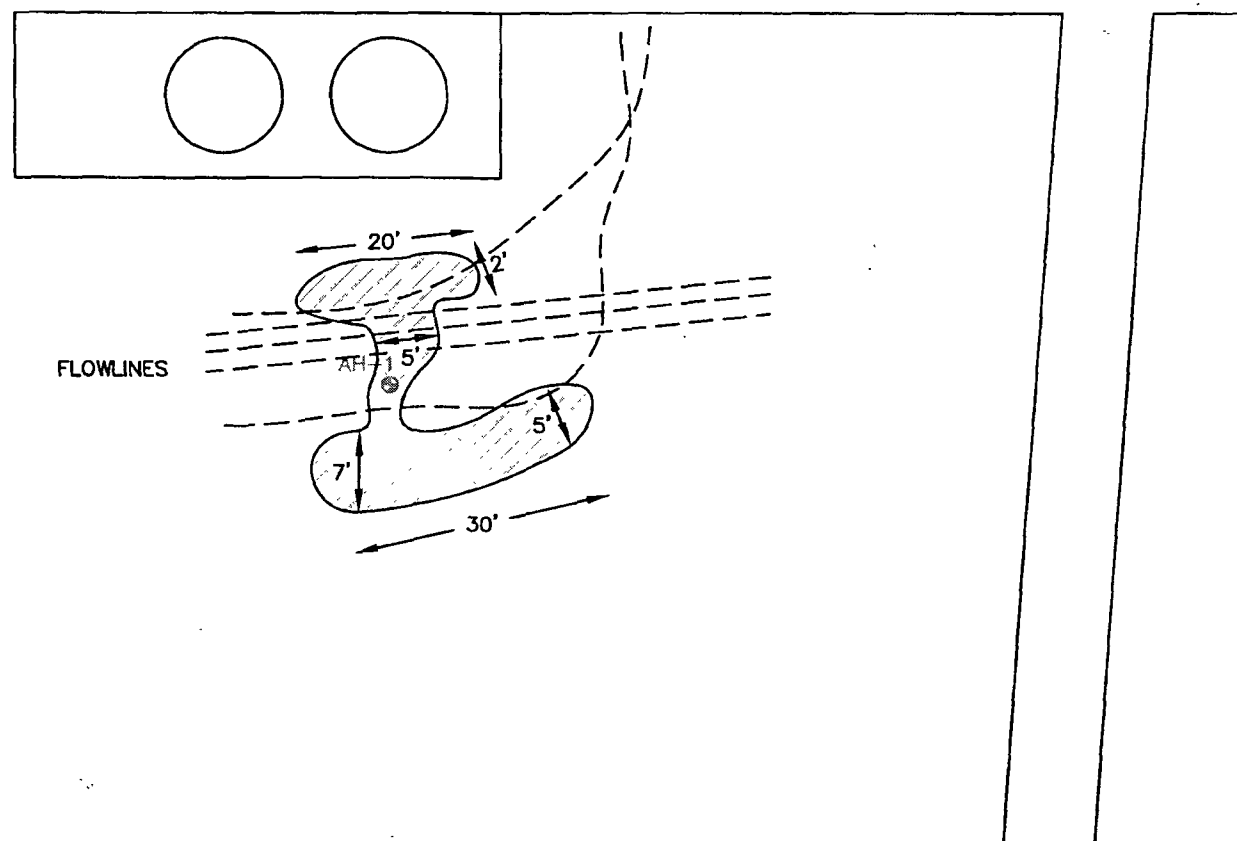
FIGURE NO. 3

On February 21, 2011, Tetra Tech personnel inspected and sampled the spill area. One (1) auger hole (AH-1) was installed using a stainless steel hand auger to assess the impacted soils. Select samples were analyzed for TPH analysis by EPA method 8015 modified, BTEX by EPA Method 8021B and chloride by EPA method 300.0. Copies of laboratory analysis and chain-of-custody documentation are included in Appendix C. The sampling results are summarized in Table 1. The auger hole location is shown on Figure 3.

Referring to Table 1, the TPH and BTEX concentrations are below the RRAL. A shallow chloride impact was detected, with a chloride concentration of 2,320 mg/kg at 0-1' and declining to <200 mg/kg at 2-2.5'.

COG proposes to remove impacted material as highlighted (green) in Table 1. Once the areas are excavated to the appropriate depth (1.0'), the excavation will be backfilled with clean soil. Upon completion, a final report will be submitted to the NMOCD.

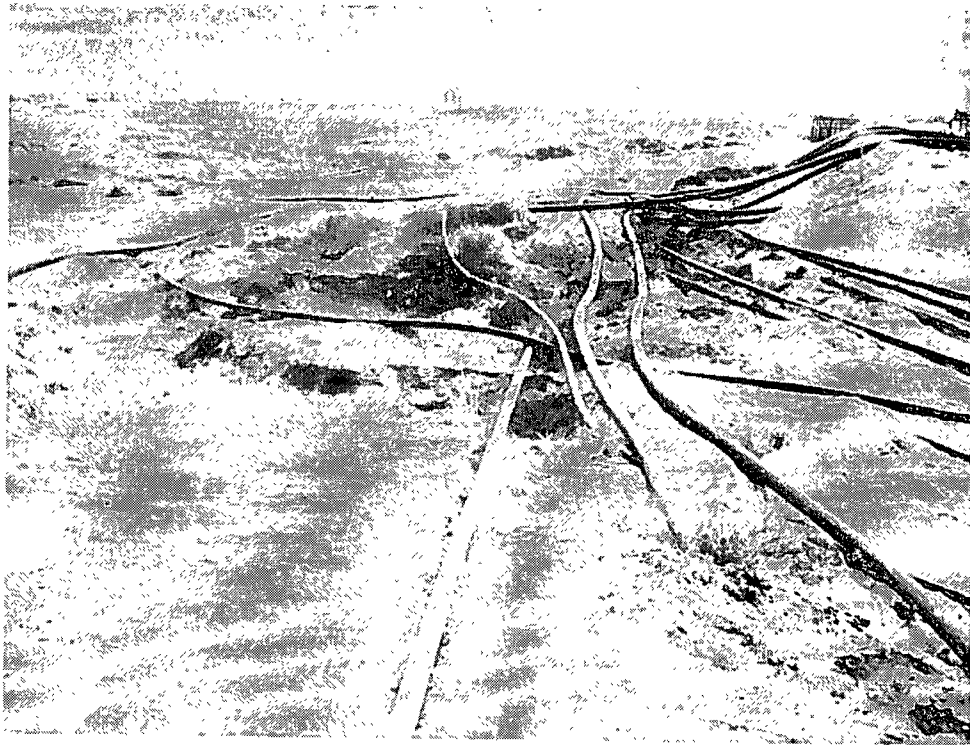
View West – AH-1

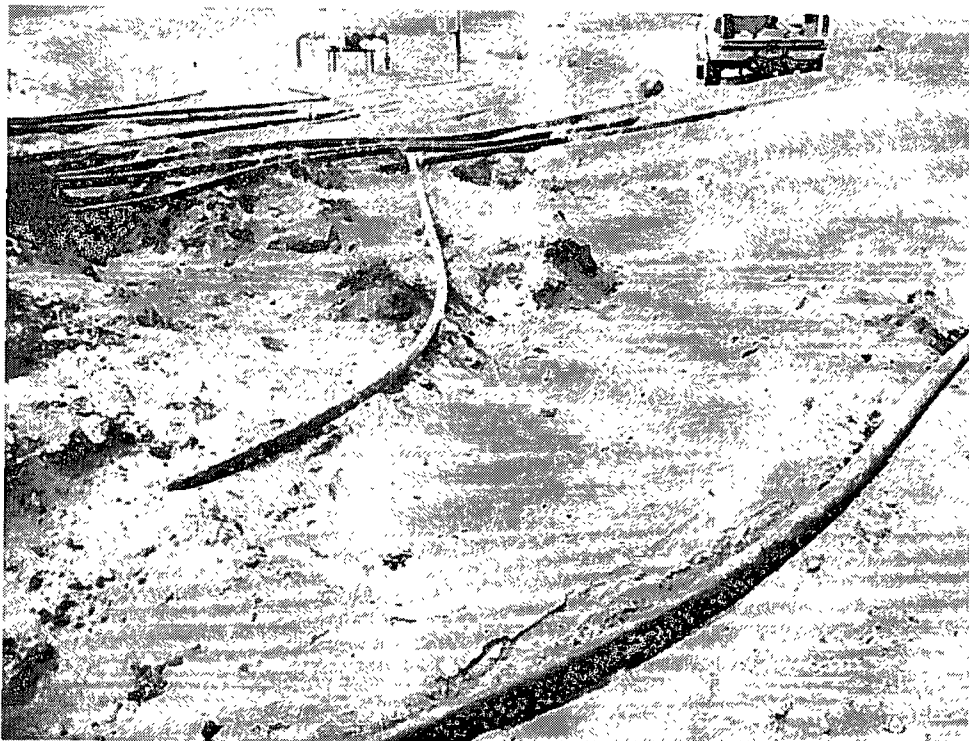
View East – AH-1
