Report Type: Work Plan

Site:	Moose Federal 23					
Company:	COG Operating LLC					
Section, Township and Range	Unit L	Sec 23	T16S	R28E		
Lease Number:	API-30-015-25332					
County:	Eddy County					
GPS:	32.905833° N			104.152166° W		
Surface Owner:	Federal					
Mineral Owner:						
Directions:	From the intersection of Hwy 82 and Co Rd 217 travel west on Hwy 82 for 9.3 miles, turn right and travel 2.5 miles, turn left and travel 2.3 miles, turn left and travel 2.3 miles, turn right and travel 0.9 miles, turn left and travel 2.7 miles to site.

Re: Work Plan for the COG Operating LLC., Moose Federal 23 Tank Battery, Unit L, Section 23, Township 16 South, Range 28 East, Eddy County, New Mexico.

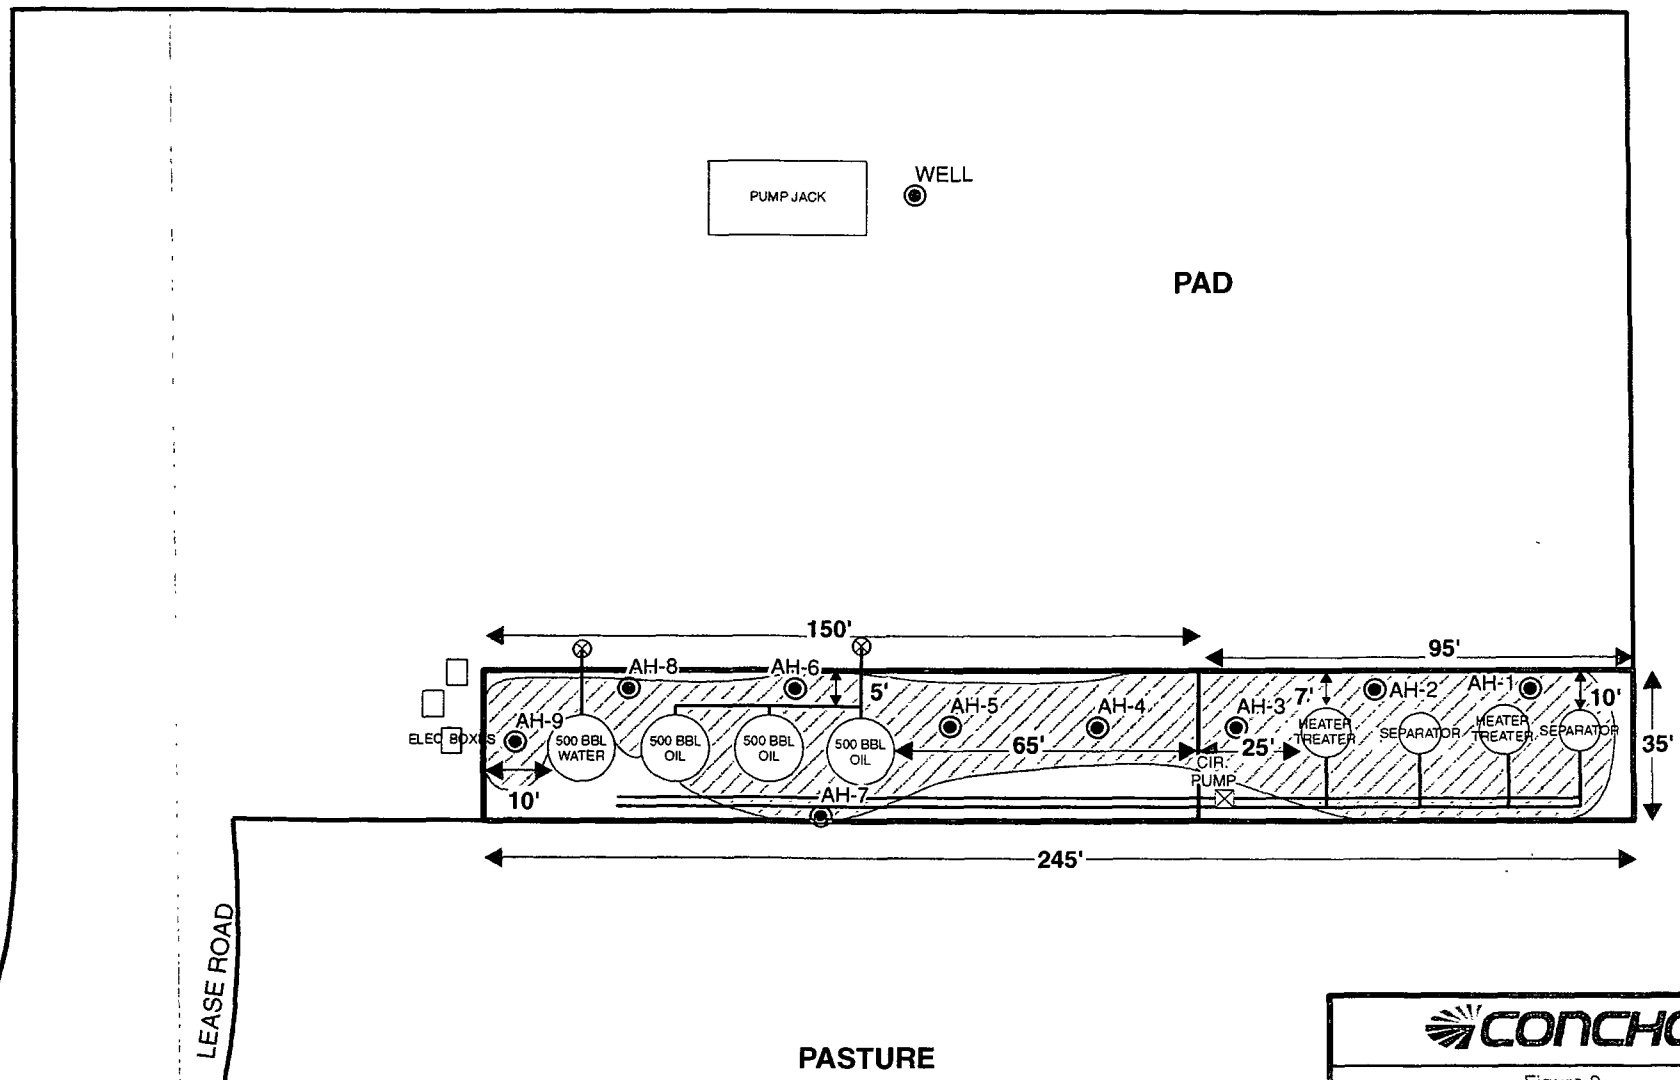
Figure 3

On March 24, 2010, Tetra Tech personnel inspected and sampled the spill area. Nine (9) auger holes (AH-1 and AH-9) were installed using a stainless steel hand auger to assess the impacted soils. Selected samples were analyzed for TPH analysis by EPA method 8015 modified, BTEX by EPA Method 8021B and chloride by EPA method 300.0. Copies of laboratory analysis and chain-of-custody documentation are included in Appendix C. The sampling results are summarized in Table 1. The spill area and auger hole locations are shown on Figure 3.

Referring to Table 1, the areas of auger holes (AH-6 and AH-7) did not show TPH and BTEX concentrations above the RRAL. However, AH-1, AH-3, AH-5 and AH-8 samples were above the RRAL for TPH at 0-1' and only

the area of AH-3 was vertically defined at 2.5' below surface. In addition, either the total BTEX or benzene concentrations exceeded the RRAL at 0-1' in the areas of AH-1, AH-2, AH-3, AH-4, AH-5, AH-8 and AH-9. Auger holes (AH-2, AH-3 and AH-4) were vertically defined at 1.0', 2.0' and 1.0', respectively.

Elevated chloride concentrations were detected at 0-1' in the areas of AH-5 and AH-8 with concentrations of 1,570 mg/kg and 2,270 mg/kg, respectively. Due to the dense caliche formation, these areas were not defined using a hand auger.

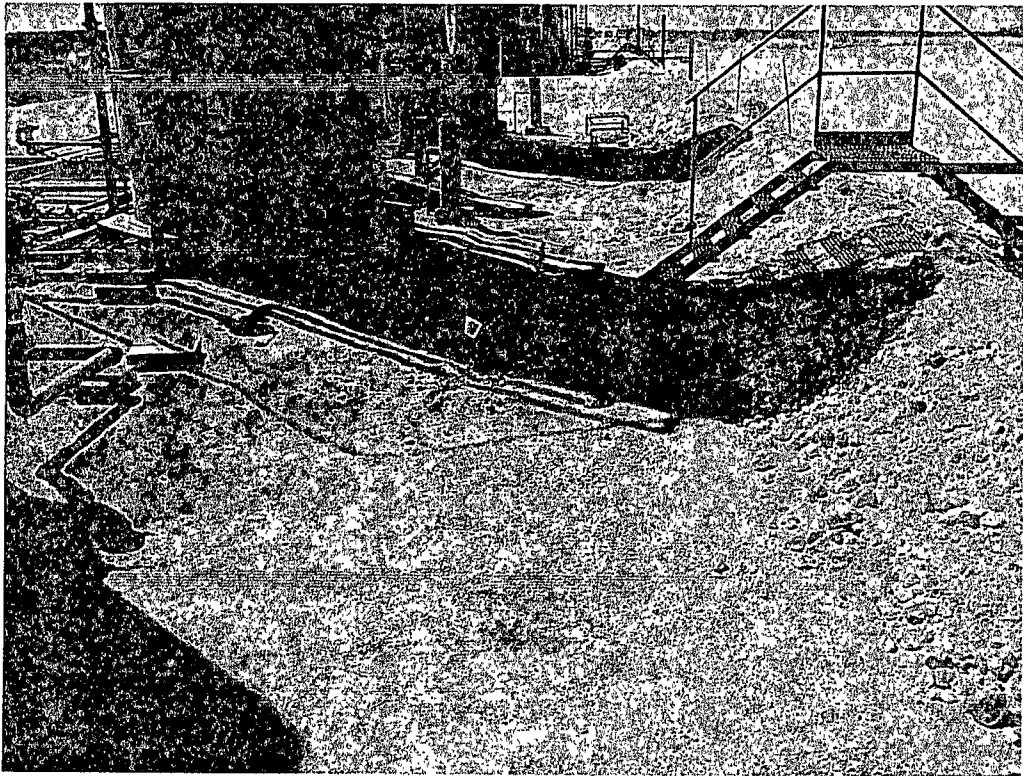
View West – AH-1, 2

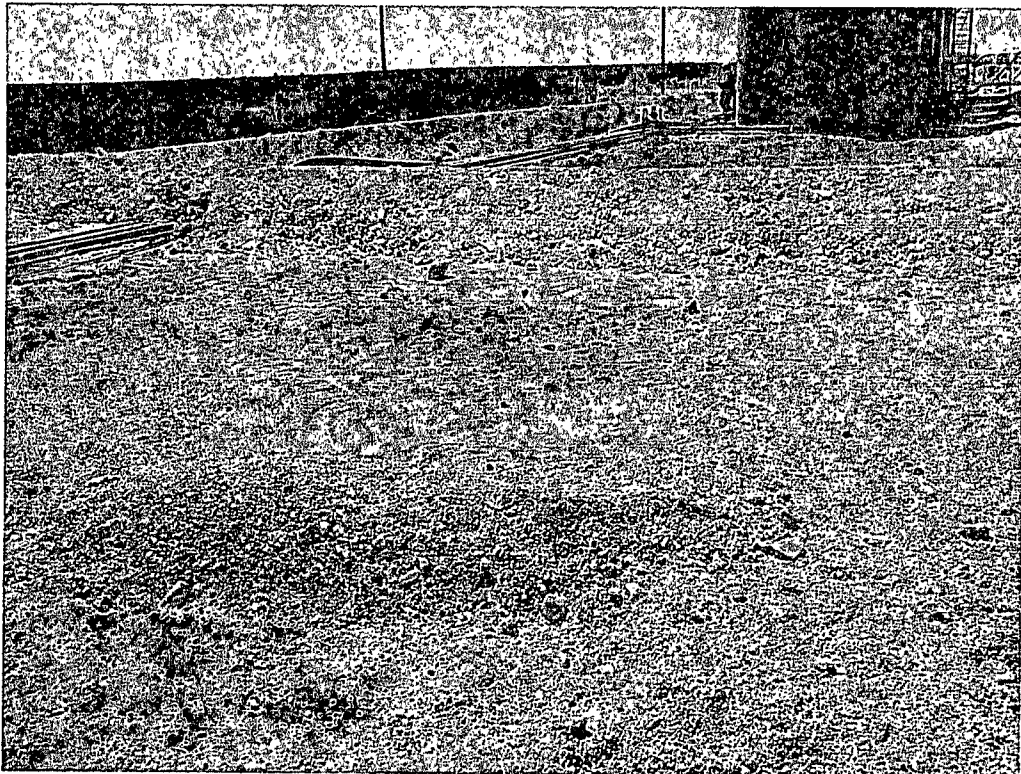
View West – AH-3, 4, 5

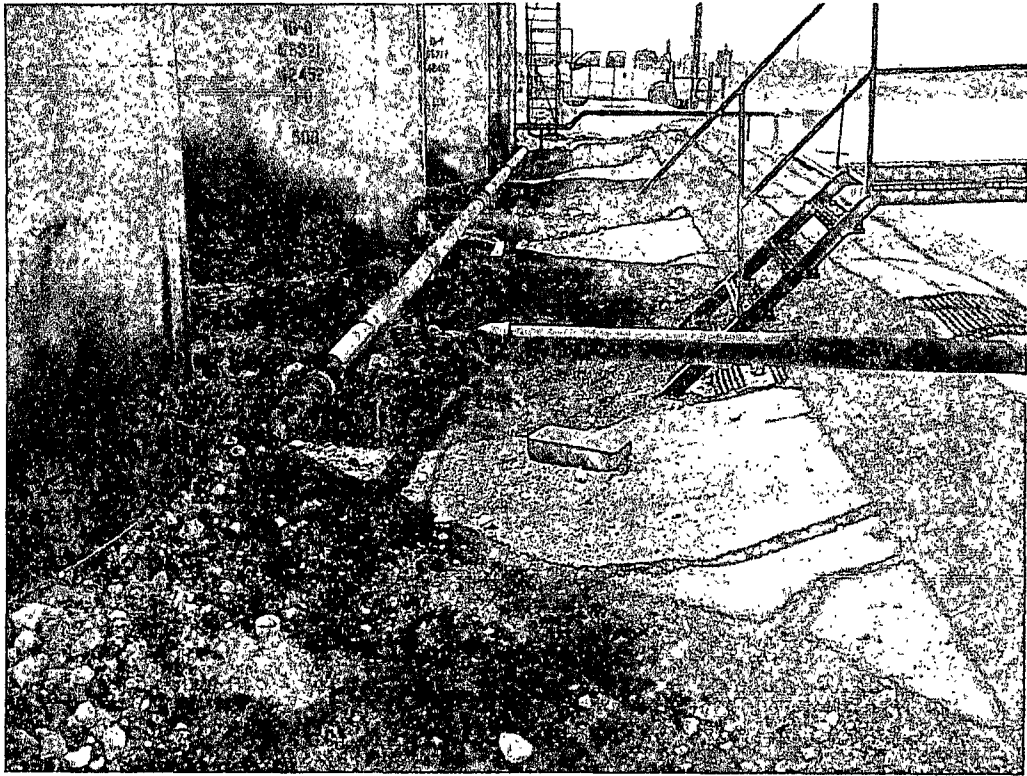
View West – AH-6, 8

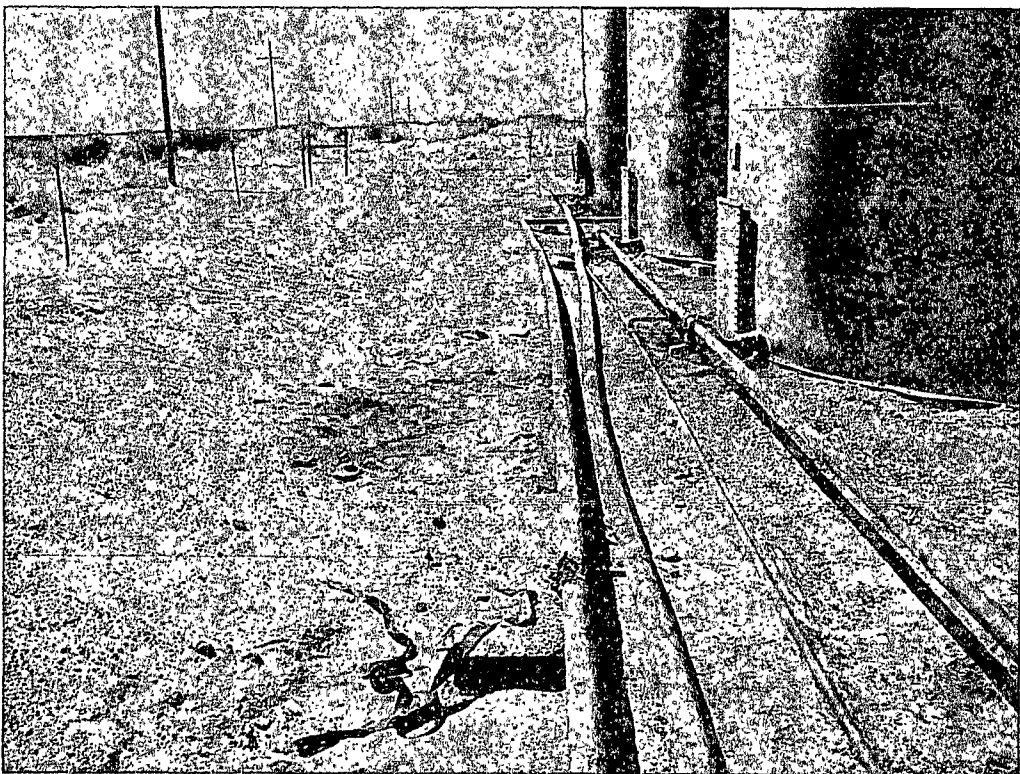
View West – AH-7

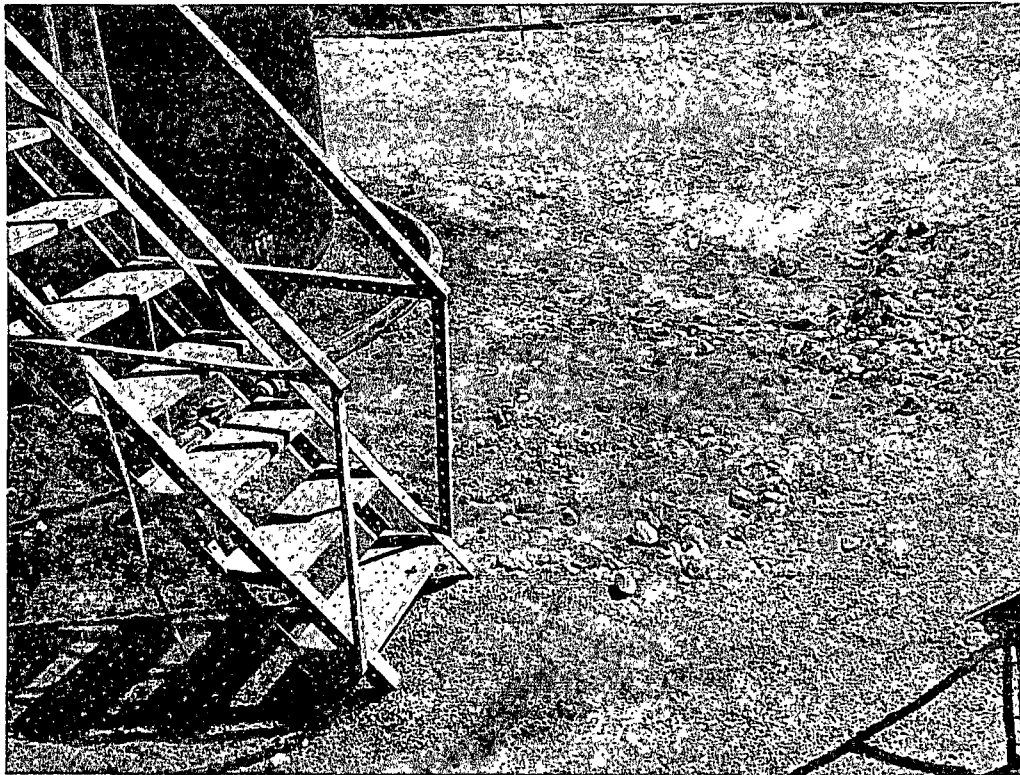
View South – AH-9
