Report Type: Work Plan

September 16, 2011

Re: Work Plan for the COG Operating LLC., Moose Federal 23 Tank Battery, Unit L, Section 23, Township 16 South, Range 28 East, Eddy County, New Mexico.

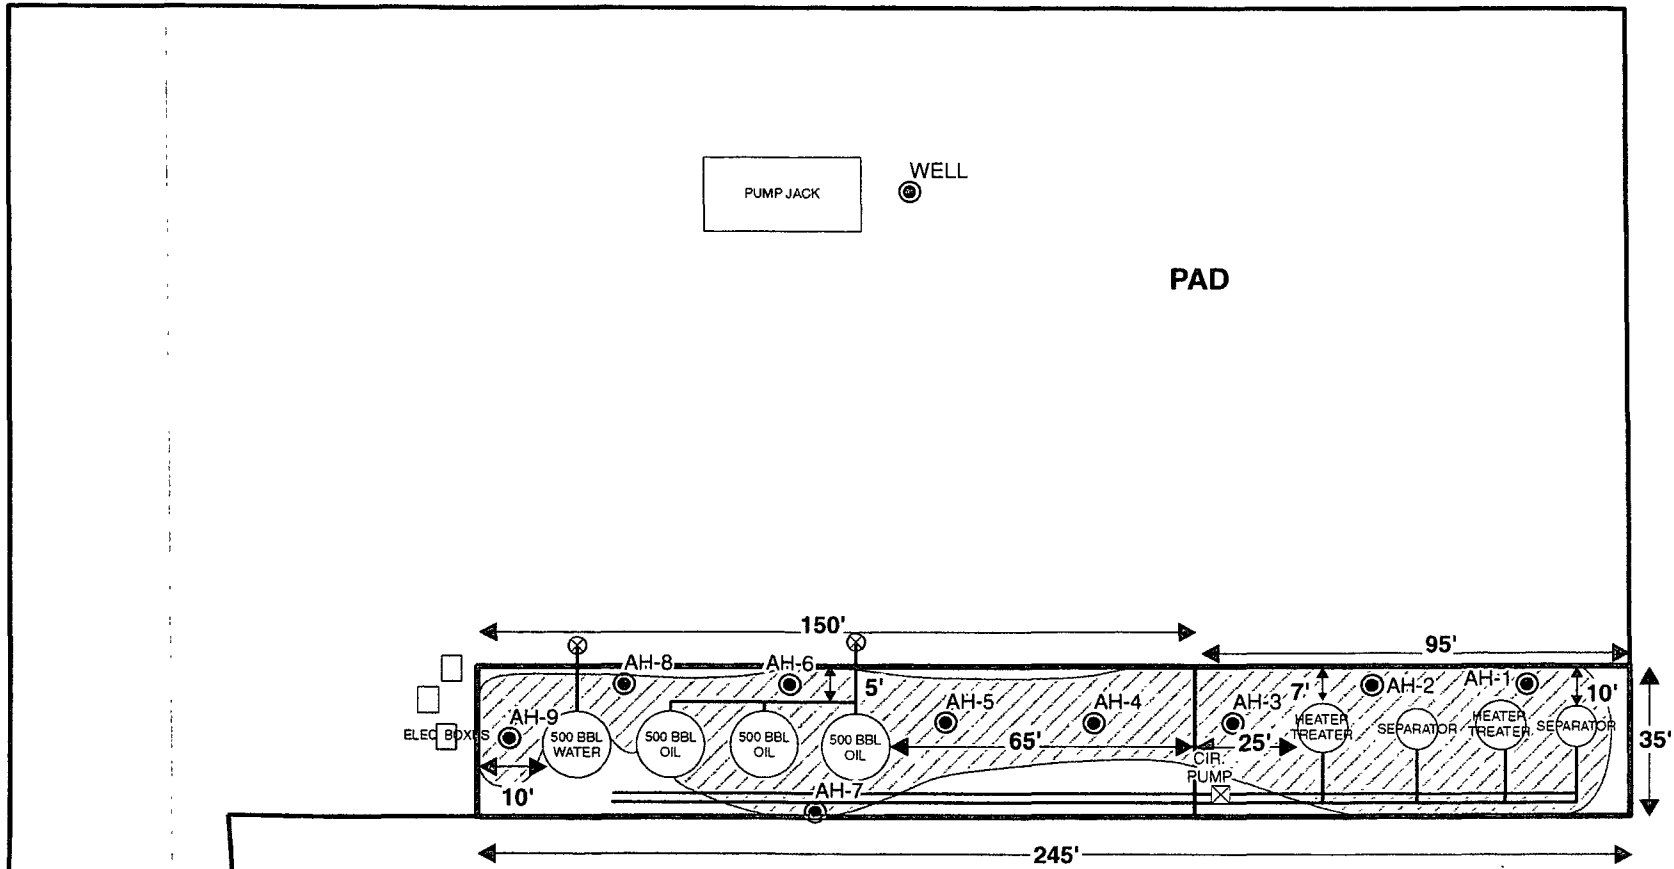
Figure 3

On March 24, 2010, Tetra Tech personnel inspected and sampled the spill area. Nine (9) auger holes (AH-1 and AH-9) were installed using a stainless steel hand auger to assess the impacted soils. Selected samples were analyzed for TPH analysis by EPA method 8015 modified, BTEX by EPA Method 8021B and chloride by EPA method 300.0. Copies of laboratory analysis and chain-of-custody documentation are included in Appendix C. The sampling results are summarized in Table 1. The spill area and auger hole locations are shown on Figure 3.

Moose 23 Federal #1 TB
Spill Assessment Map

In order to remediate the site, COG proposes to remove impacted soil above the RRAL as highlighted (green) in Table 1. The proposed excavation depths are estimated at 1.0' to 2.0' below surface. In the TPH and BTEX impacted areas not vertically defined, confirmation samples will be collected from the excavation bottoms for evaluation. In the areas of AH-5 and AH-8, backhoe trenches will be installed to better define the chloride impact in these areas. Once excavated to the appropriate depths, the excavations will backfilled with clean soil.

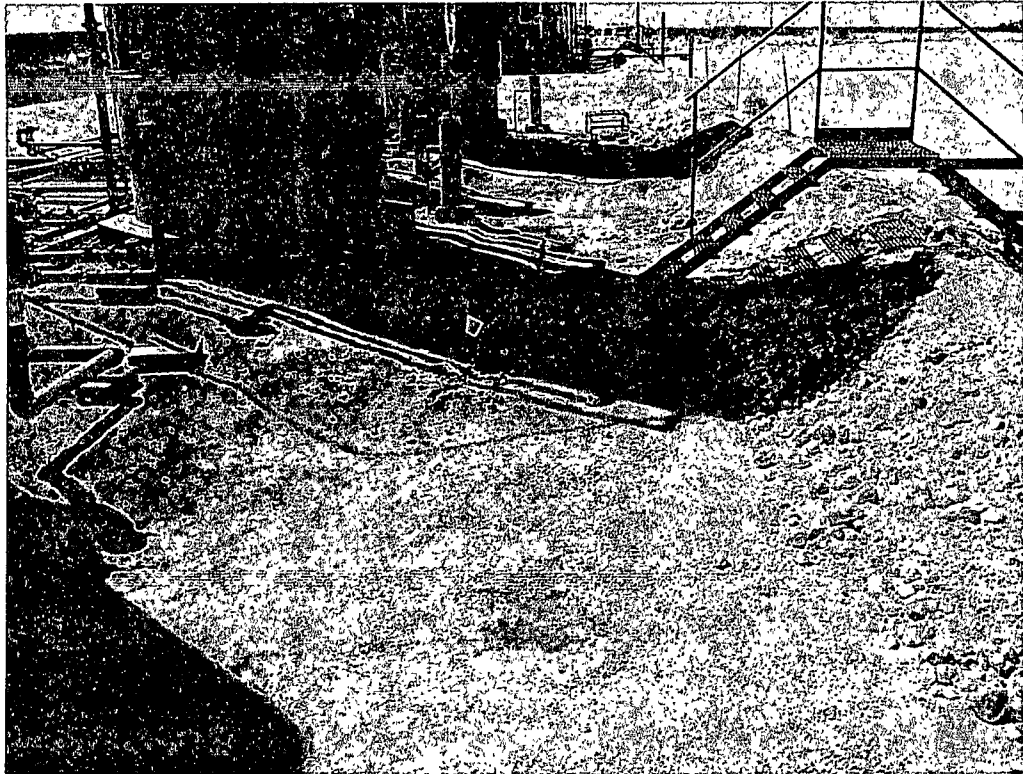
Referring to Table 1, the areas of auger holes (AH-6 and AH-7) did not show TPH and BTEX concentrations above the RRAL. However, AH-1, AH-3, AH-5 and AH-8 samples were above the RRAL for TPH at 0-1' and only

the area of AH-3 was vertically defined at 2.5' below surface. In addition, either the total BTEX or benzene concentrations exceeded the RRAL at 0-1' in the areas of AH-1, AH-2, AH-3, AH-4, AH-5, AH-8 and AH-9. Auger holes (AH-2, AH-3 and AH-4) were vertically defined at 1.0', 2.0' and 1.0', respectively.

View West – AH-1, 2

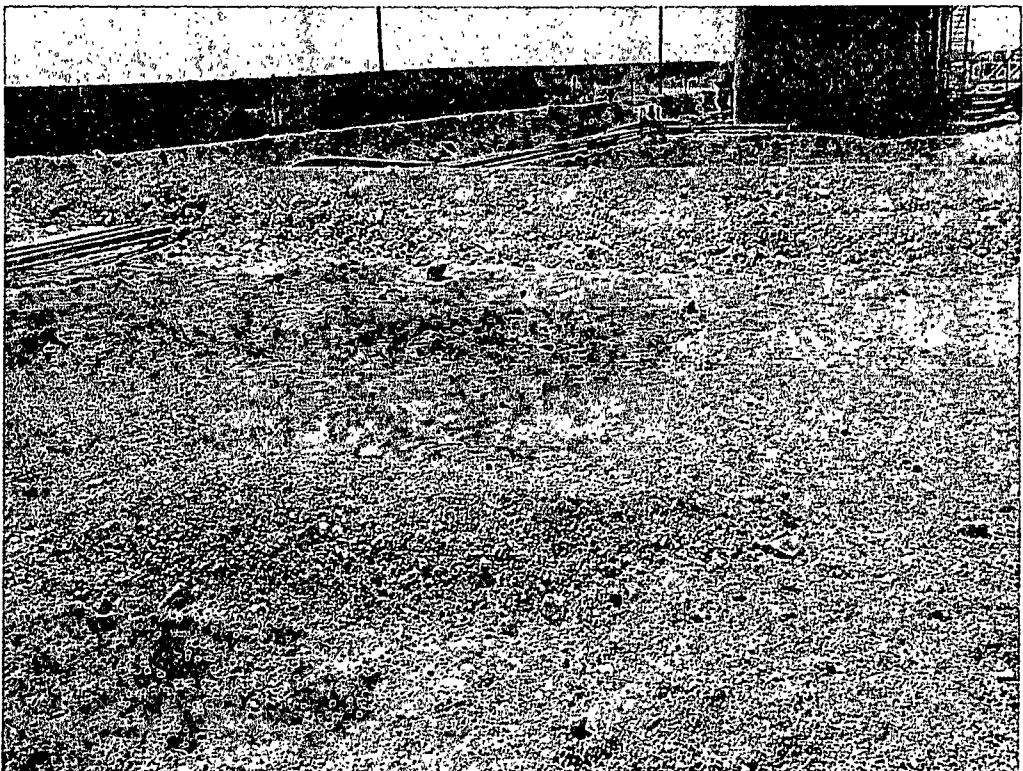
Elevated chloride concentrations were detected at 0-1' in the areas of AH-5 and AH-8 with concentrations of 1,570 mg/kg and 2,270 mg/kg, respectively. Due to the dense caliche formation, these areas were not defined using a hand auger.

View West – AH-3, 4, 5

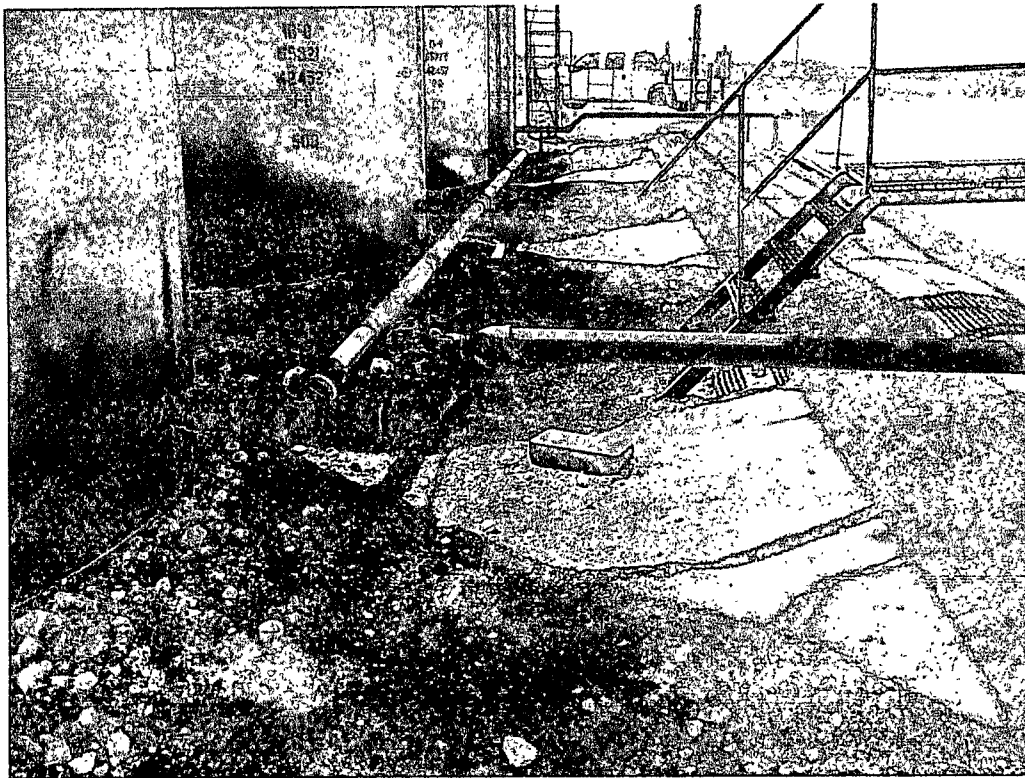
View West – AH-6, 8

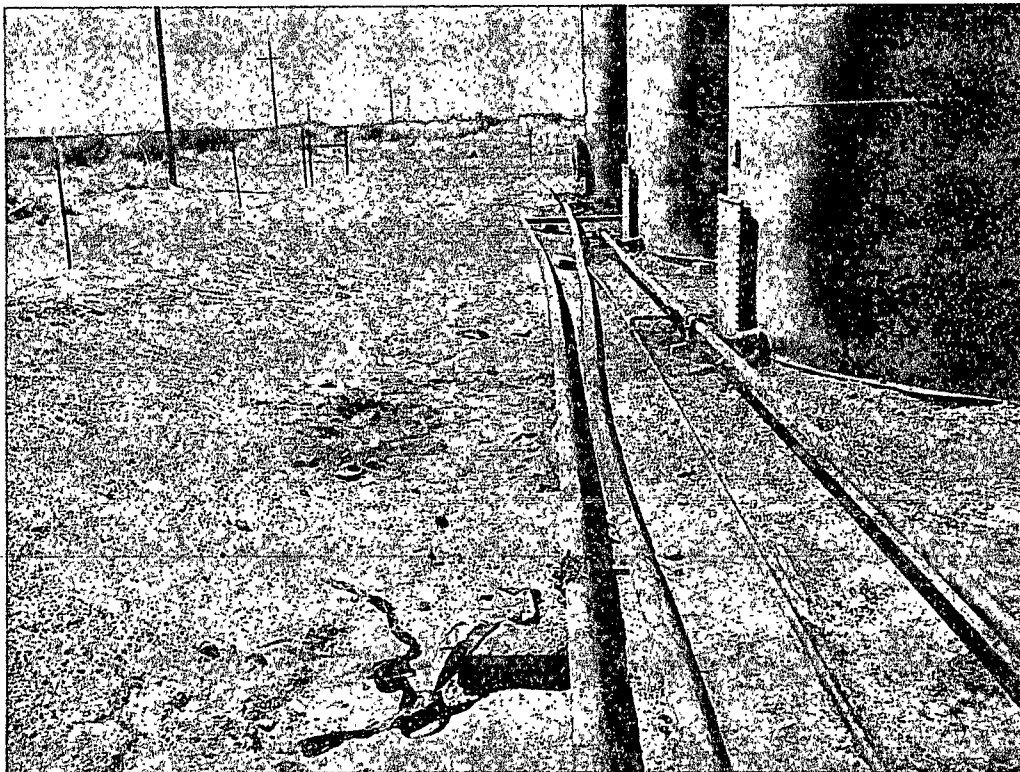
View West – AH-7

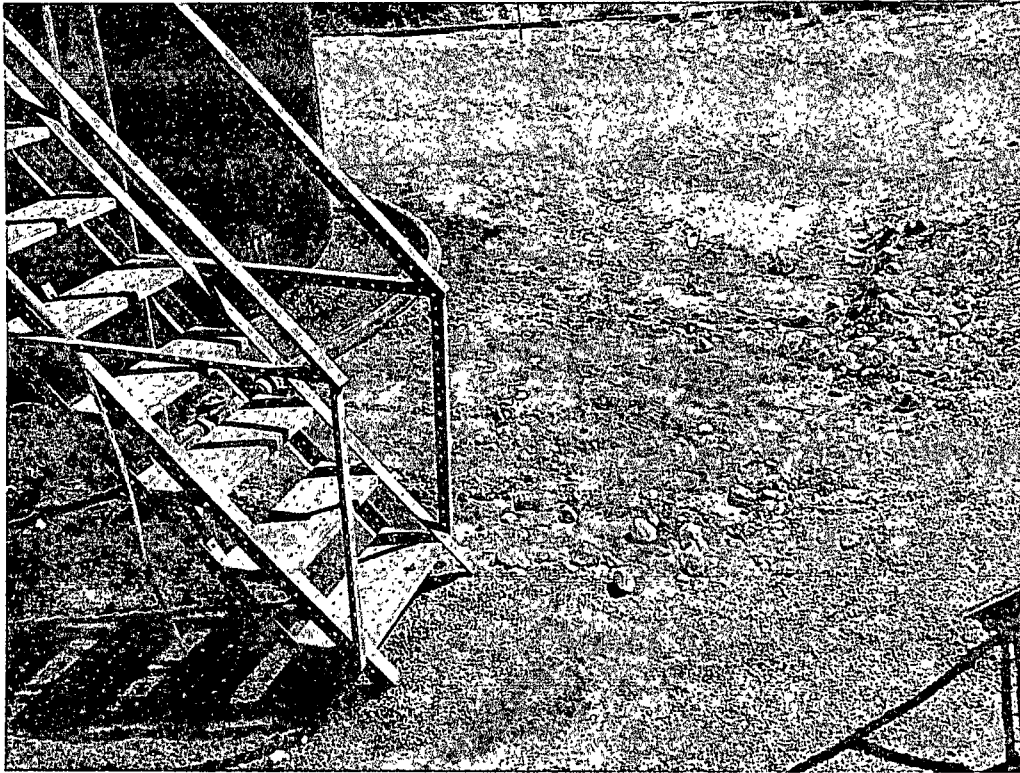
View South – AH-9
