# Grand Banks Energy Company-Remediation Project

ARU#16 API# 30-025-00368

Lea County, NM

# Grand Banks Energy Company Anderson Ranch - Saltwater Leak - Affected Area

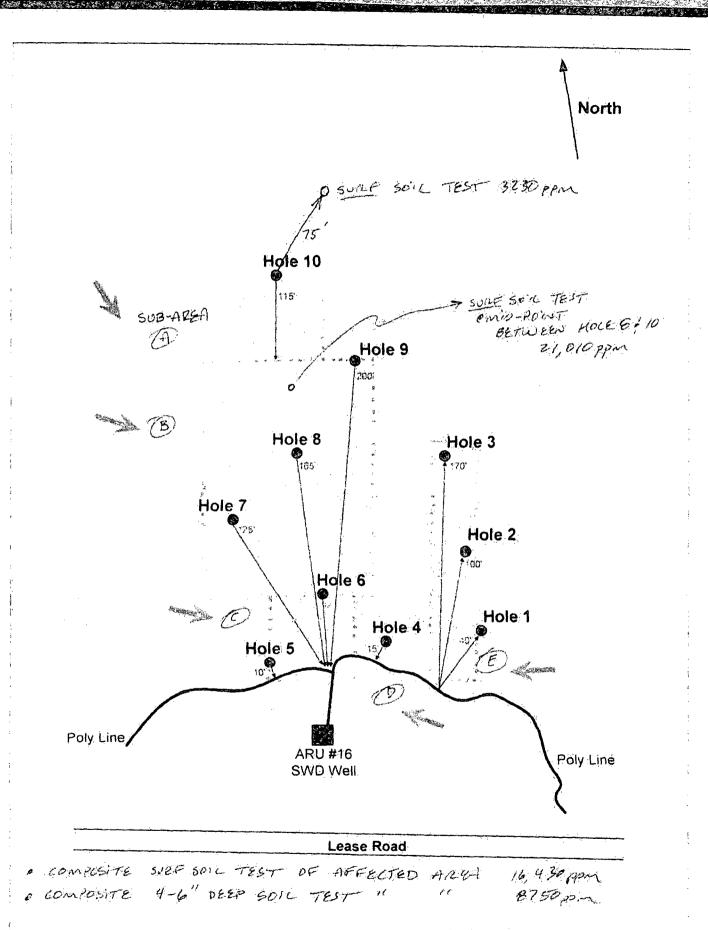
Sub-Area*	Area Length Feet	Area Width Feet	Removal Depth Inches	Area Affected SqFt	Volume Affected CuFt	Volume Affected CuYds
А	80	50	8	4,000	2,667	99
В	135	100	18	13,500	20,250	750
С	65	40	18	2,600	3,900	144
D	30	30	18	900	1,350	50
E	170	20	18	3,400	5,100	189
Total		·		24,400	33,267	1,232

<sup>\*</sup> Note: refer to map showing affected area.

Chloride	Testing o	f Soils in	Affected Area

Test Depth	Chlorides
Hole#	<u>Inches</u>	<u>ppm</u>
1	4	tstm
2	4	7,440
	12	12,960
3	4	3,590
	6	3,980
4	4	6,850
	12	3,980
5	4	tstm
	8	iţstm
6	4	8,750
	12	8,070
7	4	11,080
	12	9,470
-8	4	11,990
		9,470
9	4	6,300
	6	4,390
10	6	tstm
	12	tstm
Composite	at surface	16,430
Composite	4-6	8,750
Mid-point		<u> </u>
between 8 & 10	2	21,010
