Basin Environmental Service Technologies, LLC

Environmental Site Summary & Work Plan

Site Name: North Indian Flats 26 Federal #1 NMOCD Reference#: 2RP-1624

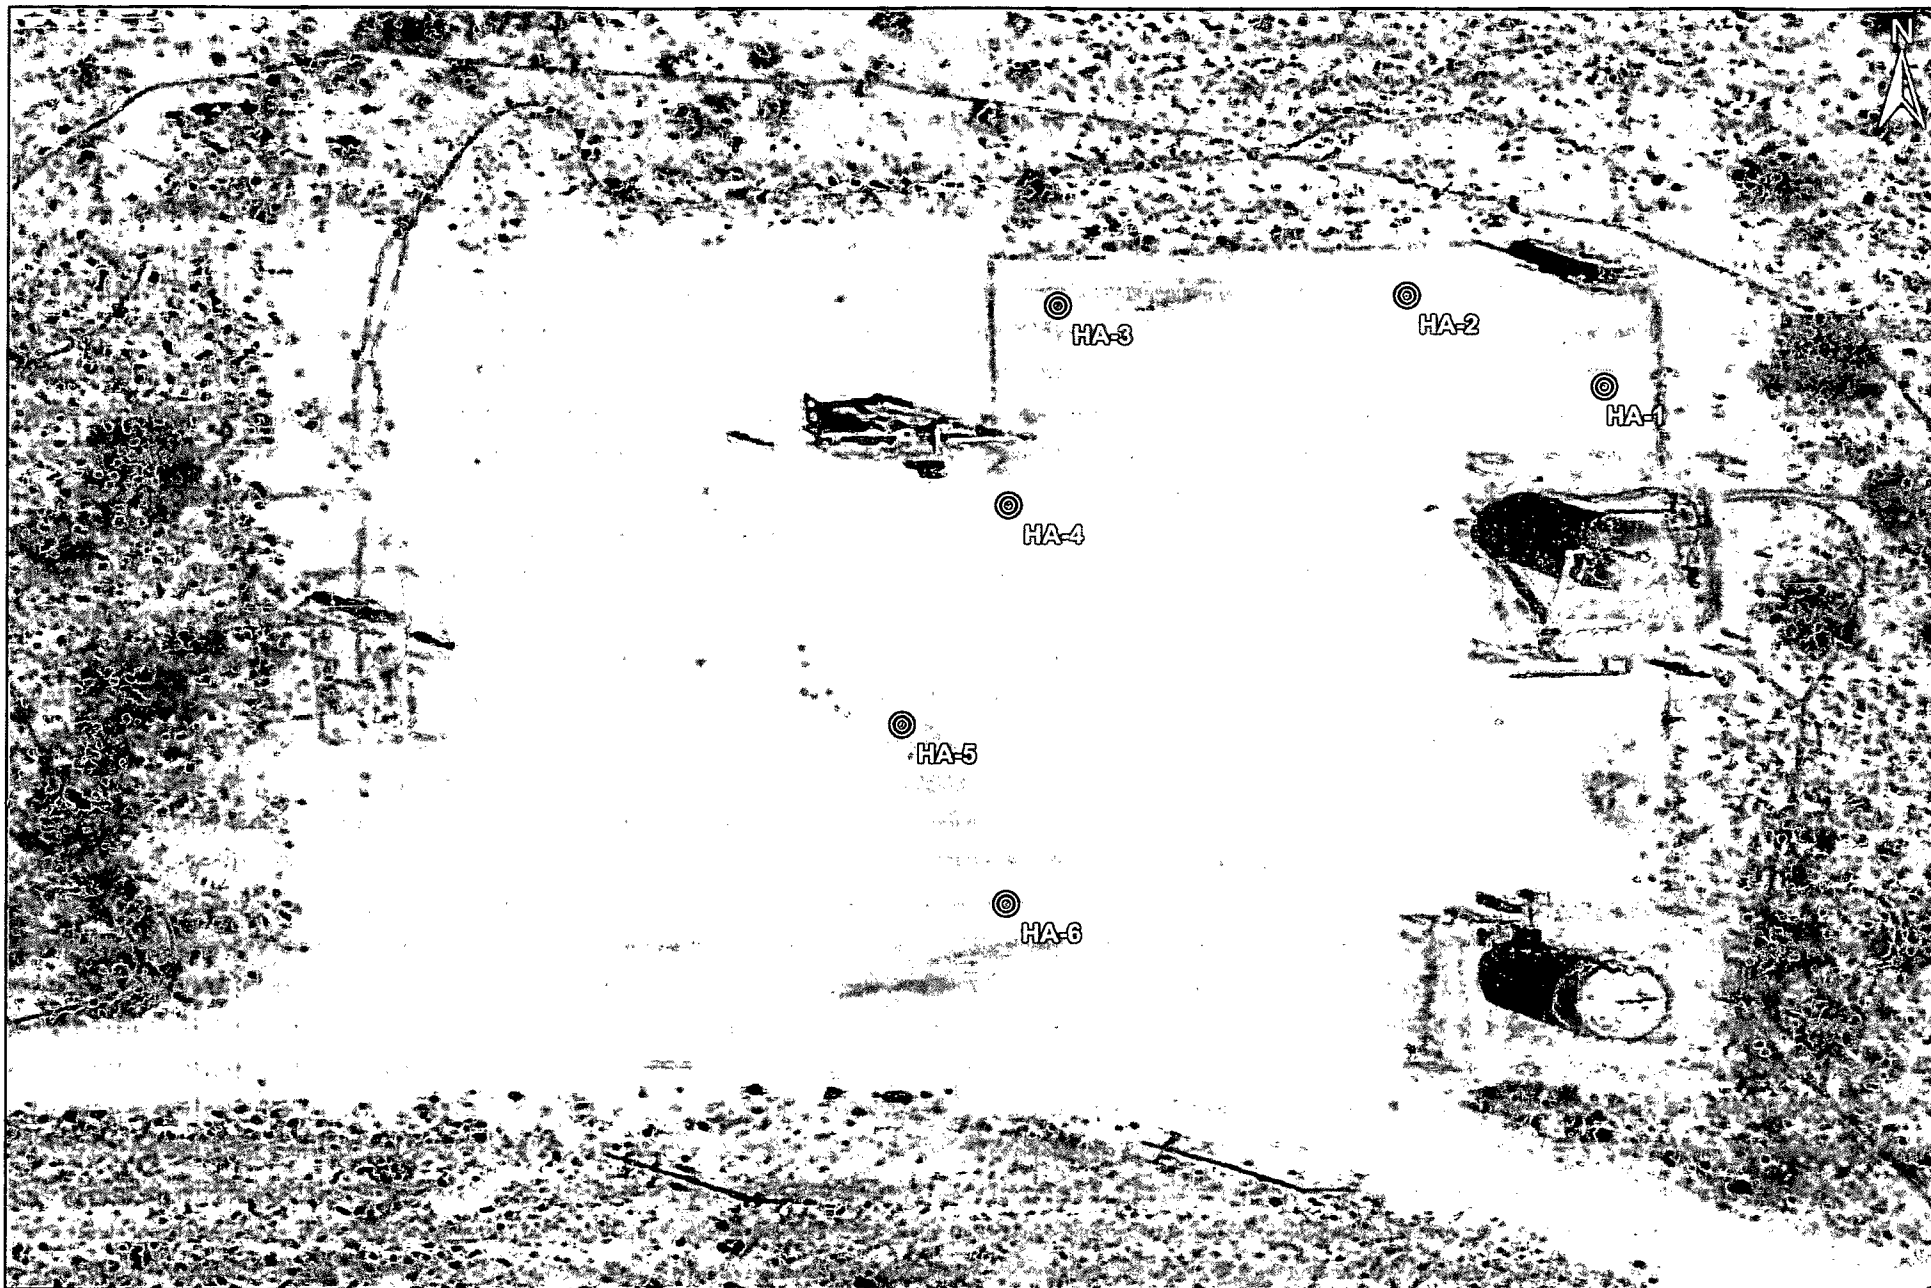
Figure 2

**Site & Sample Location Map
BOPCO, LP**

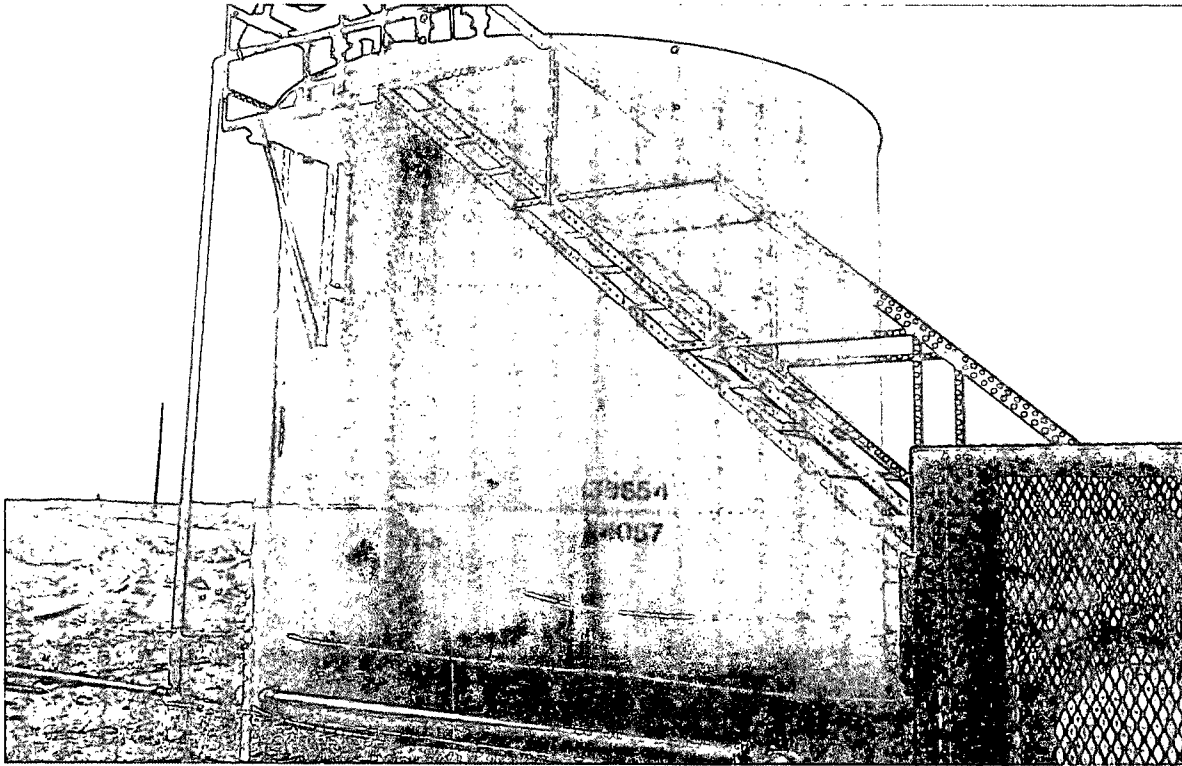
On April 4, 2013, BOPCO discovered a release had occurred at the North Indian Flats 26 Federal #1 tank battery. A 3" water dump line from the heater treater to the on-site water storage tank developed a leak, resulting in a release of produced water. The release was attributed to internal corrosion. The release impacted an area of the caliche well pad and tank battery pad measuring approximately 5,800 square feet. During initial response activities, a repair clamp was installed to mitigate the release, and heavily impacted soil was scraped up and stockpiled on-site, pending final disposition.

North Indian Flats 26 Federal Battery #1 - Release Site

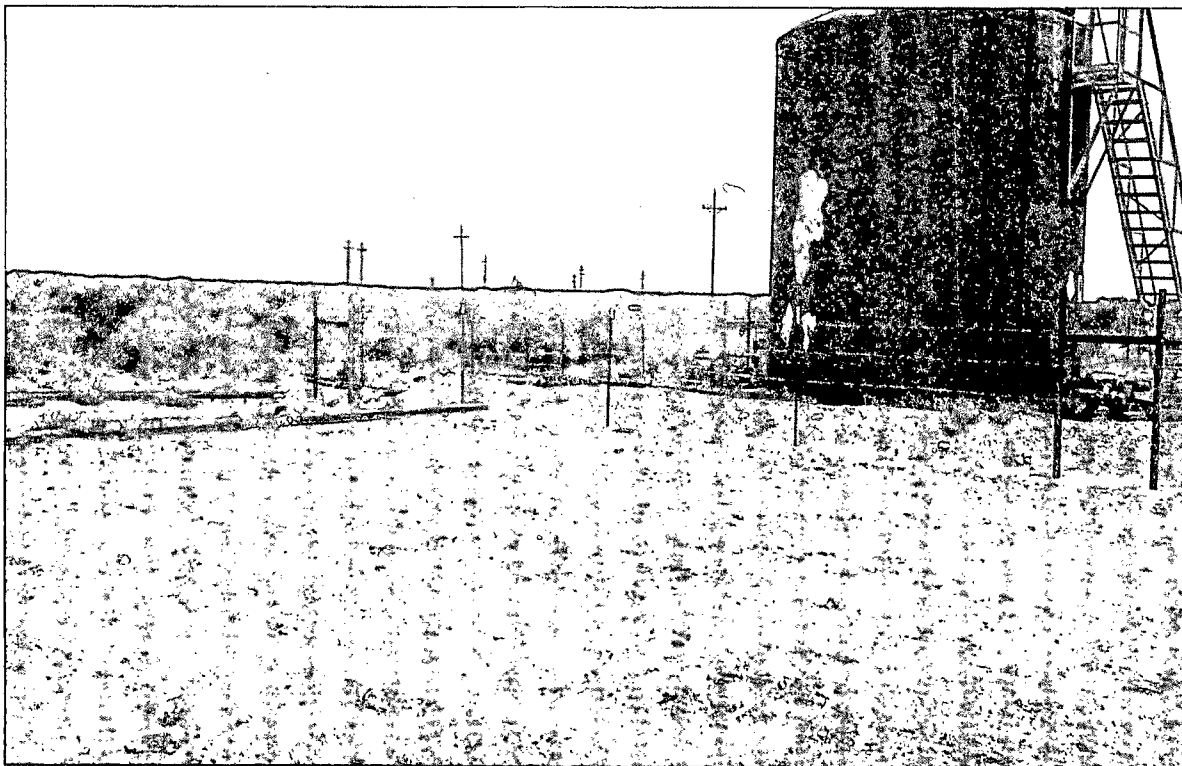
North Indian Flats 26 Federal Battery #1 - Release Site (Soil Boring HA-1 Flagged in Orange)

BOPCO proposes a risk-based strategy to progress the North Indian Flats 26 Federal #1 release site toward an NMOCD-approved closure. To achieve vertical delineation, a trench will be advanced at a location equidistant between hand-augered soil borings HA-1 and HA-2, along the flow path of the release (the most heavily impacted area at the site). If vertical delineation cannot be achieved, a drilling rig will be mobilized to the site to advance a soil boring near that location. Due to environmental and safety concerns, and to preserve the integrity of the on-site storage tanks, the areas defined by soil borings HA-1 through HA-4 will be excavated to a total depth of 3 feet bgs and backfilled with non-impacted material. Prior to backfilling, a 20-mil polyurethane liner will be installed on the floor of the excavation. This engineered control will shed moisture to the edge of the liner and beyond the maximum horizontal extent of underlying impacted soil, effectively inhibiting vertical migration of contaminants to groundwater.

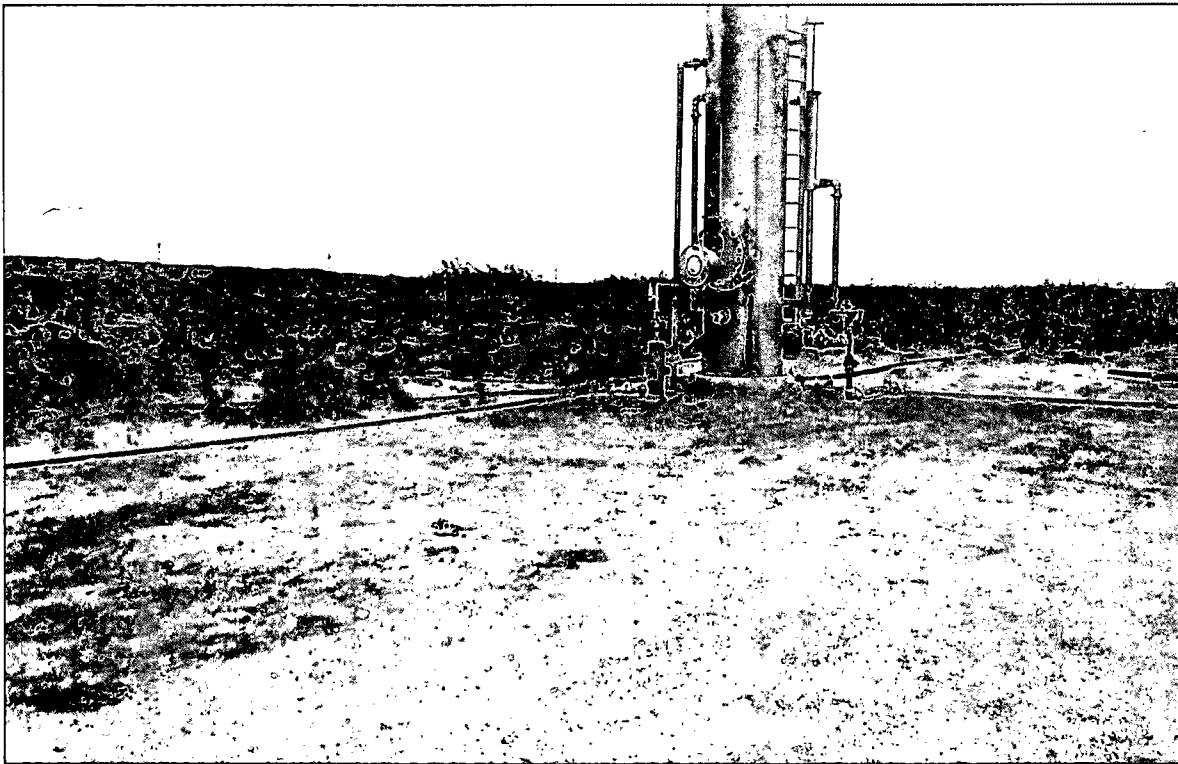
North Indian Flats 26 Federal Battery #1 - Flow Path (Soil Boring HA-2 Flagged in Orange)

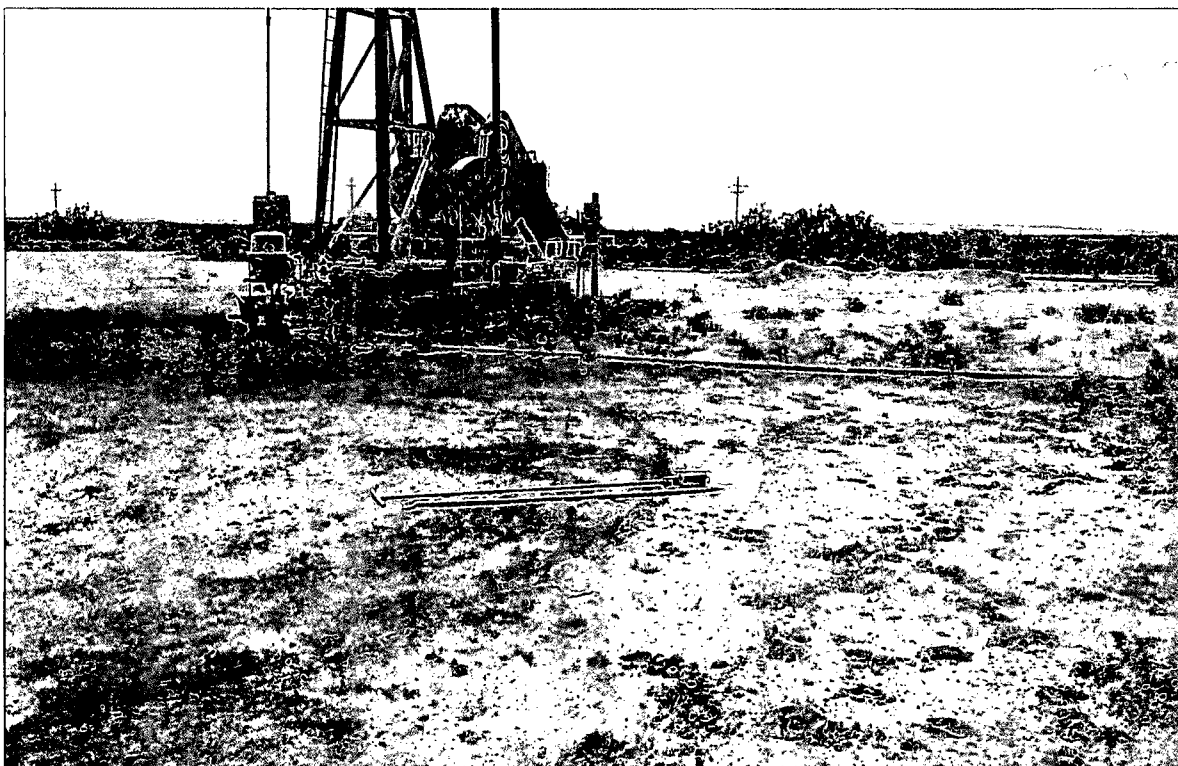
North Indian Flats 26 Federal Battery #1 - Flow Path (Soil Boring HA-3 Flagged in Orange)

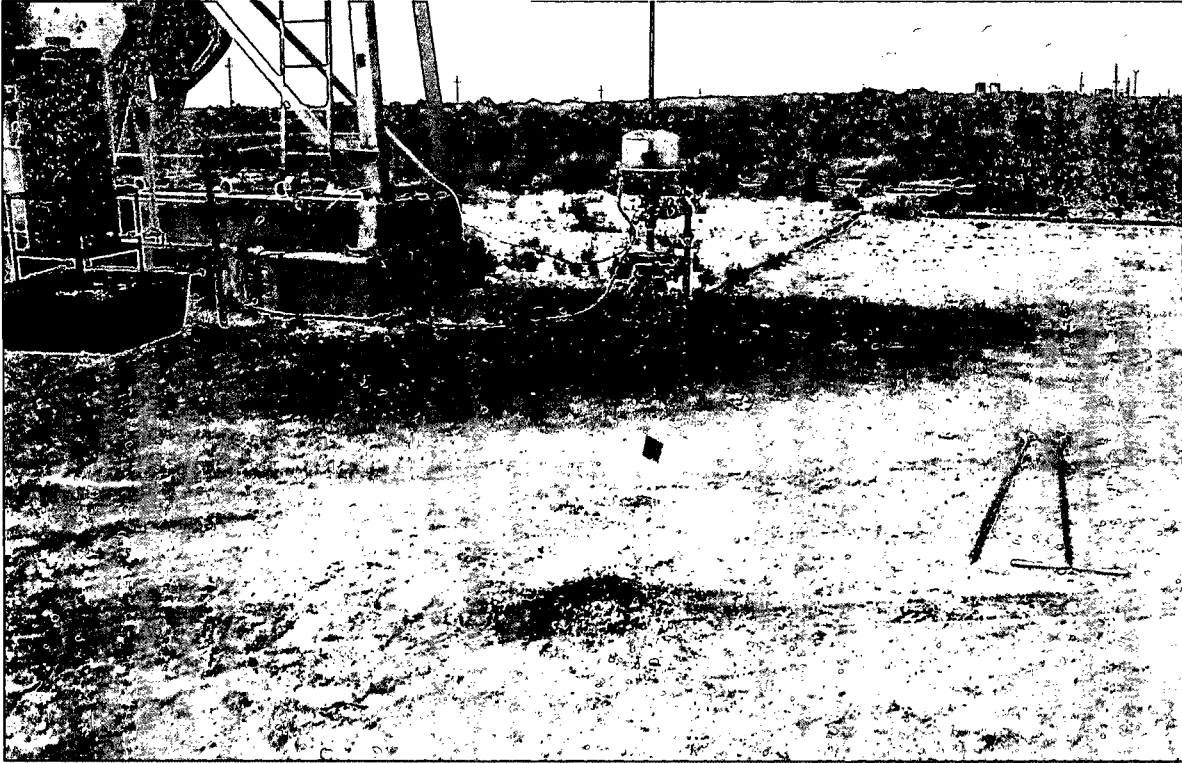
North Indian Flats 26 Federal Battery #1 - Soil Boring HA-4 (Flagged in Orange)

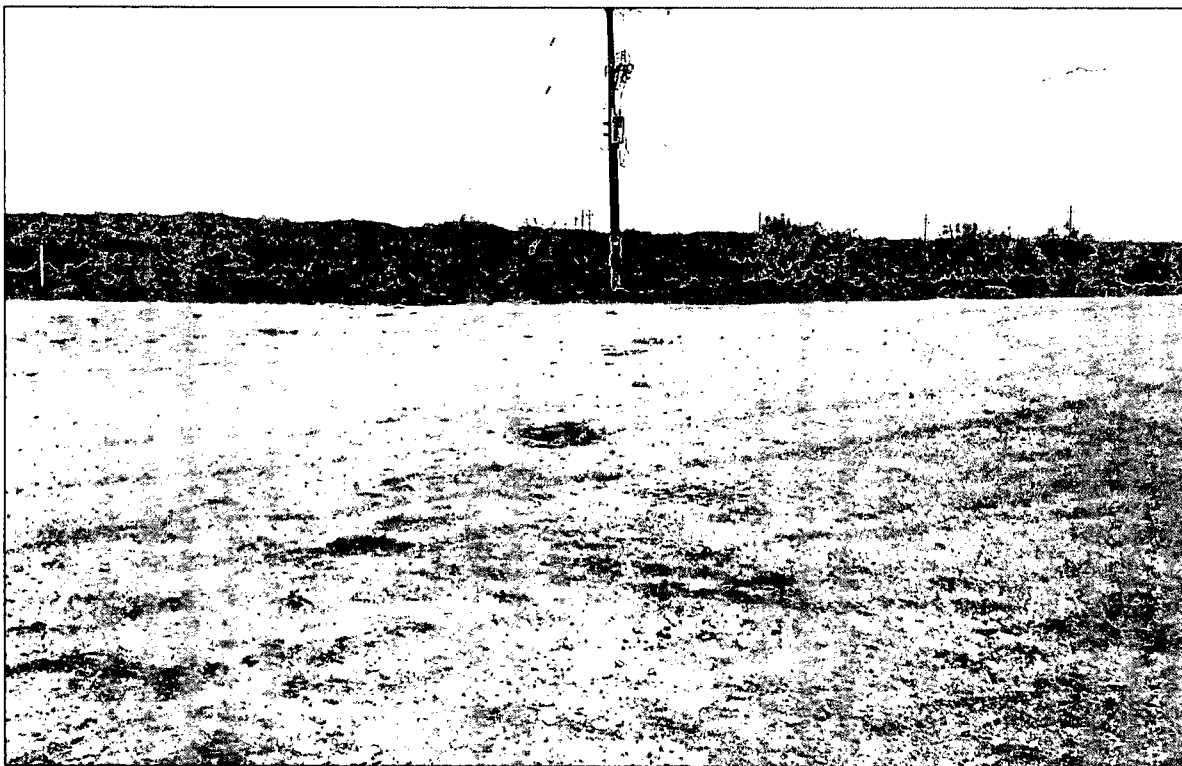
North Indian Flats 26 Federal Battery #1 - Flow Path
(Looking South (Soil Boring HA-5 Flagged in Orange))

The areas represented by soil borings HA-5 and HA-6 will be excavated to a total depth of 1 foot bgs and backfilled with non-impacted material.
