## Report Type: Work Plan

**Re: Assessment and Work Plan for the COG Operating LLC.,  
McIntyre C #6 Located in Unit H, Section 20, Township 17 South,  
Range 30 East, Eddy County, New Mexico.**

McIntyre C #6 Flowline

COG Operating LLC  
McIntyre C #6 Flowline  
Eddy County, New Mexico

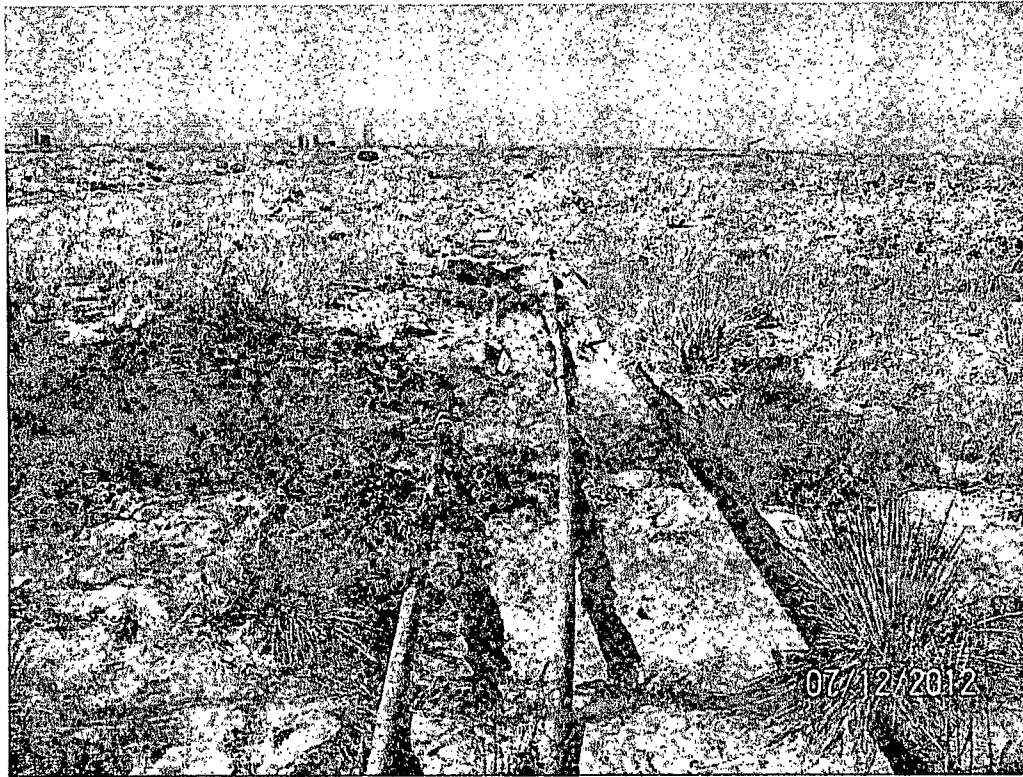
View south – Near Source

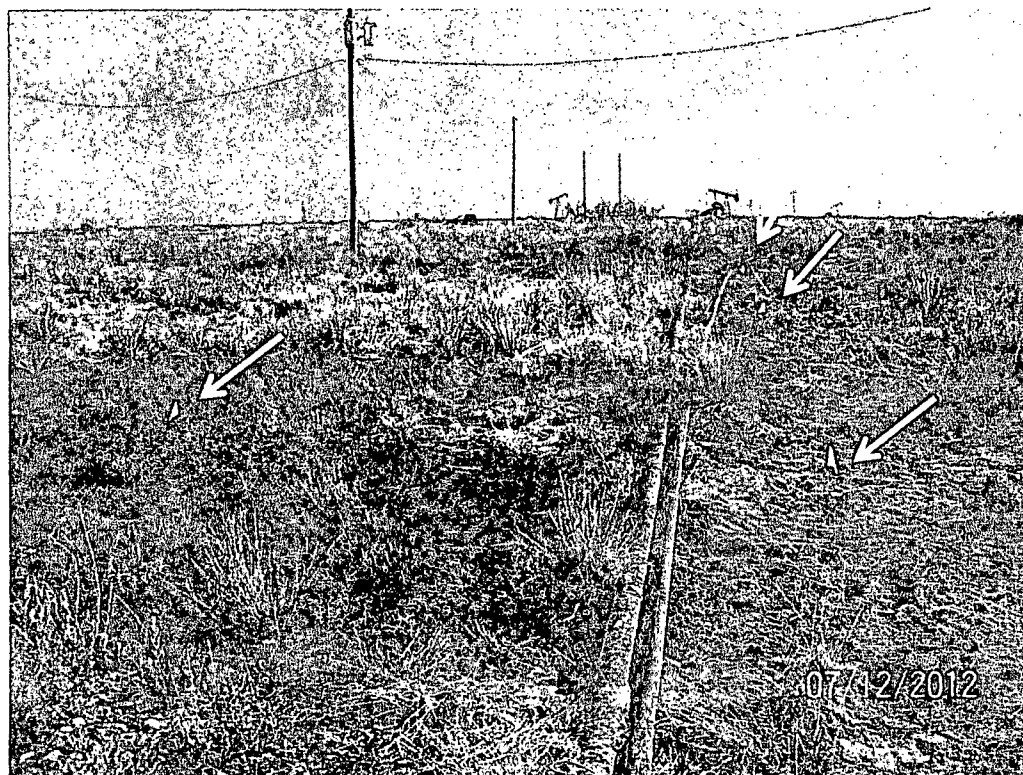
View North – Spill footprint with AH-1 through AH-4
