Site:	Jenkins B Federal Water Flood (Northwest Central)				
Company:	COG Operating LLC				
Section, Township and Range	Unit C	Sec 20	T17S	R30E	
Lease Number:	(API#) 30-015-21945				
County:	Eddy County				
GPS:	32.83021° N			103.99532° W	
Surface Owner:	Federal				
Mineral Owner:					
Directions:	From the intersection of Hwy 82 and CR 217, turn right and travel North for approximately 0.6 miles. Then turn left and travel West for 0.5 miles. The location will be on the right to the north.

Re: Work Plan for the COG Operating LLC., Jenkins B Federal Water Flood, Unit N, Section 17, Township 17 South, Range 29 East, Eddy County, New Mexico.

Spill Assessment Map

Proposed Excavation Areas & Depths Map

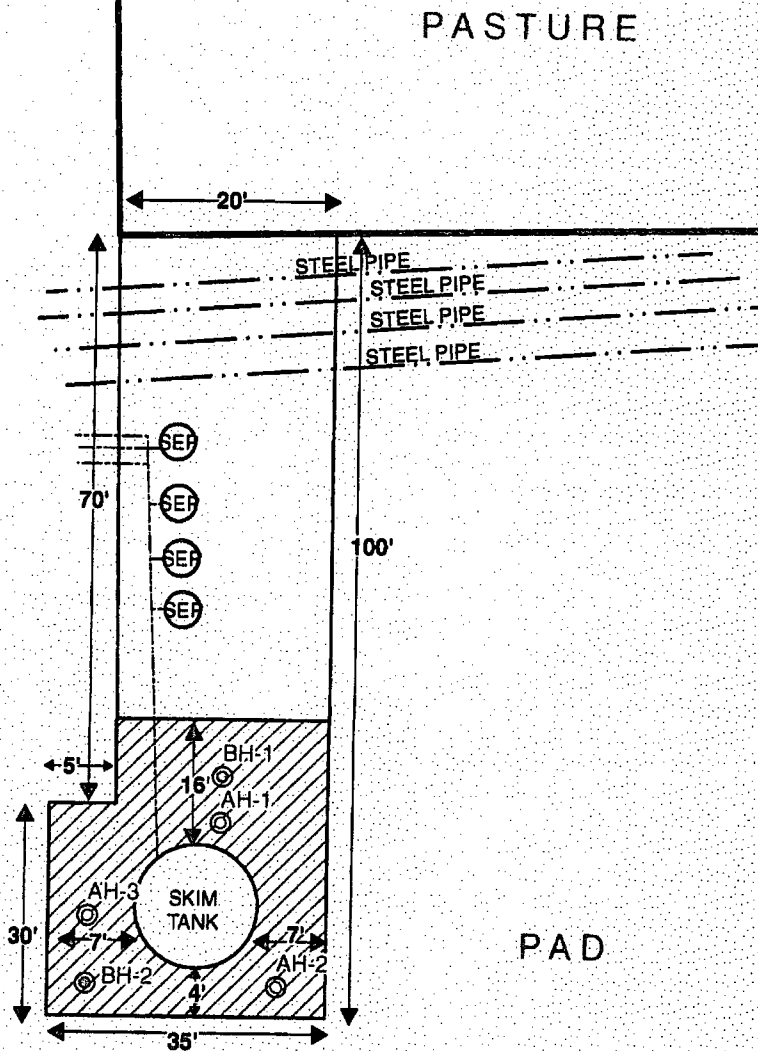
Figure 3

On April 20, 2012, Tetra Tech personnel inspected and sampled the spill area. Three (3) auger holes (AH-1, AH-2 and AH-3) were installed using a stainless steel hand auger to assess the impacted soils. Selected samples were analyzed for TPH analysis by EPA method 8015 modified, BTEX by EPA Method 8021B and chloride by EPA method 300.0. Copies of laboratory analysis and chain-of-custody documentation are included in Appendix C. The sampling results are summarized in Table 1. The auger hole locations are shown on Figure 3.

Referring to Table 1, the area of AH-2 did show a shallow hydrocarbon impact, which was above the RRAL for Total BTEX and Total TPH at 0-1' but declined below regulatory levels at 1.5' below surface. Auger holes (AH-1 and AH-3) did not exceed the RRAL for total BTEX or TPH. In addition, all auger holes (AH-1, AH-2, and AH-3) also showed elevated chloride concentrations and AH-1 and AH-3 were not vertically defined. Deeper samples were not collected due to a dense formation. The area of AH-2 chloride concentrations declined to 166 mg/kg at 2-2.5' below surface.

On June 6, 2012, Tetra Tech supervised the installation of two (2) soil borings (BH-1 and BH-2) using an air rotary drilling rig to assess the soils. The soil bores were installed in the areas of AH-1 and AH-3 to define the vertical extents. The boreholes were installed to a depth of 79-80' below surface. Copies of the laboratory analysis chain-of-custody documentation are included in Appendix C. The soil boring results are summarized in Table 1 and shown on Figure 3. Referring to Table 1, both of the boreholes were not vertically defined due to the flowing sands at the depths of 50' to 80', which collapse the borehole.
