RE: Turner A #045 – Work Plan

UL/C, Section 19, T17S R31E

API No. 30-015-28890

2RP-1873

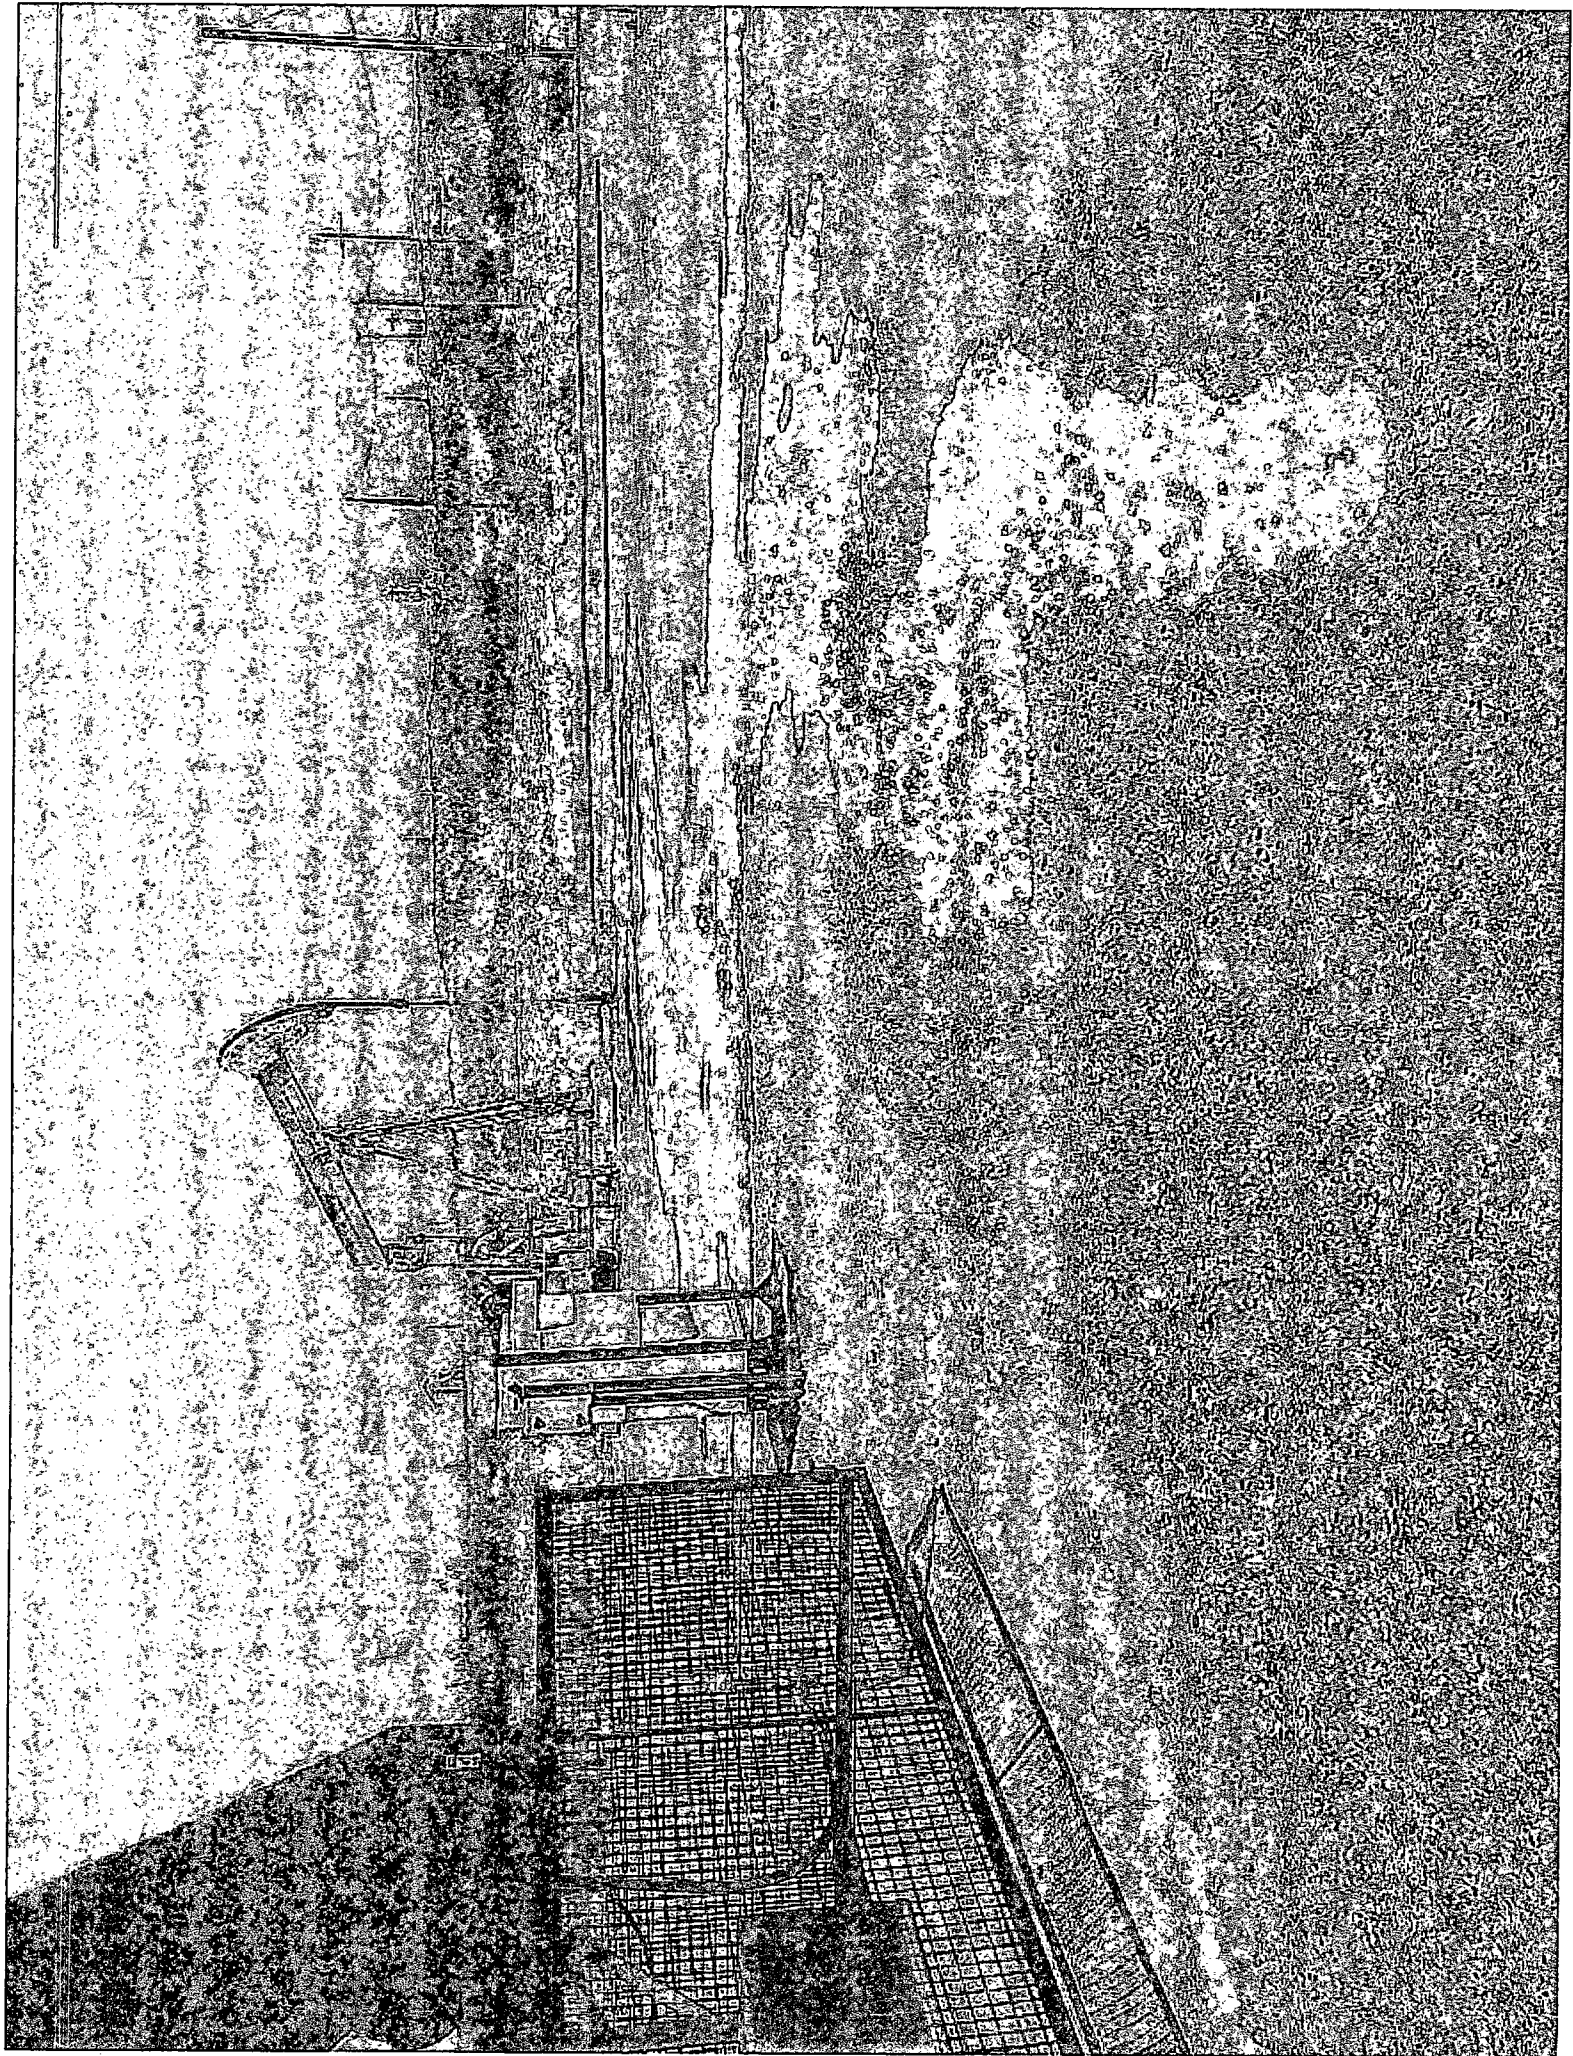
The site is located west of Maljamar NM, in Eddy County. The site resulted from a produced water leak in a corroded valve in a flow line near the wellhead. The line rupture released fluids onto approximately 5,000 square feet of caliche well pad area. A vacuum truck recovered 2 bbls of standing fluids and the line was repaired. A form C-141 was submitted to the NMOCD on August 26, 2013.

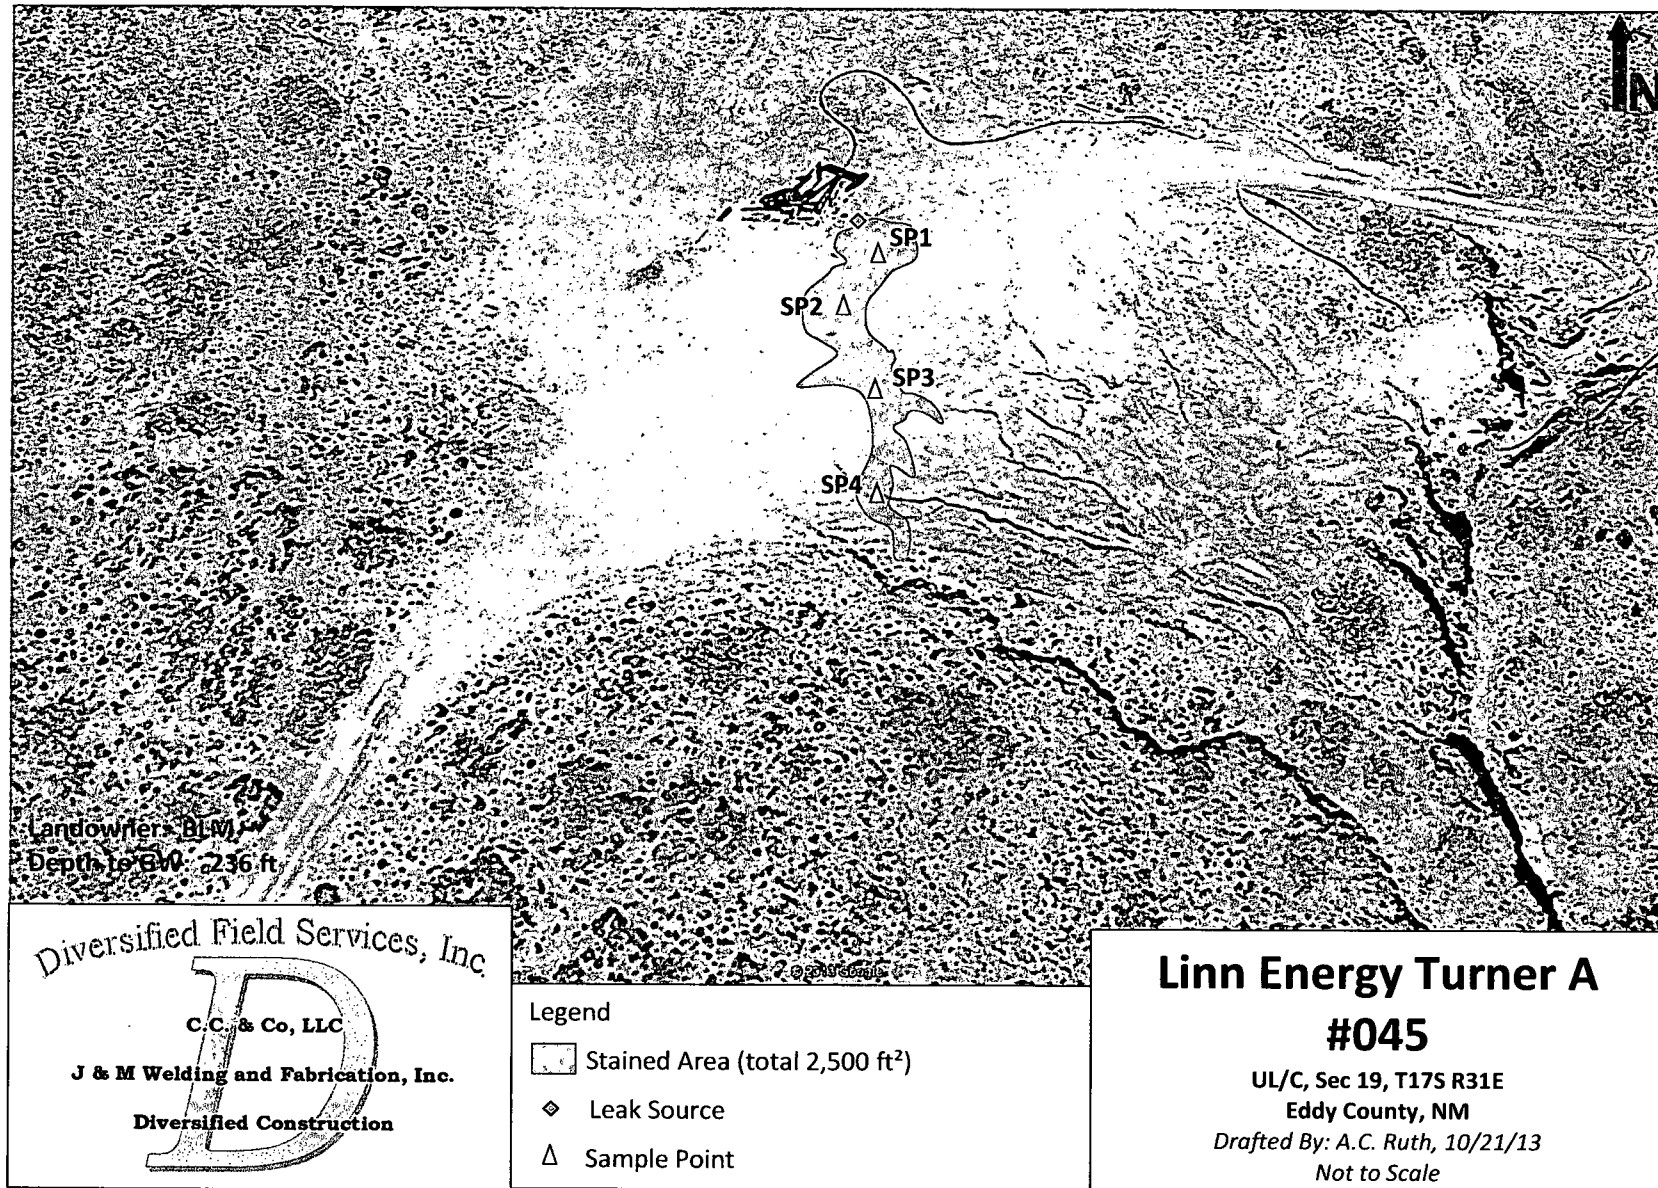
Site Diagram with Proposed Sample Points

DFSI personnel will use a hand auger to vertically delineate the leak area at several sample points. Soil samples will be field screened for chloride. Samples will be collected at surface and in 1 ft. intervals until two consecutive samples show chloride well below 1,000 mg/kg. Surface and bottom samples will be submitted to a commercial laboratory for chloride, TPH, and BTEX analyses.
