RE: Corrective Action Plan Linn Energy – McClay Federal #7 (2RP-1914) UL/C sec. 33 T18S R30E API No. 3001510370

LINN MCCLAY
FEDERAL #7
TANK BATTERY
(2RP-1914)

Linn McClay Federal #7 Tank Battery

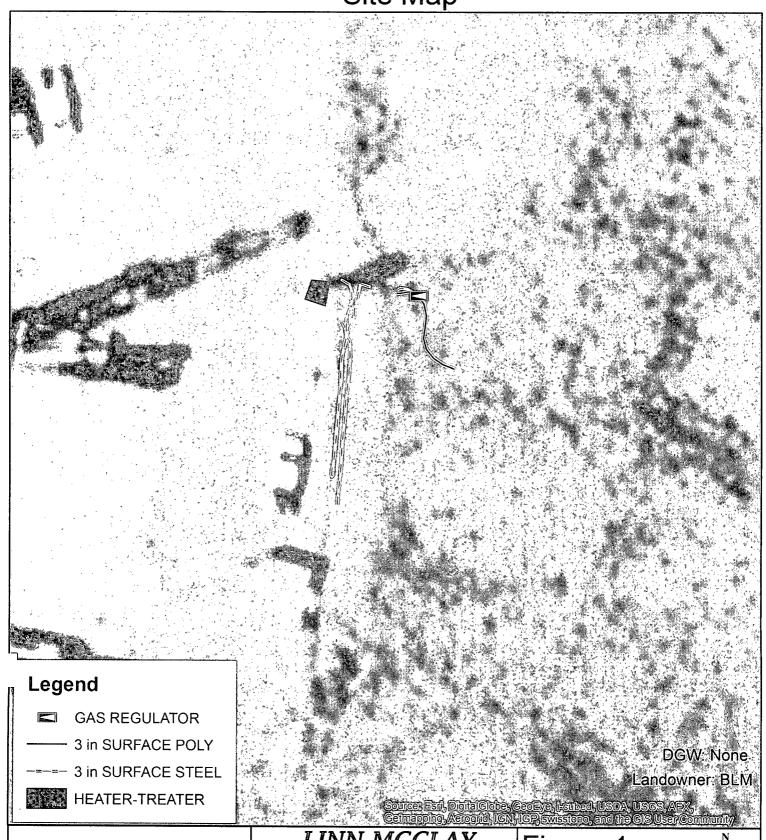
Figure 1

On September 8th, 2013, a hole at the base of the heater at the McClay #7 Battery released a total of 4 barrels of produced water and oil into the lined, bermed area surrounding the heater. A vacuum truck was called to the site and recovered one barrel of fluid from the bermed area and emptied the heater. A total of 31 sq ft of the lined, bermed area surrounding the heater was affected (Figure 1). An initial C-141 was sent by Linn to NMOCD and BLM on September 10th, 2013 (Appendix A).

RECS recommends that the contaminated caliche above the liner be removed and taken to a NMOCD approved facility for disposal. Clean caliche will be imported to the site to replace the contaminated caliche. Once this has been completed, a Termination Request will be sent to BLM and NMOCD that will ask for 'remediation termination' or similar site closure status for the site along with a final C-141.

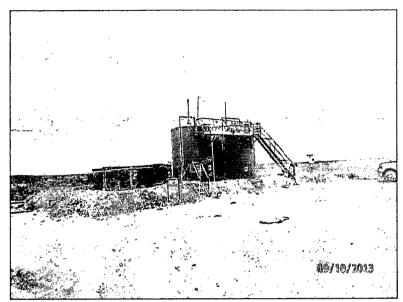
Initial site photo, facing southeast

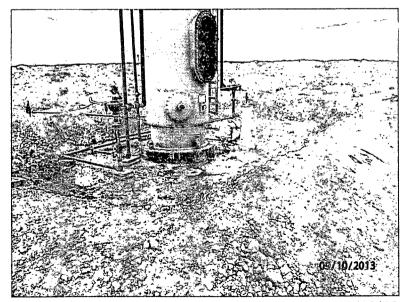
Initial site photo, facing southwest

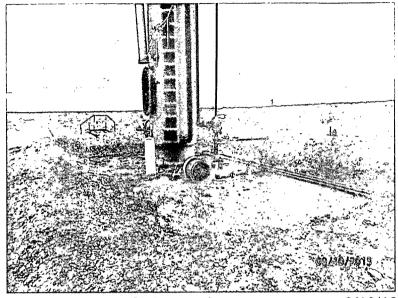
Initial site photo, facing northwest

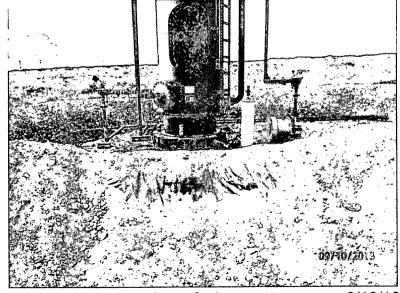
RECS personnel arrived on site on September 10th, 2013. The site was photographed and mapped. The liner was found across the base of the heater and none of the release occurred outside the liner (Appendix B).

Showing berm with liner, facing west
