Release Notification and Corrective Action

Name of Company: BOPCO, L.P.	Contact: Tony Savoie
Address: 522 W. Mermod, Suite 704 Carlsbad, N.M. 88220	Telephone No. 575-887-7329
Facility Name: JRU-21-Legg Federal SWD Battery	Facility Type: SWD

FIELD SPILL REPORT

LOCATION OF SPILL SITE: Legg Federal SWD Battery (API-30-015-04734)

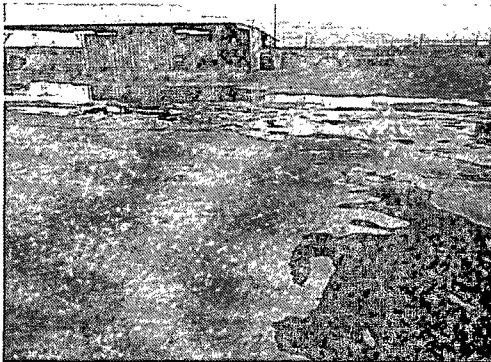
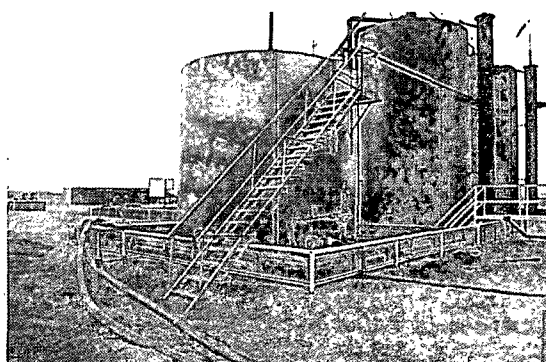
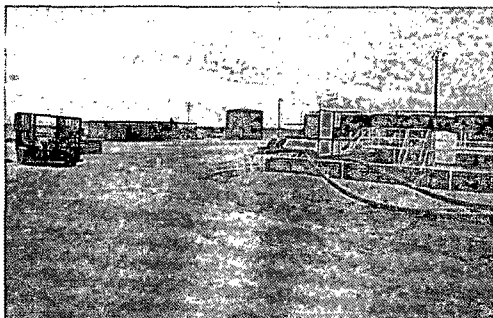
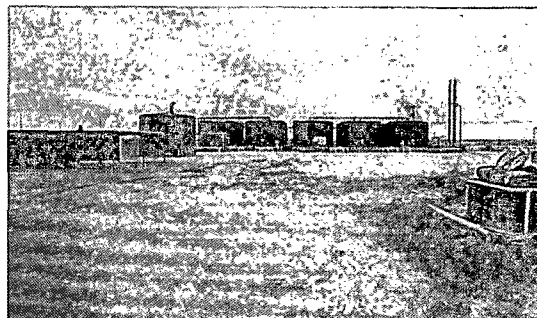
PICTURE ATTACHMENT:

Describe Area Affected and Cleanup Action Taken.*
The skim tank was located in 0-perm containment capable of holding 382 bbls, the skim tank containment overflowed spilling approximately 27 bbls of crude oil on the ground and approximately 70 bbls into the adjoining containment around the gun barrel tanks. Seven bbls of oil was recovered off the ground and 193 bbls from the containments. Also spilled was 279 bbls of produced water which was all contained in the 0-perm.
The spill impacted approximately 8,950 sq. ft. of caliche tank battery area. All of the free standing fluid was recovered and approximately 14 cubic yards of saturated soil was scraped up and placed on plastic.
The impacted area will be cleaned up in accordance to the NMOCD and BLM remediation guidelines.

A motor valve failed causing the skim tank to overflow. The containment around the skim tank overflowed to the ground and to the containment around the gun-barrel tanks. Discovered at 4:00 a.m. 12/21/14. Reported to agencies at 3:10 p.m. 12/21/14

Describe Cause of Problem and Remedial Action Taken.* A motor valve failed sending all of the fluid to the skim tank causing it to over-flow. The vessel was by-passed until the motor valve could be replaced.

A vacuum truck recovered 7 bbls off of the ground and all of the fluid in the containments. The containments were washed down and approximately 14 cubic yards of soil was scraped up and placed on plastic. All of the spill was contained inside the fenced area.
