From: Tavarez, Ike <Ike.Tavarez@tetrattech.com>
Sent: Monday, August 05, 2013 3:08 PM
To: Bratcher, Mike, EMNRD; Jeff Robertson (jrobertson@blm.gov)
Cc: highway.child@rocketmail.com; James_Amos@blm.gov
Subject: Lime Rock - Hondo Federal #1 Tank Battery - Spill Update and Remediation Notification
Attachments: Lime Rock - Table and Figures .pdf

Lime Rock Resources, LP
Hondo Federal #1 Tank Battery
Section 4, T18S, R27E
Eddy County, New Mexico
32.77732 -104.277998

Spill Assessment Map

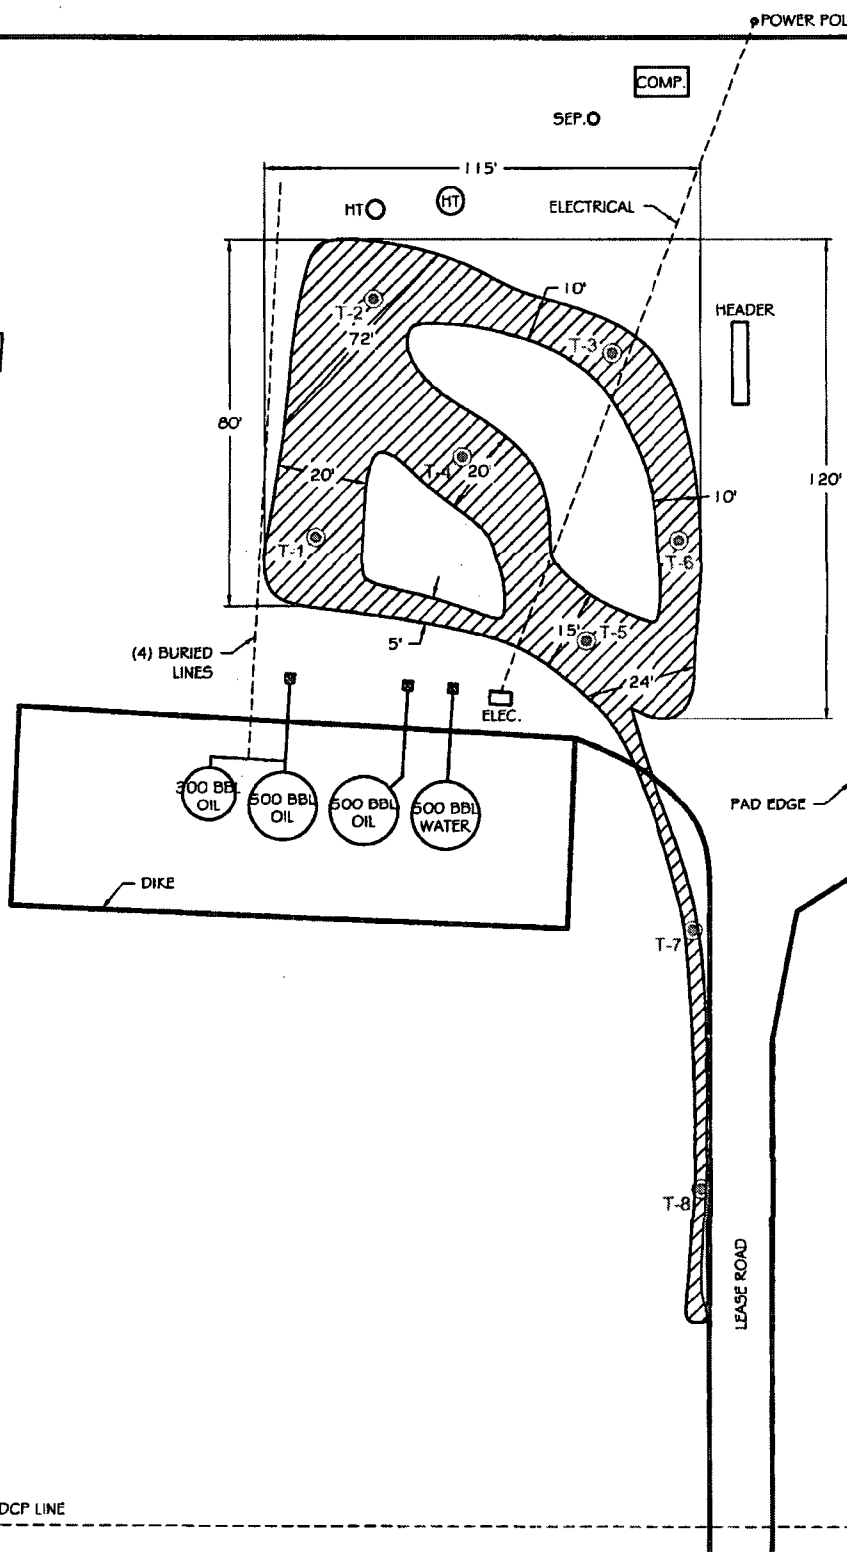
Figure 3

Referring to Table 1, the chloride sample did show a slight concentration of 791 mg/kg and declined with depth. The chloride detected does not appear to be issue or related to the crude oil release. The areas of T-1, T-6, T-7 and T-8 either exceeded the RRAL's for TPH or BTEX concentrations. The areas of T-1, T-6 and T-7 showed a shallow impact with concentrations below the RRAL at 1-1.5' and T-8 declined below the RRAL at 2.0' below surface. The remaining areas were all below the RRAL.

Tetra Tech proposes to excavate the areas of T-1, T-6, T-7 and T-8 to remove the soils exceeding the RRAL. Once excavated to the appropriate depths, the areas will be immediately backfilled with clean soil, for safety concerns. All of the excavated soil will be transported to proper disposal. Once the remedial activities are completed, a closure report will be prepared and submitted for closure of the spill issue.
