# SITE INFORMATION

## Report Type: Work Plan

June 27, 2012

**Re: Assessment and Work Plan for the COG Operating LLC.,  
Diamondback State Tank Battery, Section 28, Township 17 South,  
Range 29 East, Eddy County, New Mexico.**

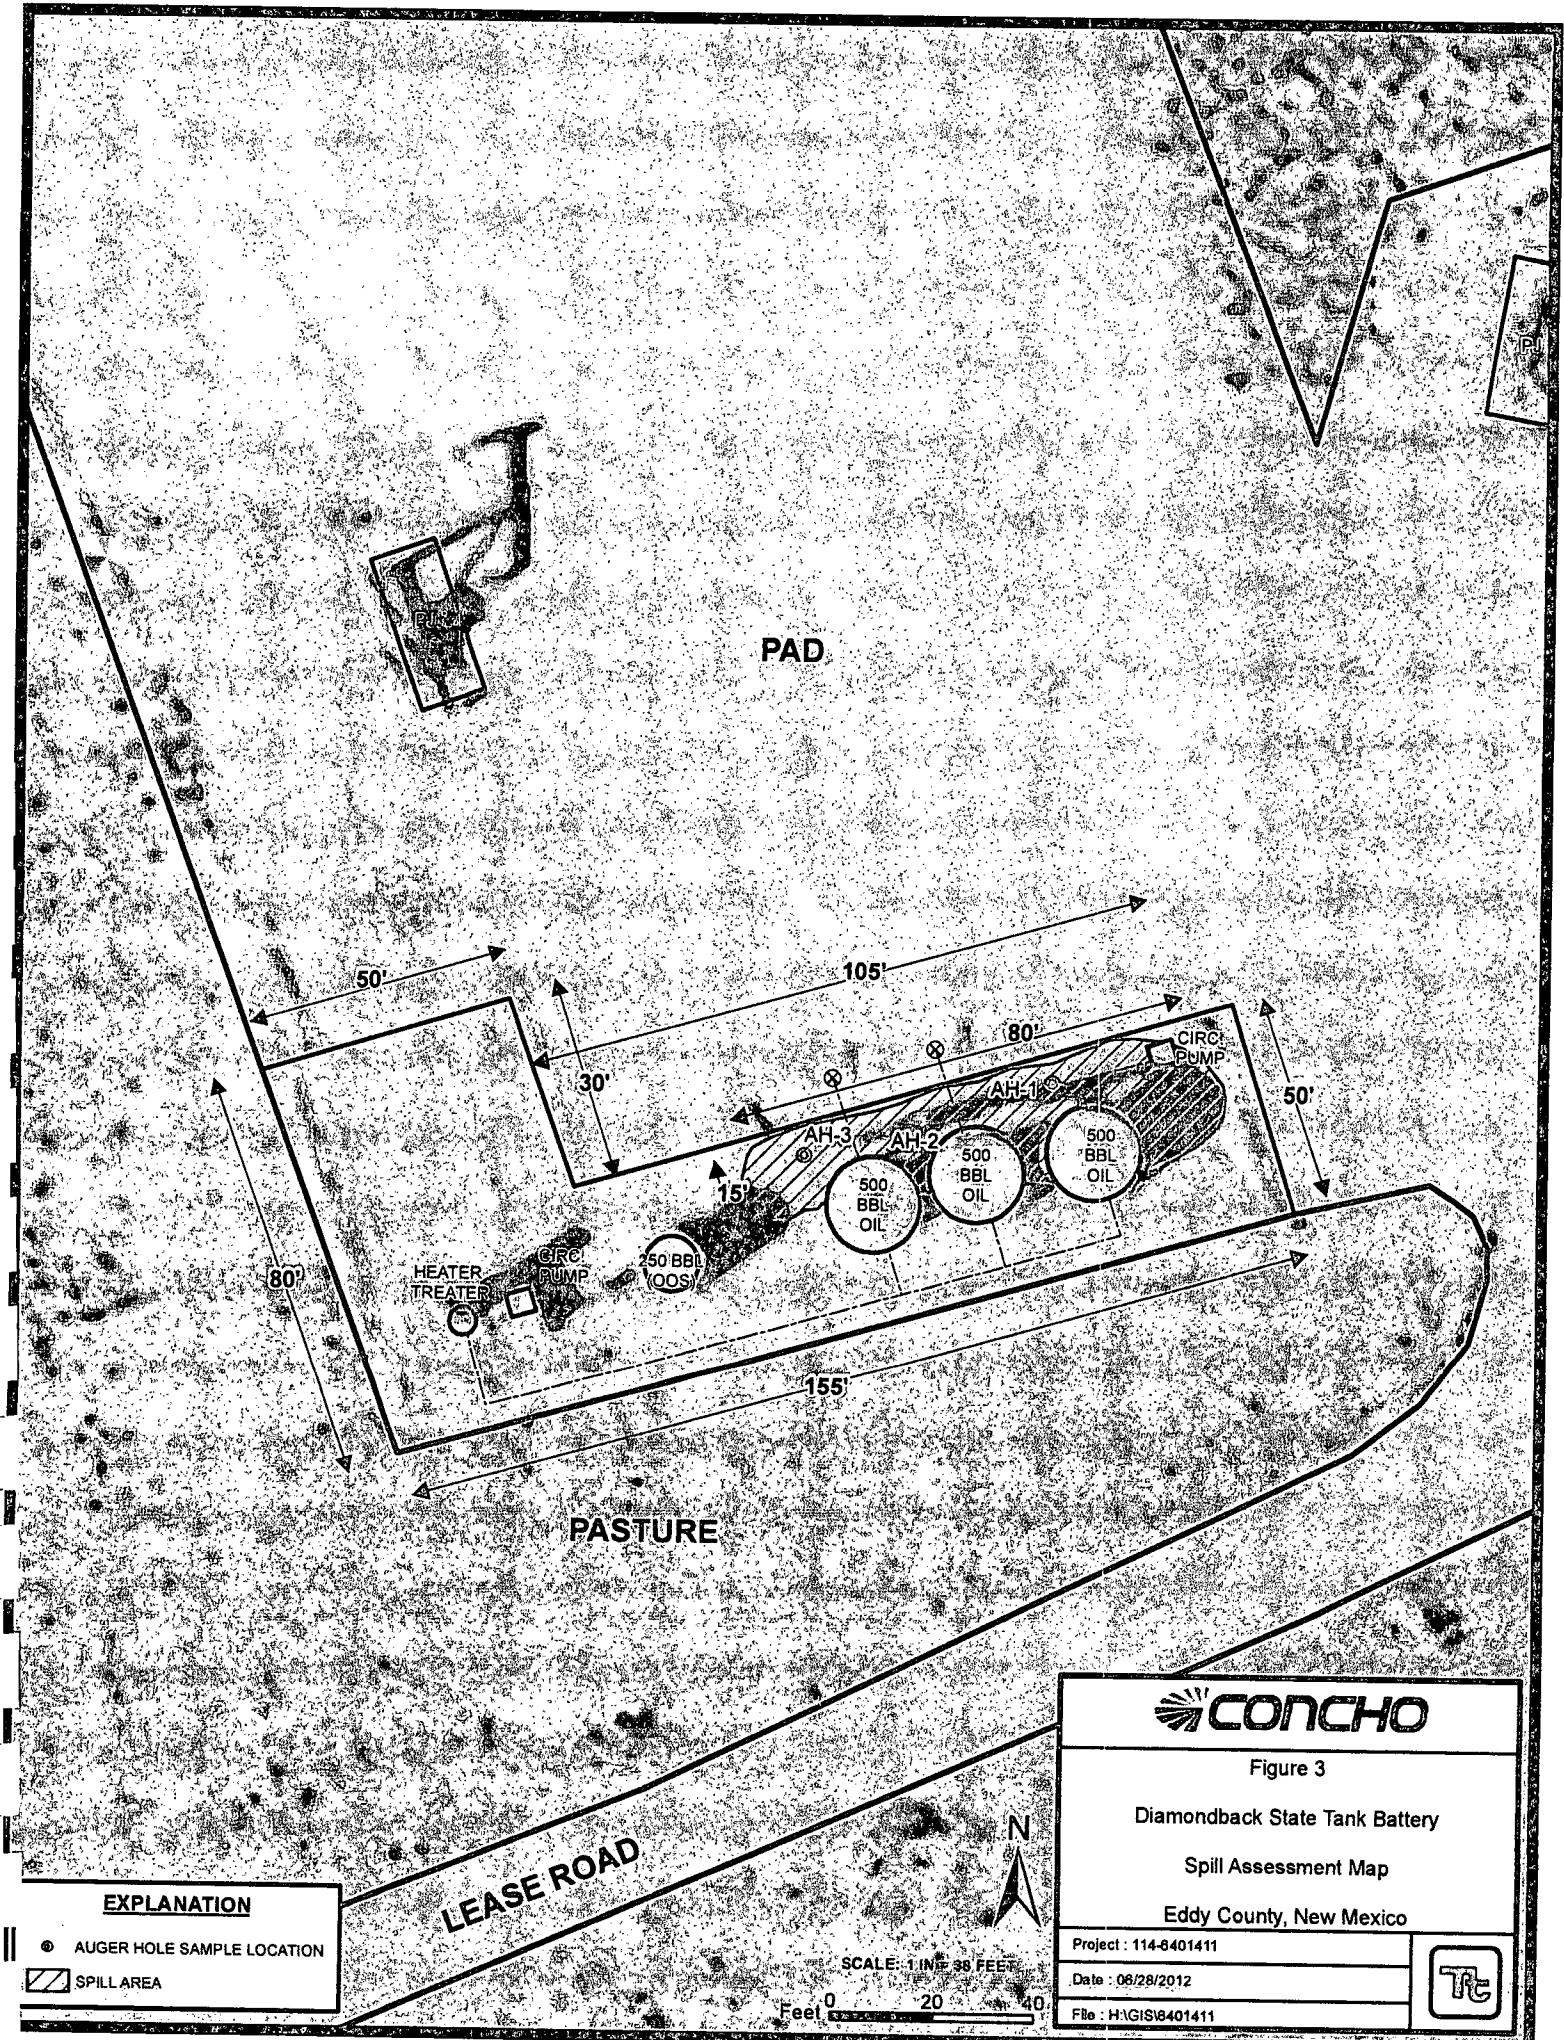
Figure 3

According to the State of New Mexico Oil Conservation Division (NMOCD) Form C-141 Initial Report, the leak was discovered on April 25, 2012. The spill released approximately thirty-nine (39) barrels of oil from an over-pressured load line. COG was able to recover approximately 35 barrels of oil with a vacuum truck. To alleviate the problem, COG repaired the line and installed a pressure vent. The impacted area measured approximately 15'x 80'. The entire spill area was contained within the facility firewalls. The spill area is shown on Figures 3. The initial Form C-141 is enclosed in Appendix A.

On May 30, 2012, Tetra Tech personnel inspected and sampled the spill area. A total of three (3) auger holes (AH-1 through AH-3) were installed using a stainless steel hand auger to assess the impacted area. Selected samples were analyzed for TPH analysis by EPA method 8015 modified, BTEX by EPA Method 8021B and chloride by EPA method 300.0. Copies of laboratory analysis and chain-of-custody documentation are included in Appendix C. The sampling results are summarized in Table 1. The auger hole locations are shown on Figure 3.

Referring to Table 1, all of the auger holes samples showed TPH, benzene and total BTEX exceeding the RRAL at 0-1' and 1-1.5' below surface. The deeper samples at 2-2.5' declined below the RRAL and were vertically defined. Elevated chloride concentrations were detected in the areas of AH-1 (0-1') of 2,600 mg/kg and AH-2 (0-1') 1,880 mg/kg, but significantly declined at 1-1.5' to 457 mg/kg and 311 mg/kg, respectively. The area of AH-3 did not show a chloride impact the soils.

COG proposes to remove the impacted material as highlighted (green) in Table 1. To remove the impacted soil above the RRAL, the spill area will be excavated to a depth of approximately 2.0' below surface. Once excavated to the appropriate depths, the excavation will be backfilled with clean soil. The excavated soil will be hauled to proper disposal.

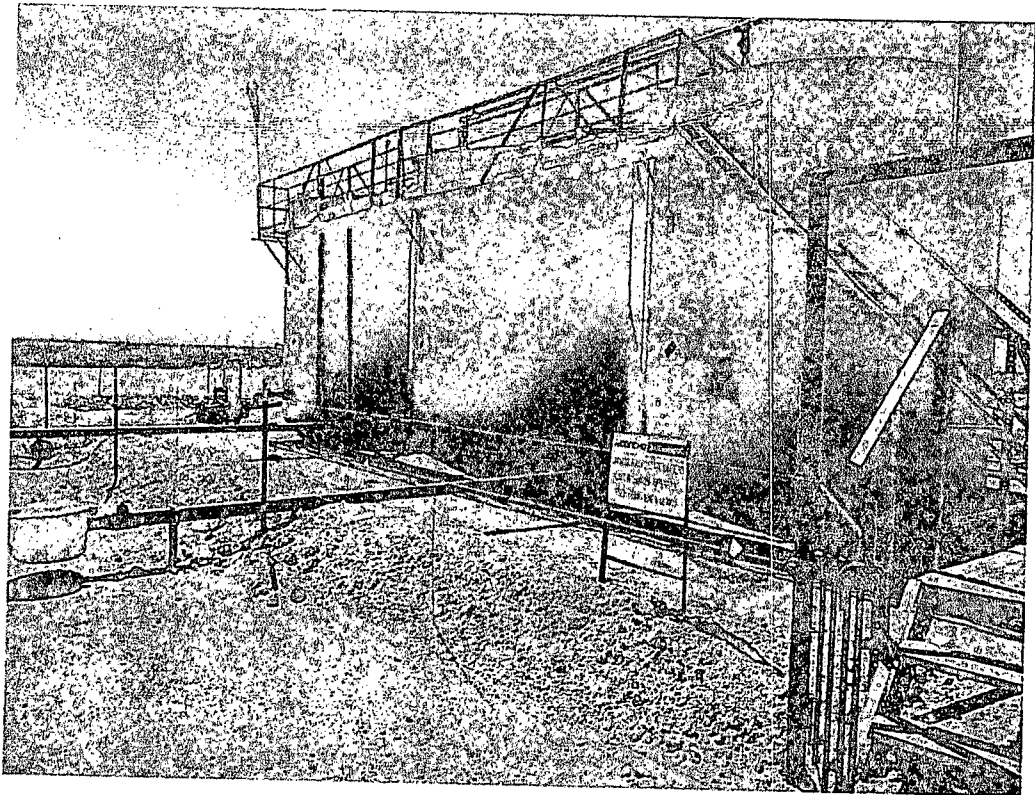
View south east – Near AH-3

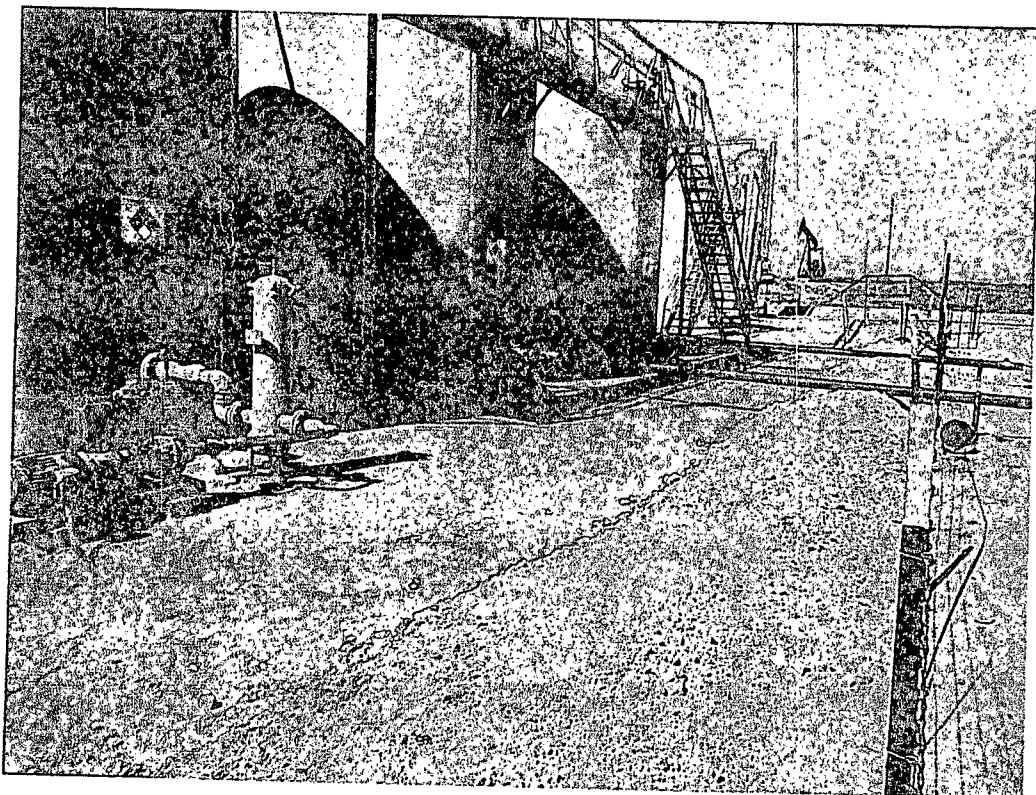
View south west – Near AH-1
