Holly Energy Partners Navaho Apache DAD Lateral Closure Report

Section 30, T17S, R29E Eddy County, New Mexico

July 19, 2013

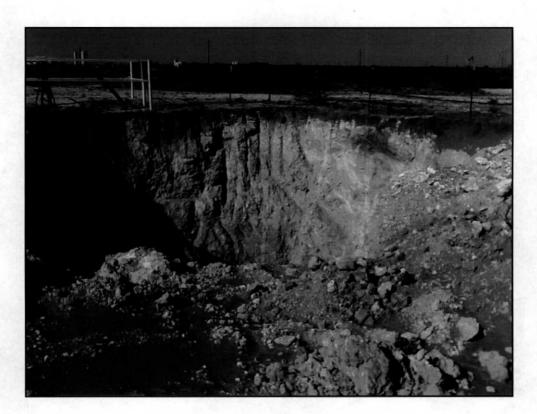
West Pit Excavation (Facing Southeast)

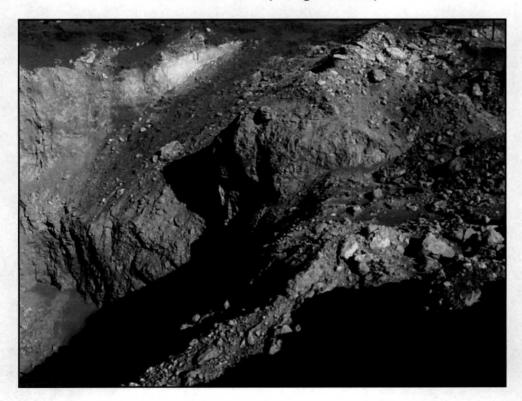
West Pit Excavation (Facing West)

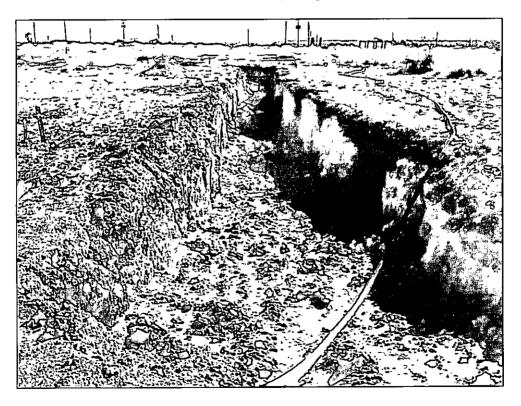
Excavation (Facing Northeast)

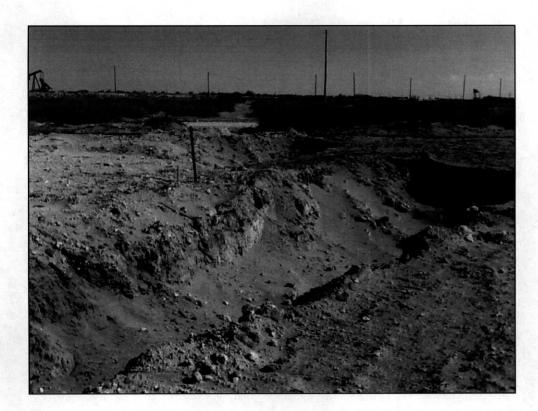
Excavation (Facing North)

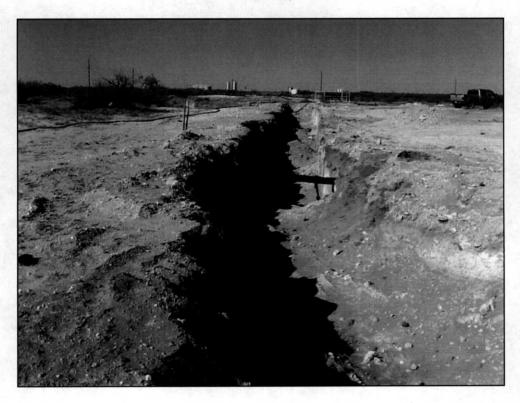
Excavation (Facing Southwest)
