Release Notification and Corrective Action

OXY USA, Inc.
South Unit Hobbs Injection Trunk Line
Delineation Report and Work Plan

Section 06, T19S, R38E
Lea County, New Mexico

April 17, 2014

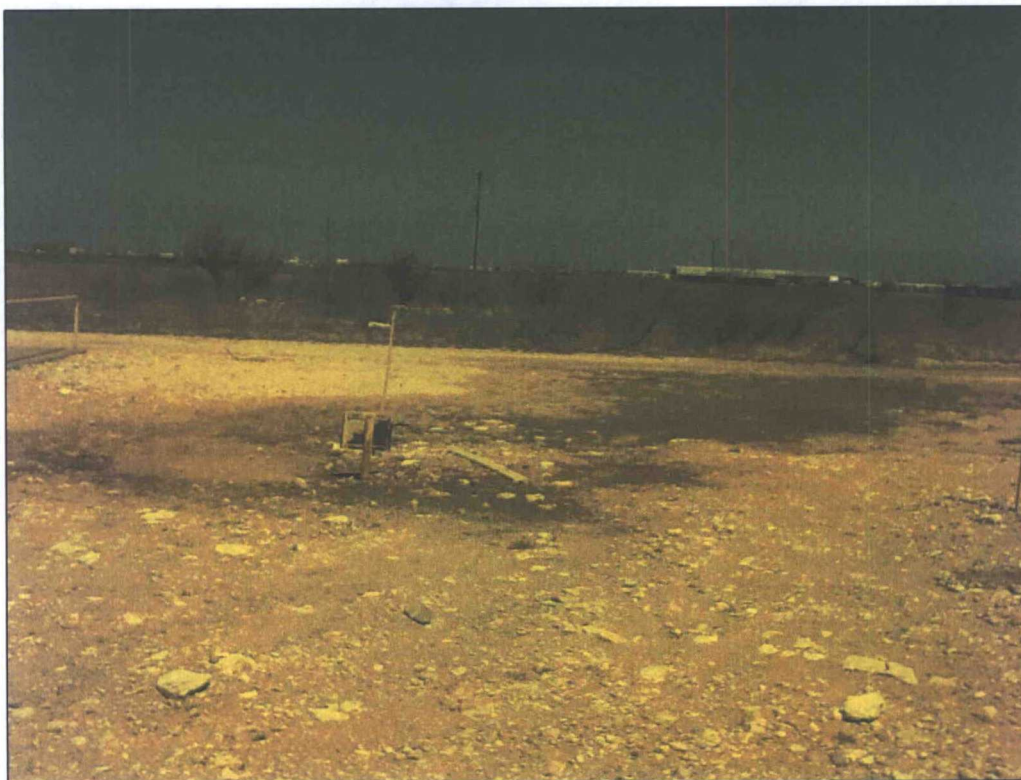
Spill-Facing North

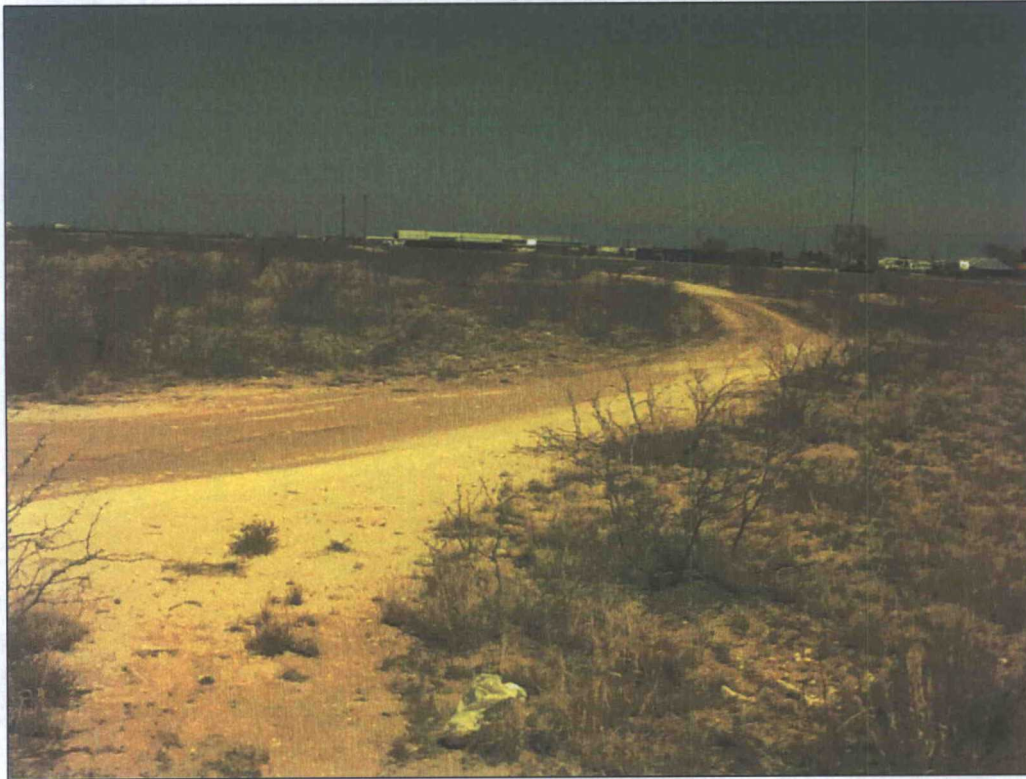
Spill down road-Facing Northeast

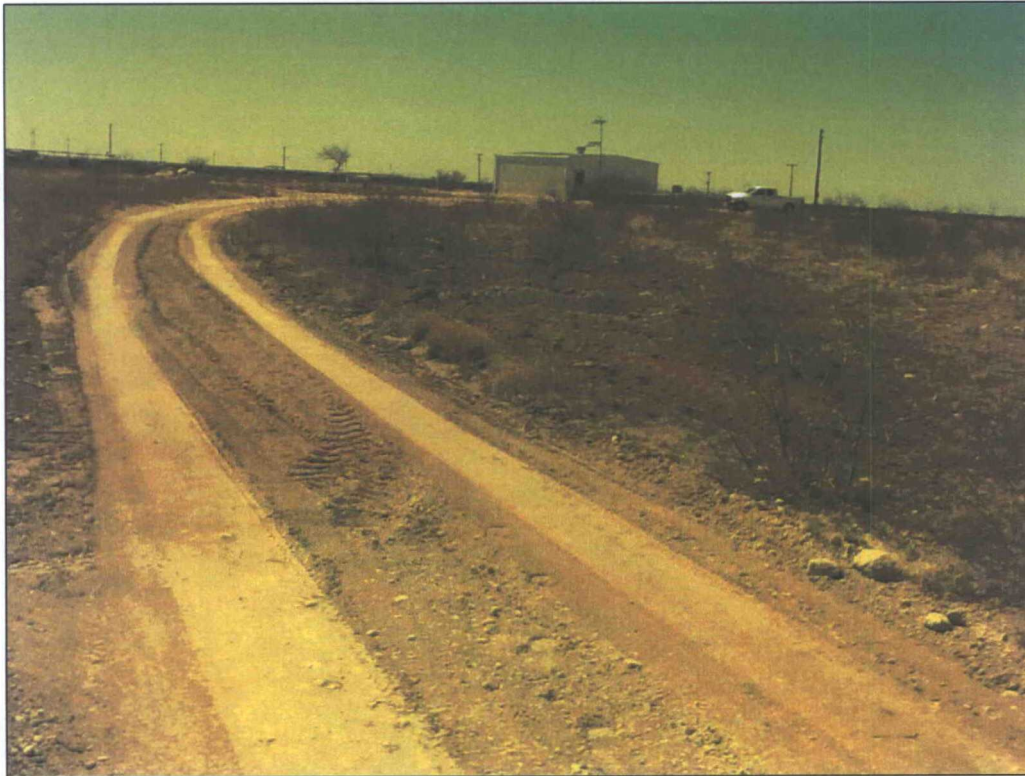
Spill down road in pasture-Facing Southwest

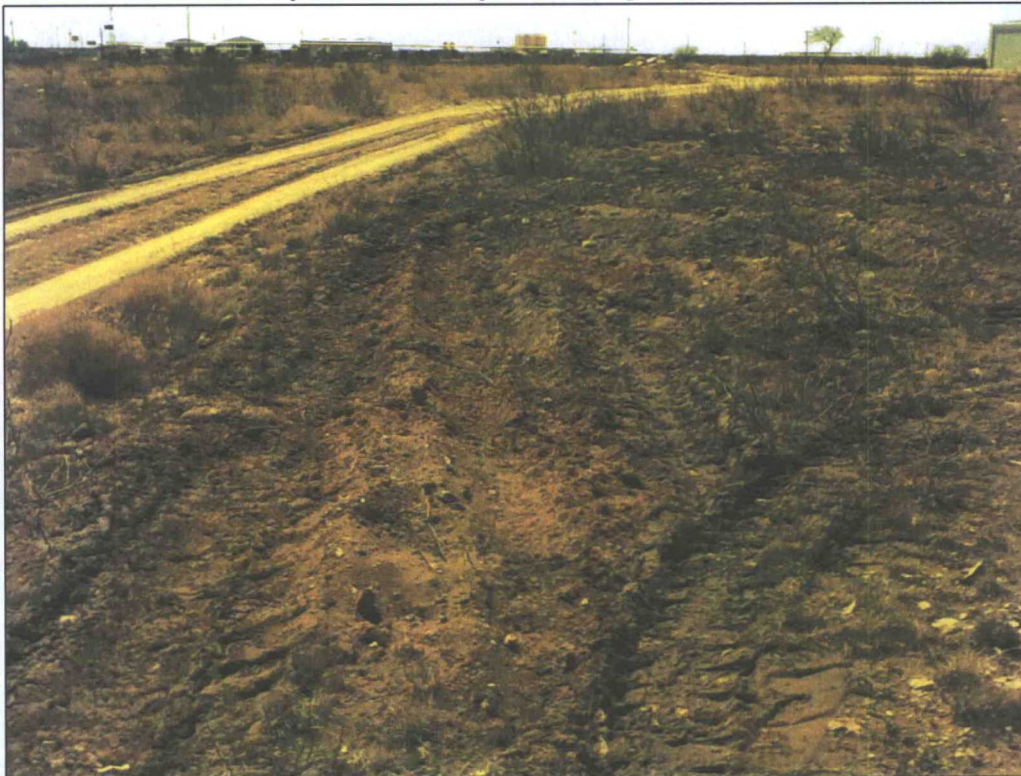
Spill in pasture-Facing South

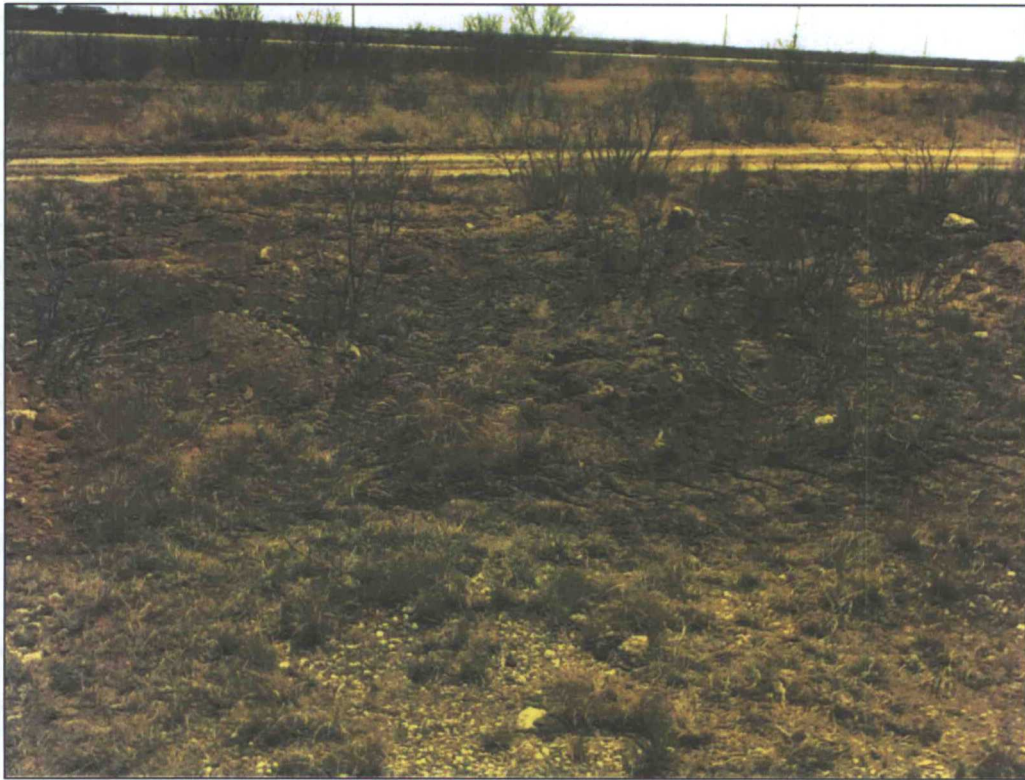
Spill in pasture-Facing Southeast

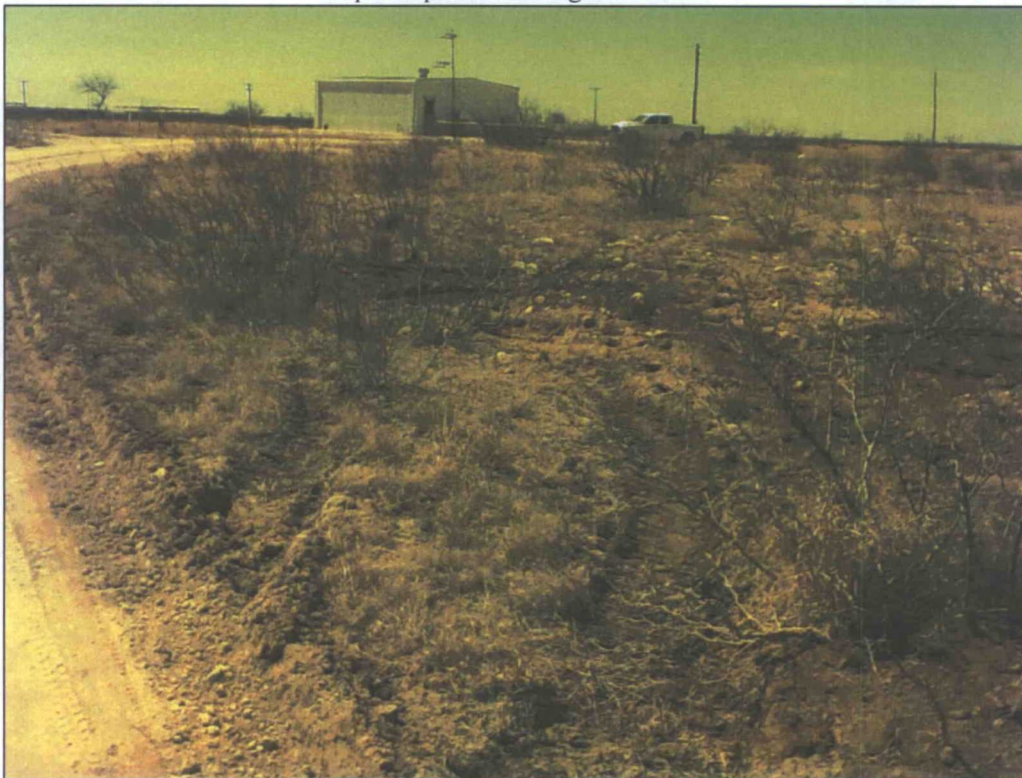
Spill in pasture-Facing Southwest

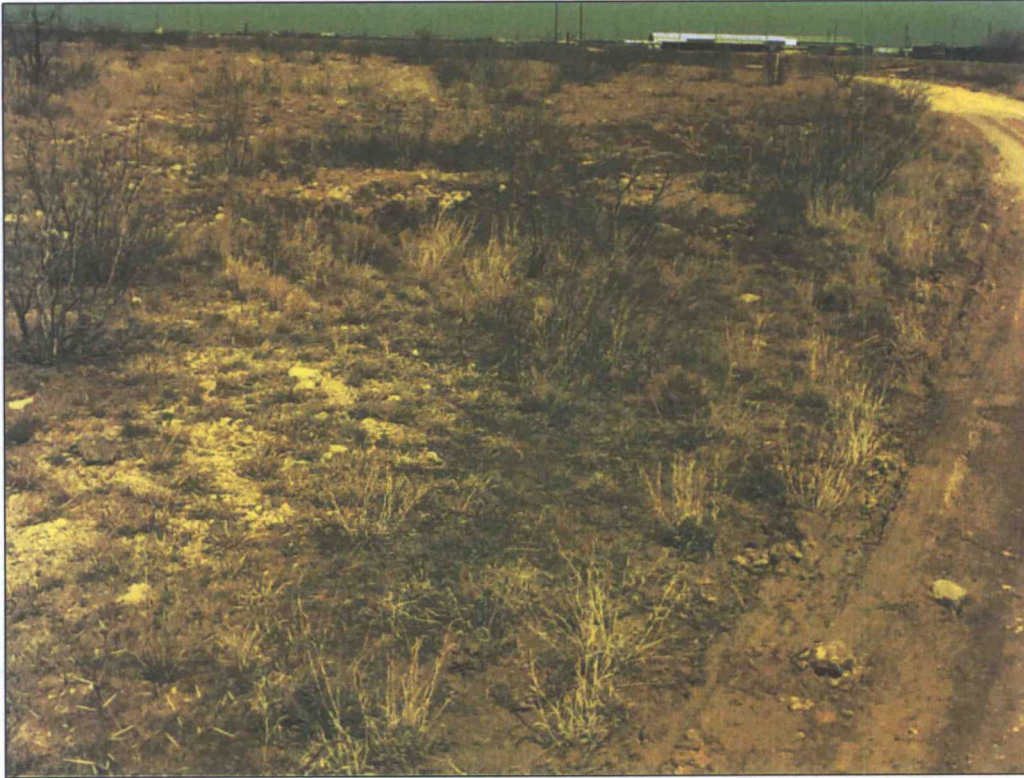
Spill in pasture-Facing Northeast

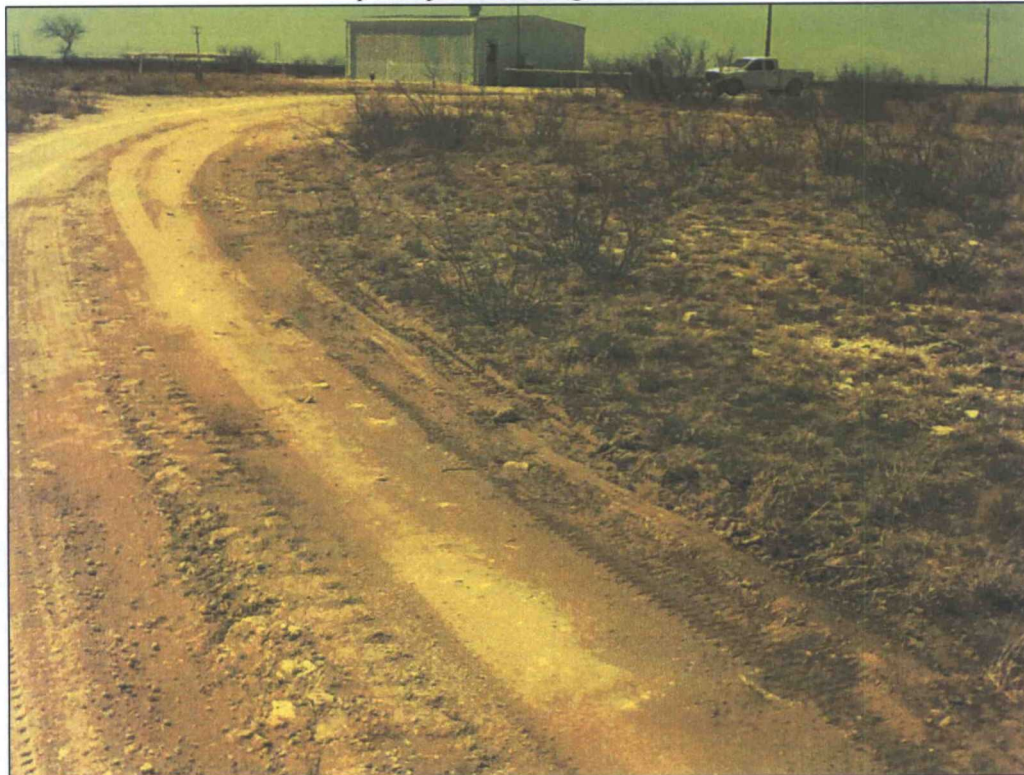
Spill in pasture-Facing Southwest

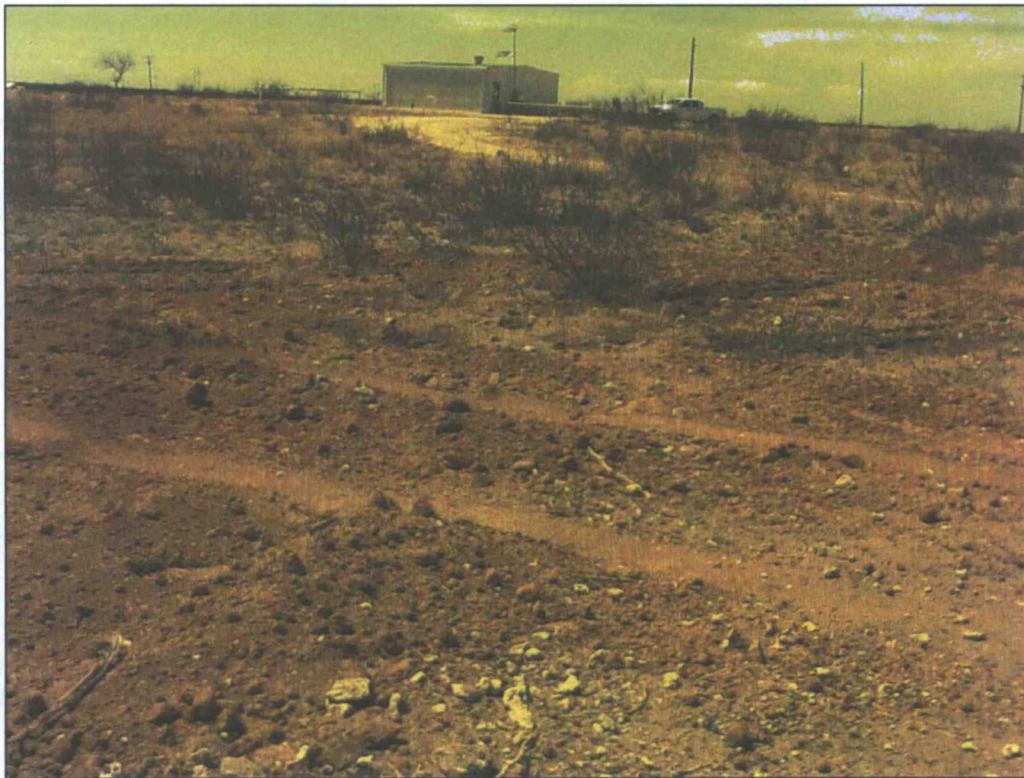
Spill in pasture-Facing Southwest

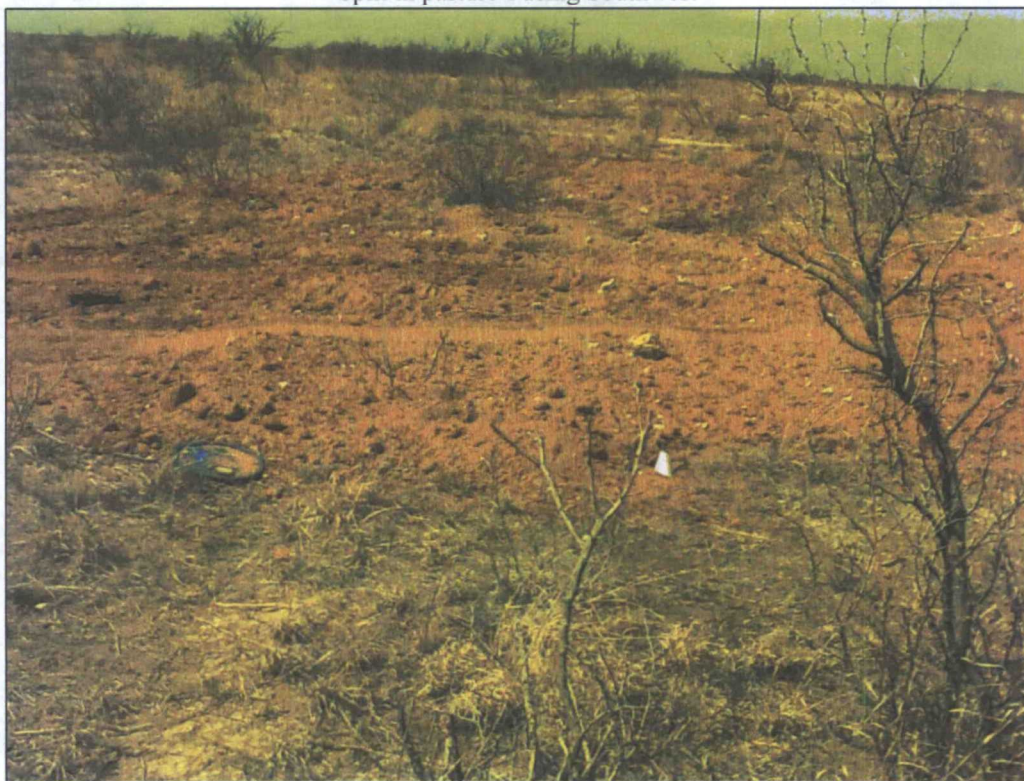
Spill in pasture-Facing West

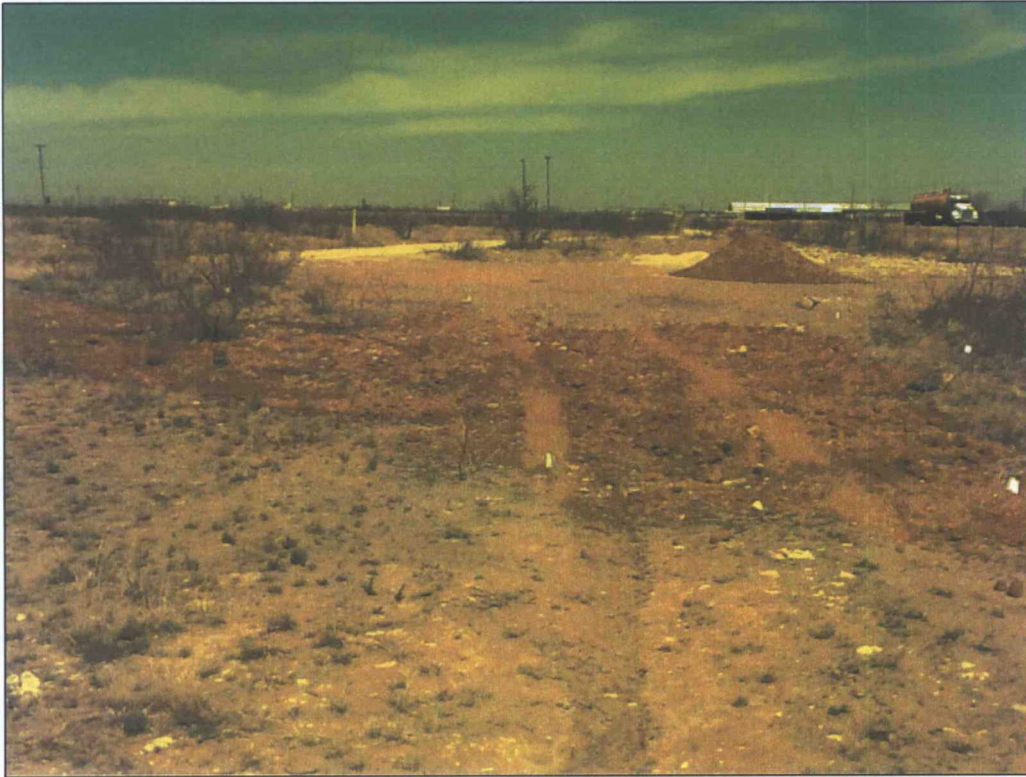
Spill in pasture-Facing North
