Release Notification and Corrective Action

Name of Company	Apache Corporation	Contact	Natalie Gladden
Address	PO Box 1849 Eunice NM 88231	Telephone No.	575-390-4186
Facility Name	Southeast Lusk 34 #6 Battery	Facility Type	Production Facility
Surface Owner	BLM	Mineral Owner	State
		API No.	30-025-37681

APACHE SE LUSK 34 FEDERAL #006 TANK BATTERY

Southeast Lusk 34 Federal #6

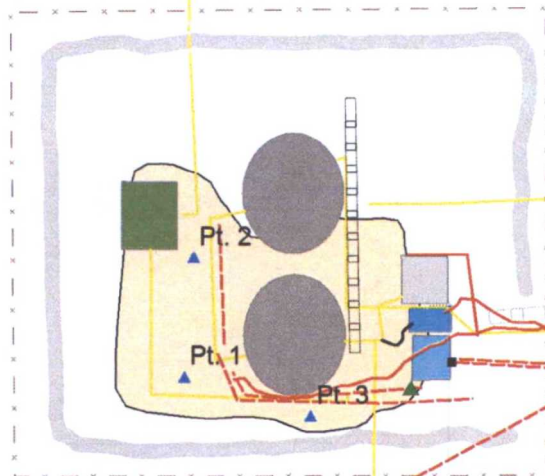
Initial Sampling Data

Sample Description	Cl-	PID	LAB Cl-	GRO	DRO
pt 1 surface	14,059	4.2	15,600	<10	<10
pt 1 @ 6"	16,315	1.7			
pt 1 @ 1'	11,122	1.3

Sample Description	Cl-	PID	LAB Cl-	GRO	DRO
pt 2 surface	9,872	2.3	11,400	<10	35.9
pt 2 @ 6"	16,305	1.8			
pt 2 @ 1'	11,001	1

Sample Description	Cl-	PID	LAB Cl-	GRO	DRO
pt 3 surface	14,847	5.1	20,800	<10	<10
pt 3 @ 6"	7,198	0.2			
pt 3 @ 1'	3,717	0.5			
pt 3 @ 1'6"	3,580	0.5			
pt 3 @ 2'	3,836	0.5

Sample Description	Cl-	PID
5PT BTM COMP	13960	28.9

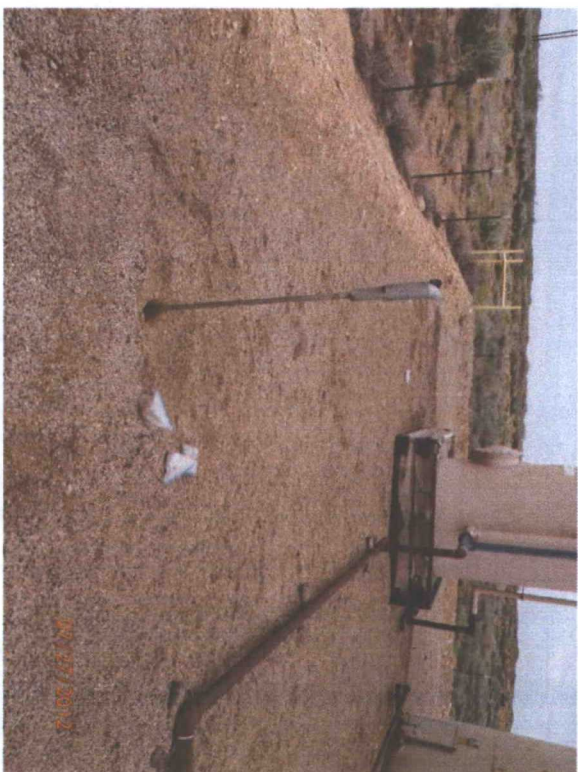
Sampling initial release, facing north

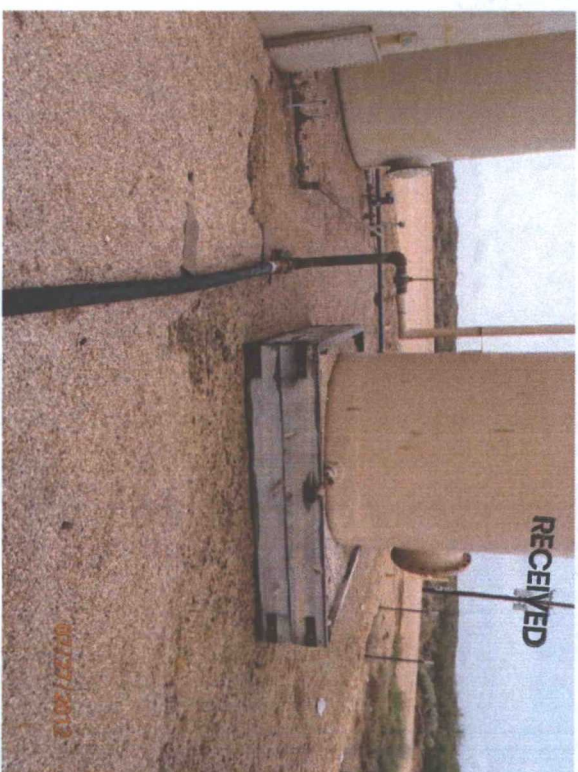
Sampling initial release, facing south

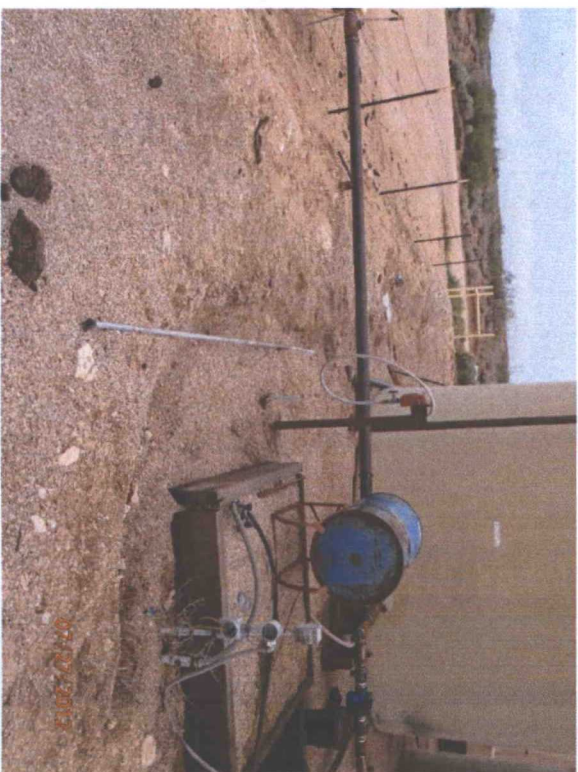
Sampling initial release, facing west

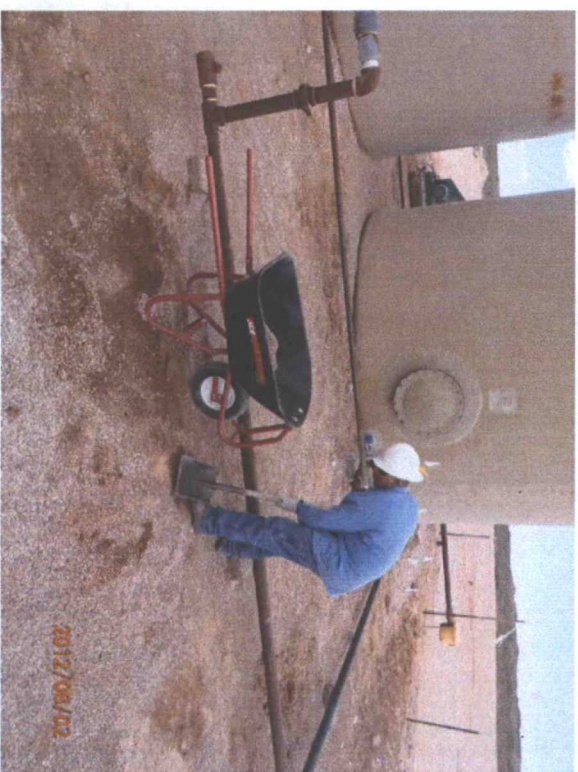
Excavating leak, facing east

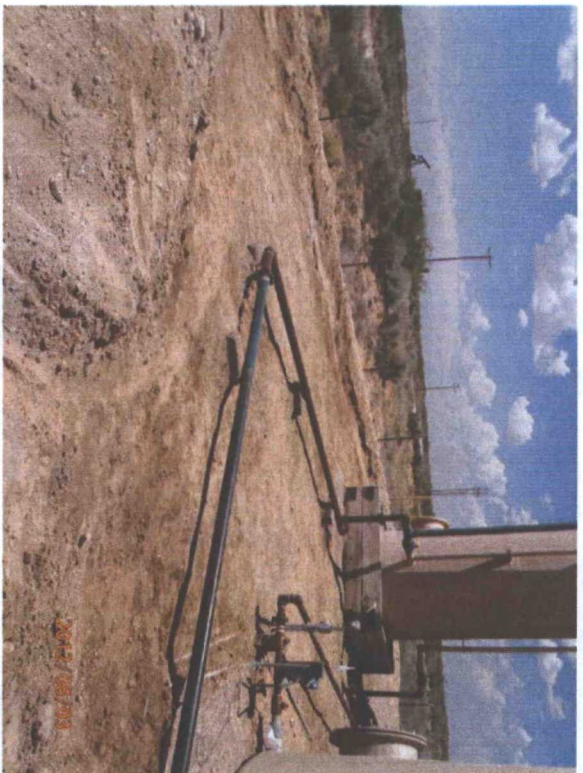
Final excavation, facing north

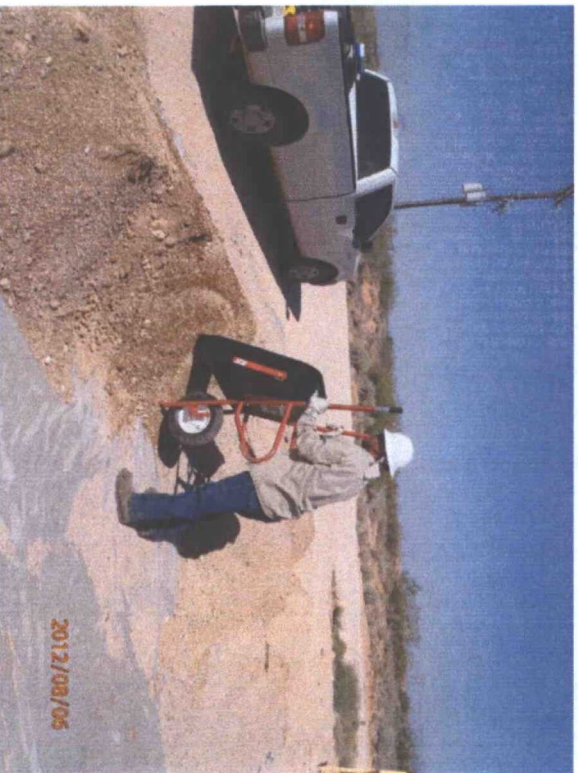
Stockpiling on plastic, facing west

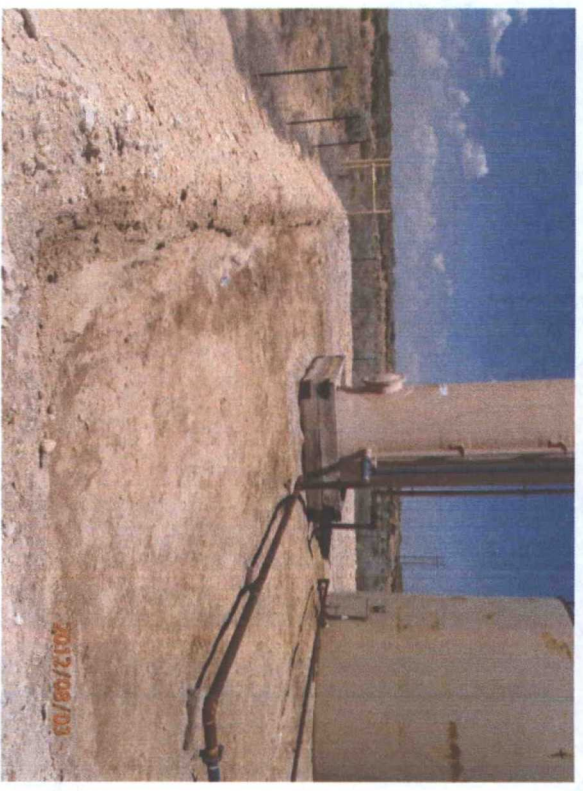
Final excavation, facing north

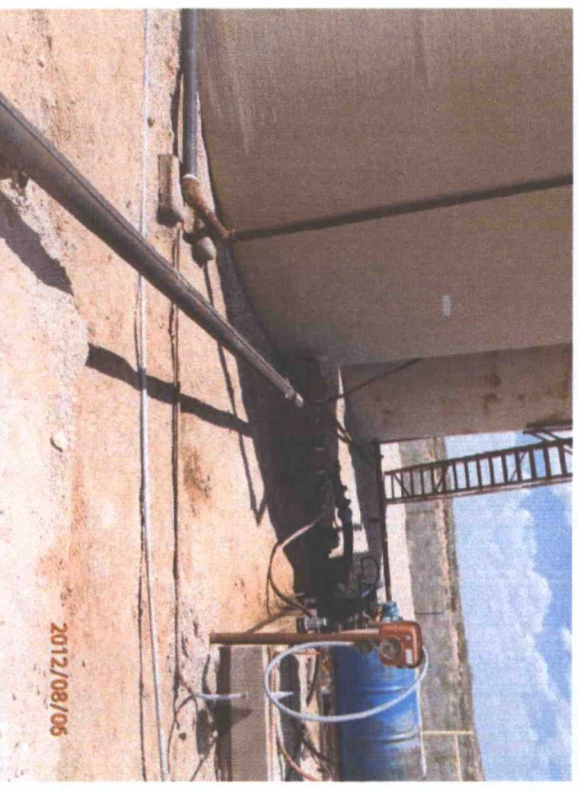
Final excavation, facing north
