1RP - 1523

SOUTHERN UNION GAS COMPANY

Site & Sample Location Map
Southern Union Gas Services
Trunk "O" #5 (1RP-1523)
Lea County, NM

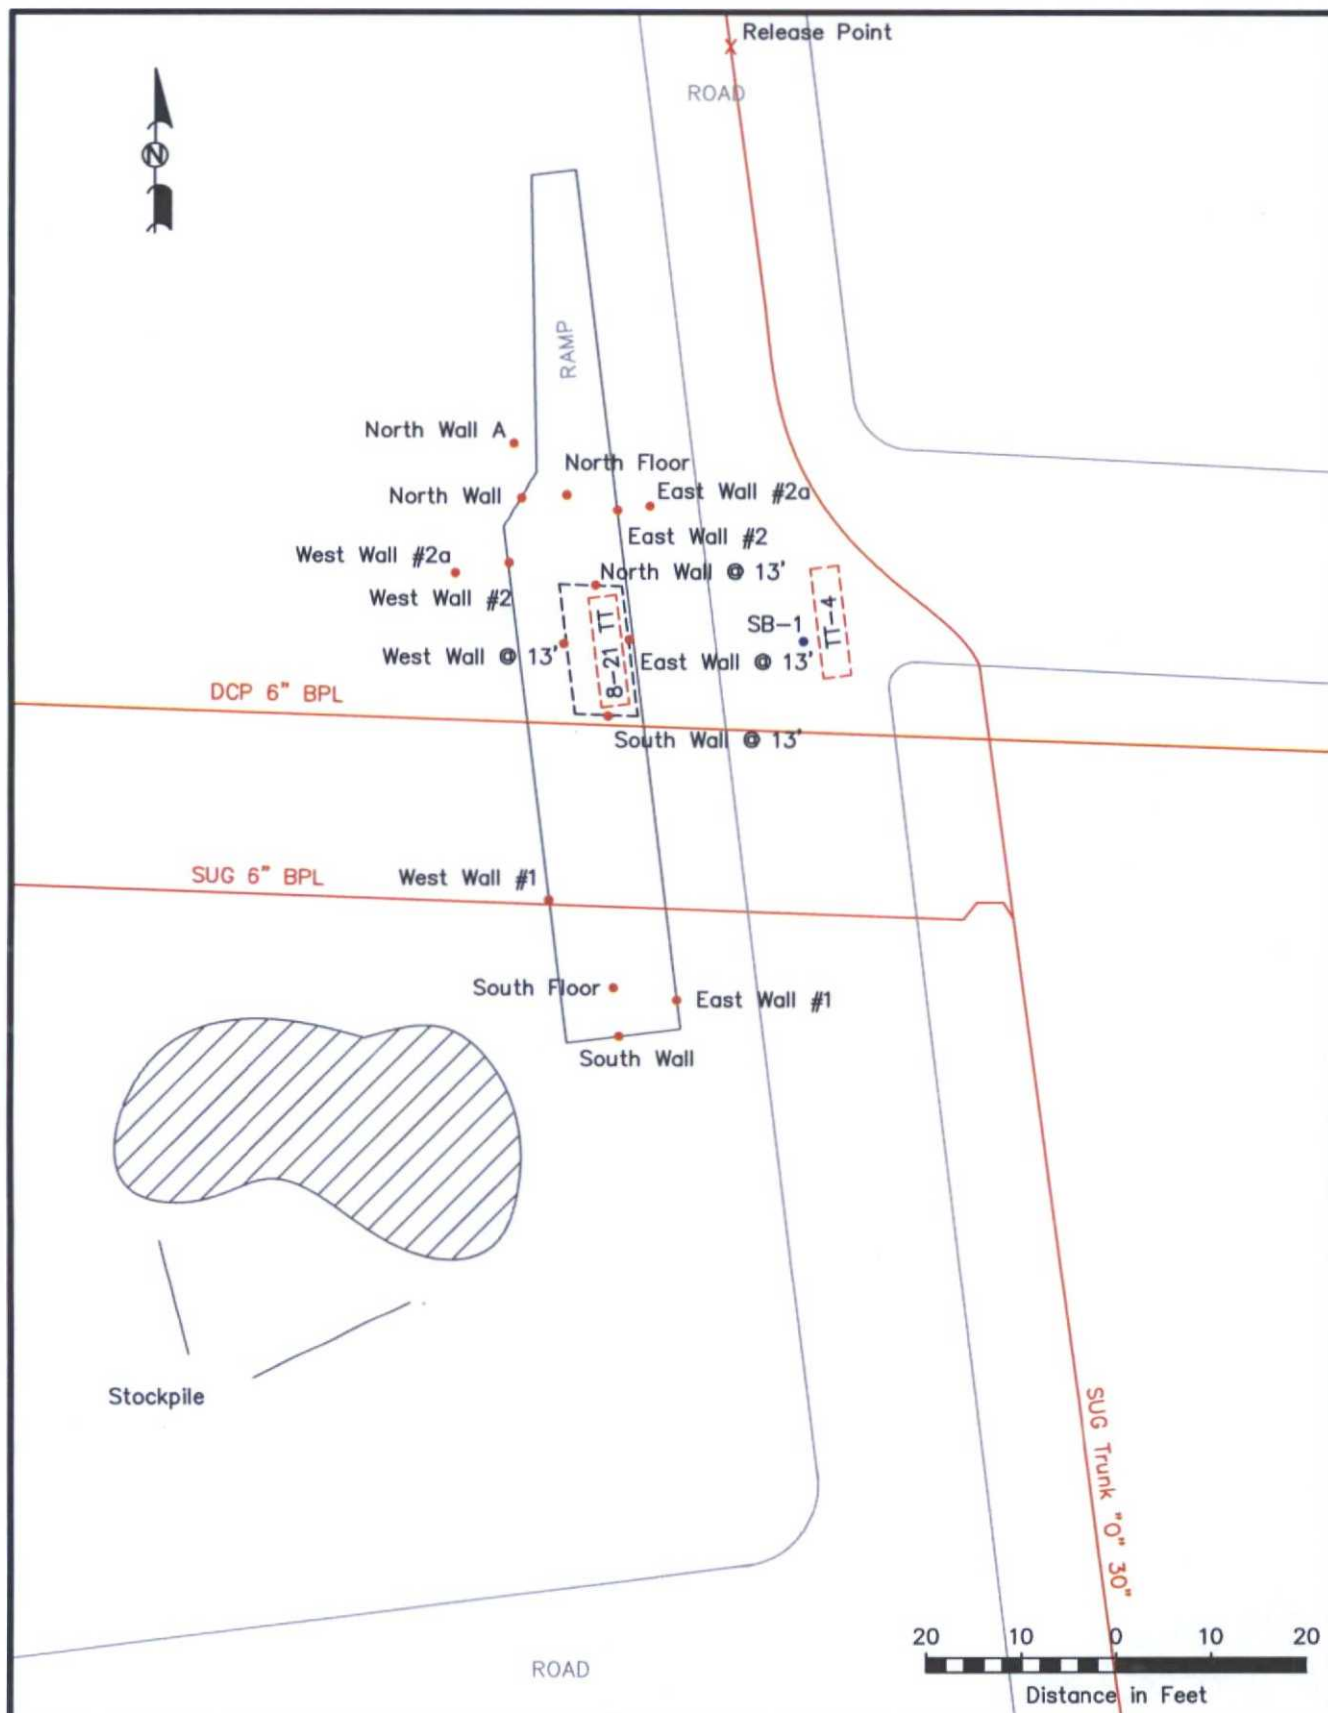
Figure 2

TT-4	
Depth	Cl-
Surface	*3,032
1'	*1,736
2'	*260
3'	*980
4'	*296
5'	*196
8'	*332
10'	*2,308

Release Point	
Depth	Cl-
1'	*412
2'	*412

TT-3	
Depth	Cl-
2'	*<112
3'	*260
5'	*<112

TT-1	
Depth	Cl-
2'	*<112
3'	*<112

TT-2	
Depth	Cl-
2'	*168

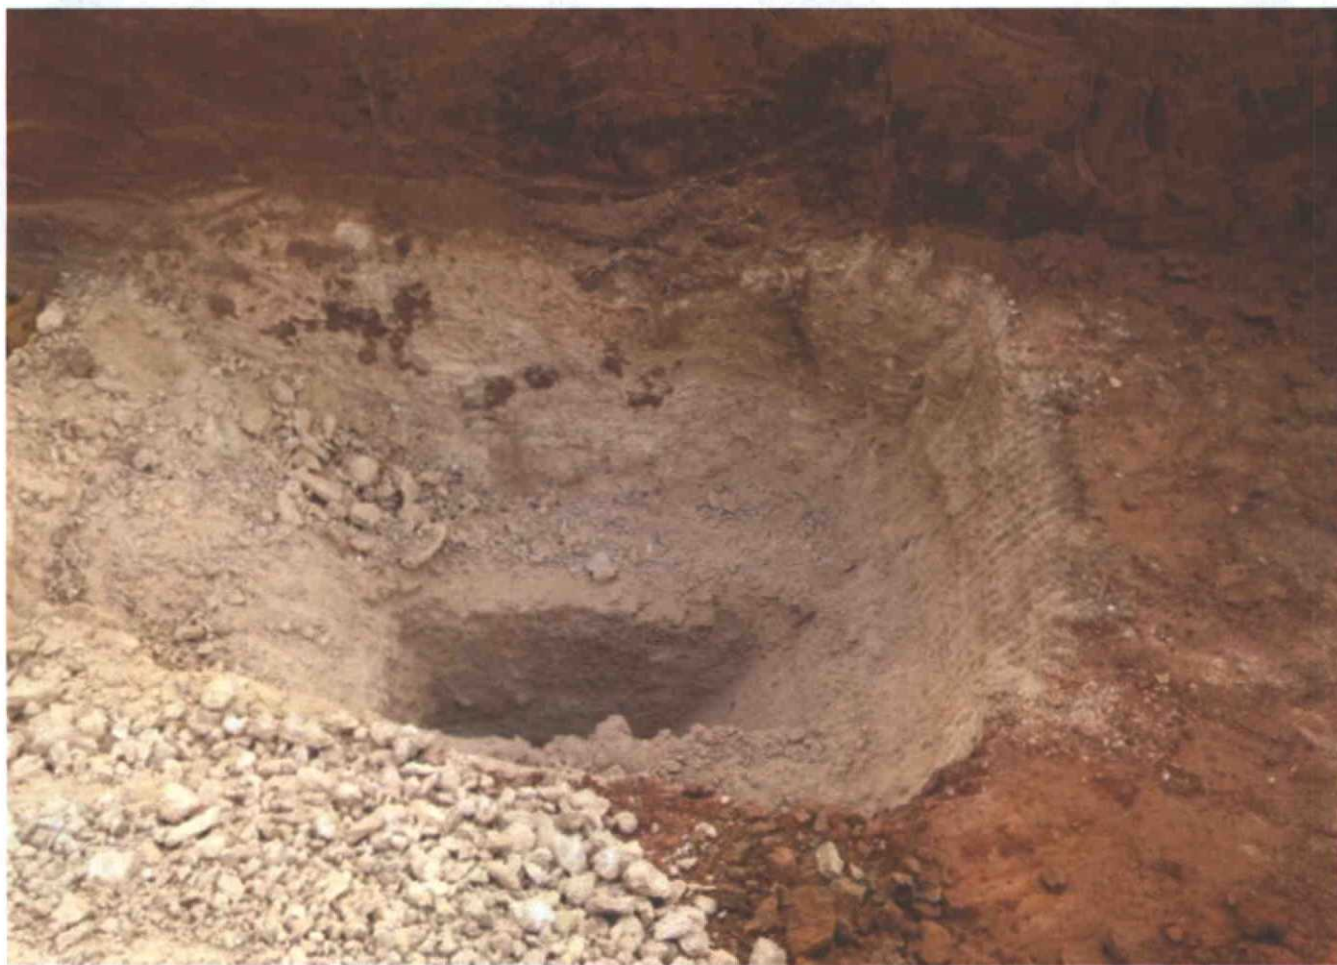
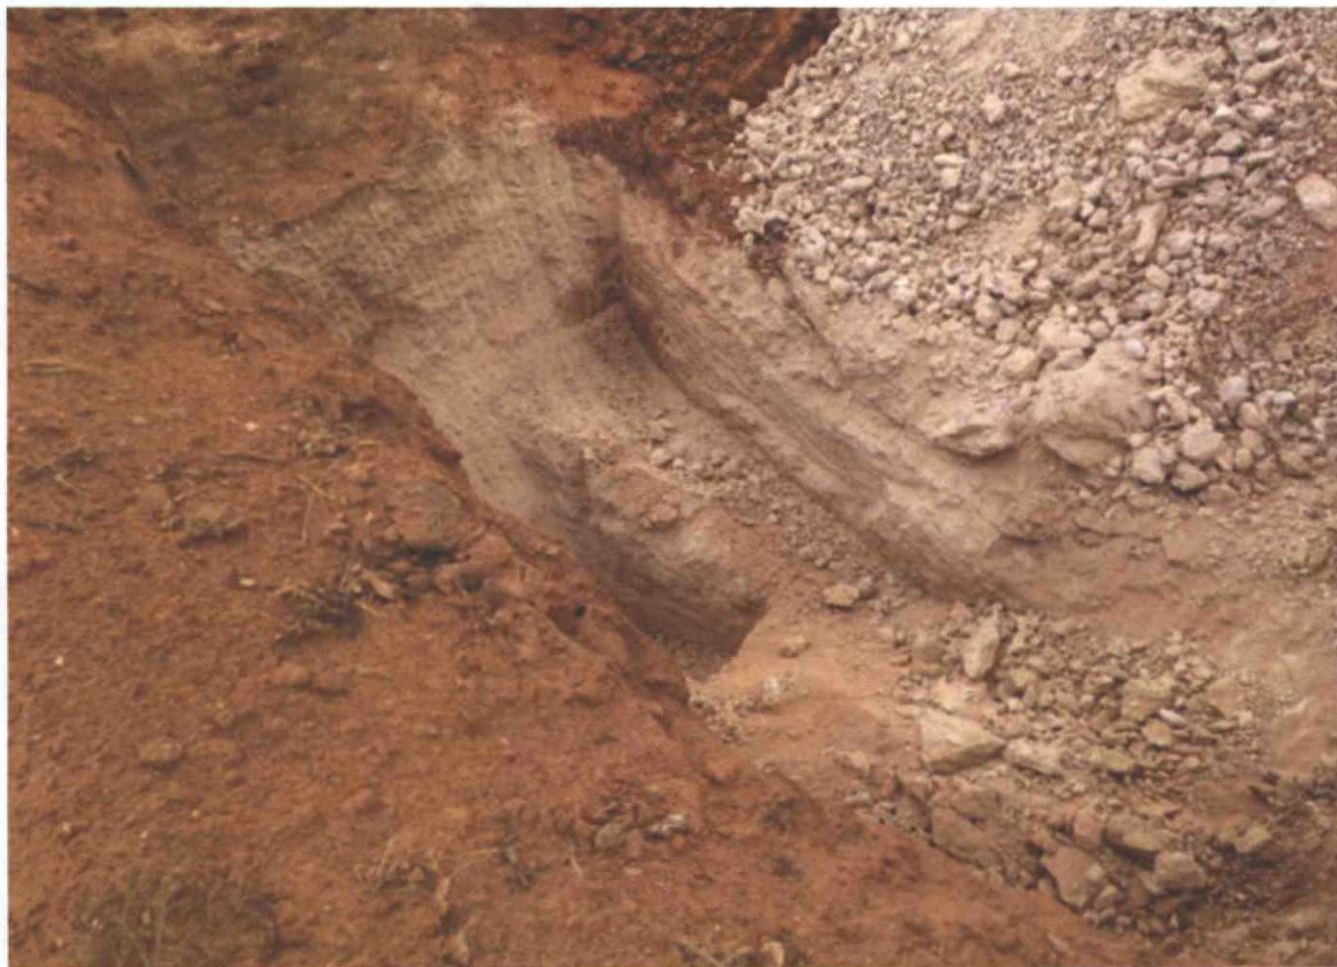
REGISTRY TRUNK 0 #5

CONDITION OF ABANDONED LINE
