RE: M-14 Leak Corrective Action Plan Justis Salt Water Disposal System UL/M SEC 14 T24S R37E

CORRECTIVE ACTION PLAN

Justis M-14 Release Unit 'M', Sec, 14, T17S, R35E

Justis M-14 Leak Site

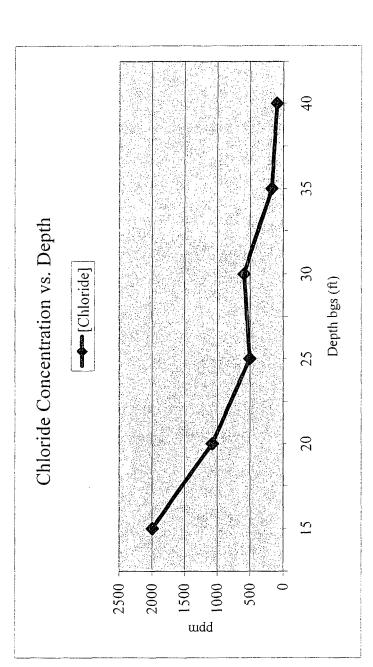
Soil Bore Delineation Field Tests

[CI] ppm	1994	1076	507	595	176	100
Depth bgs (ft)	15	20	25	30	35	40

Groundwater = 79 ft

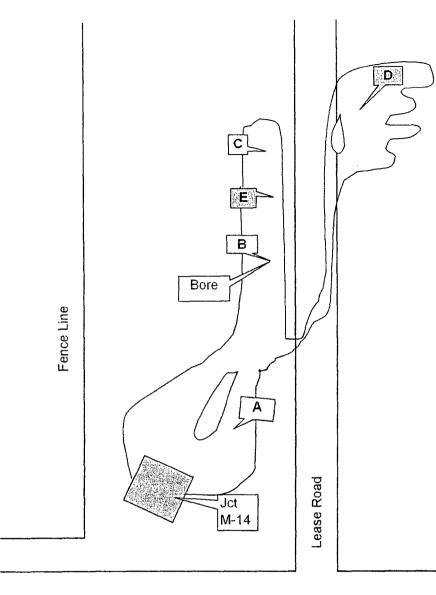
Backhoe Samples 10/31/05										
SP A		SF	°В	SP C		SF	D	SP E		
Depth	ppm	Depth	ppm	Depth	ppm	Depth	ppm	Depth	ppm	
1'	379	1'	856	1'	97	1'	730	1'	1046	
2'	835	2'	1568	2'	147	2'	609	2'	370	
3'	1040	3'	1181	3'	108	3'	1128	3'	754	
4'	1336	4'	1061	4'	177	4'	1559	4'	710	
5'	3080	5'	937	5'	116	5'	1844	5'	881	
6'	2795	6'	1131	6'	124	6'	1698	6'	763	
7'	3258	7'	1534	7'	142	7'	2321	7'	878	
8'	1815	8'	2464	8'	n/a	8'	2633	8'	373	
9'	1409	9'	2217	9'	n/a	9'	2077	9'	647	
10'	1623	10'	1718	10'	n/a	10'	1869	10'	402	
11'	1686	11'	2074	11'	n/a	11'	1734	11'	671	
11.5'	1458	12'	1560	12'	n/a	12'	1179	12'	547

Soil B	ore 12/	12/05
Depth	ppm	Lab
10-15'	1994	
15-20'	1076	
20-25'	507	l
25-30'	595	
30-35'	176	92
35-40'	100

- 1. ROC will give driving directions to the contact company that will be performing the site restoration to submit a One-Call for pipeline location.
- 2. Areas highly impacted will be excavated to 3 ft, which is well below the root zone. These soils will be hauled to a NMOCD approved disposal facility.
- 3. Lower concentrations will be blended on site to concentrations that will support the growth of native vegetation.
- 4. ROC will haul in clean topsoil.
- 5. The topsoil will then be tilled and seeded with a blend of native vegetation. Fertilizer and water will be added as needed.
- 6. ROC will continue to monitor the site in the future for regrowth of vegetation.
