**3RP - 1024**

**DJR OPERATING, LLC**

## Release Notification

Site Name <b>Ciniza Pipeline S13-T25N-R13W</b>	Site Type <b>Pipeline</b>
Date Release Discovered <b>9-11-2018</b>	API# (if applicable) <b>N/A</b>

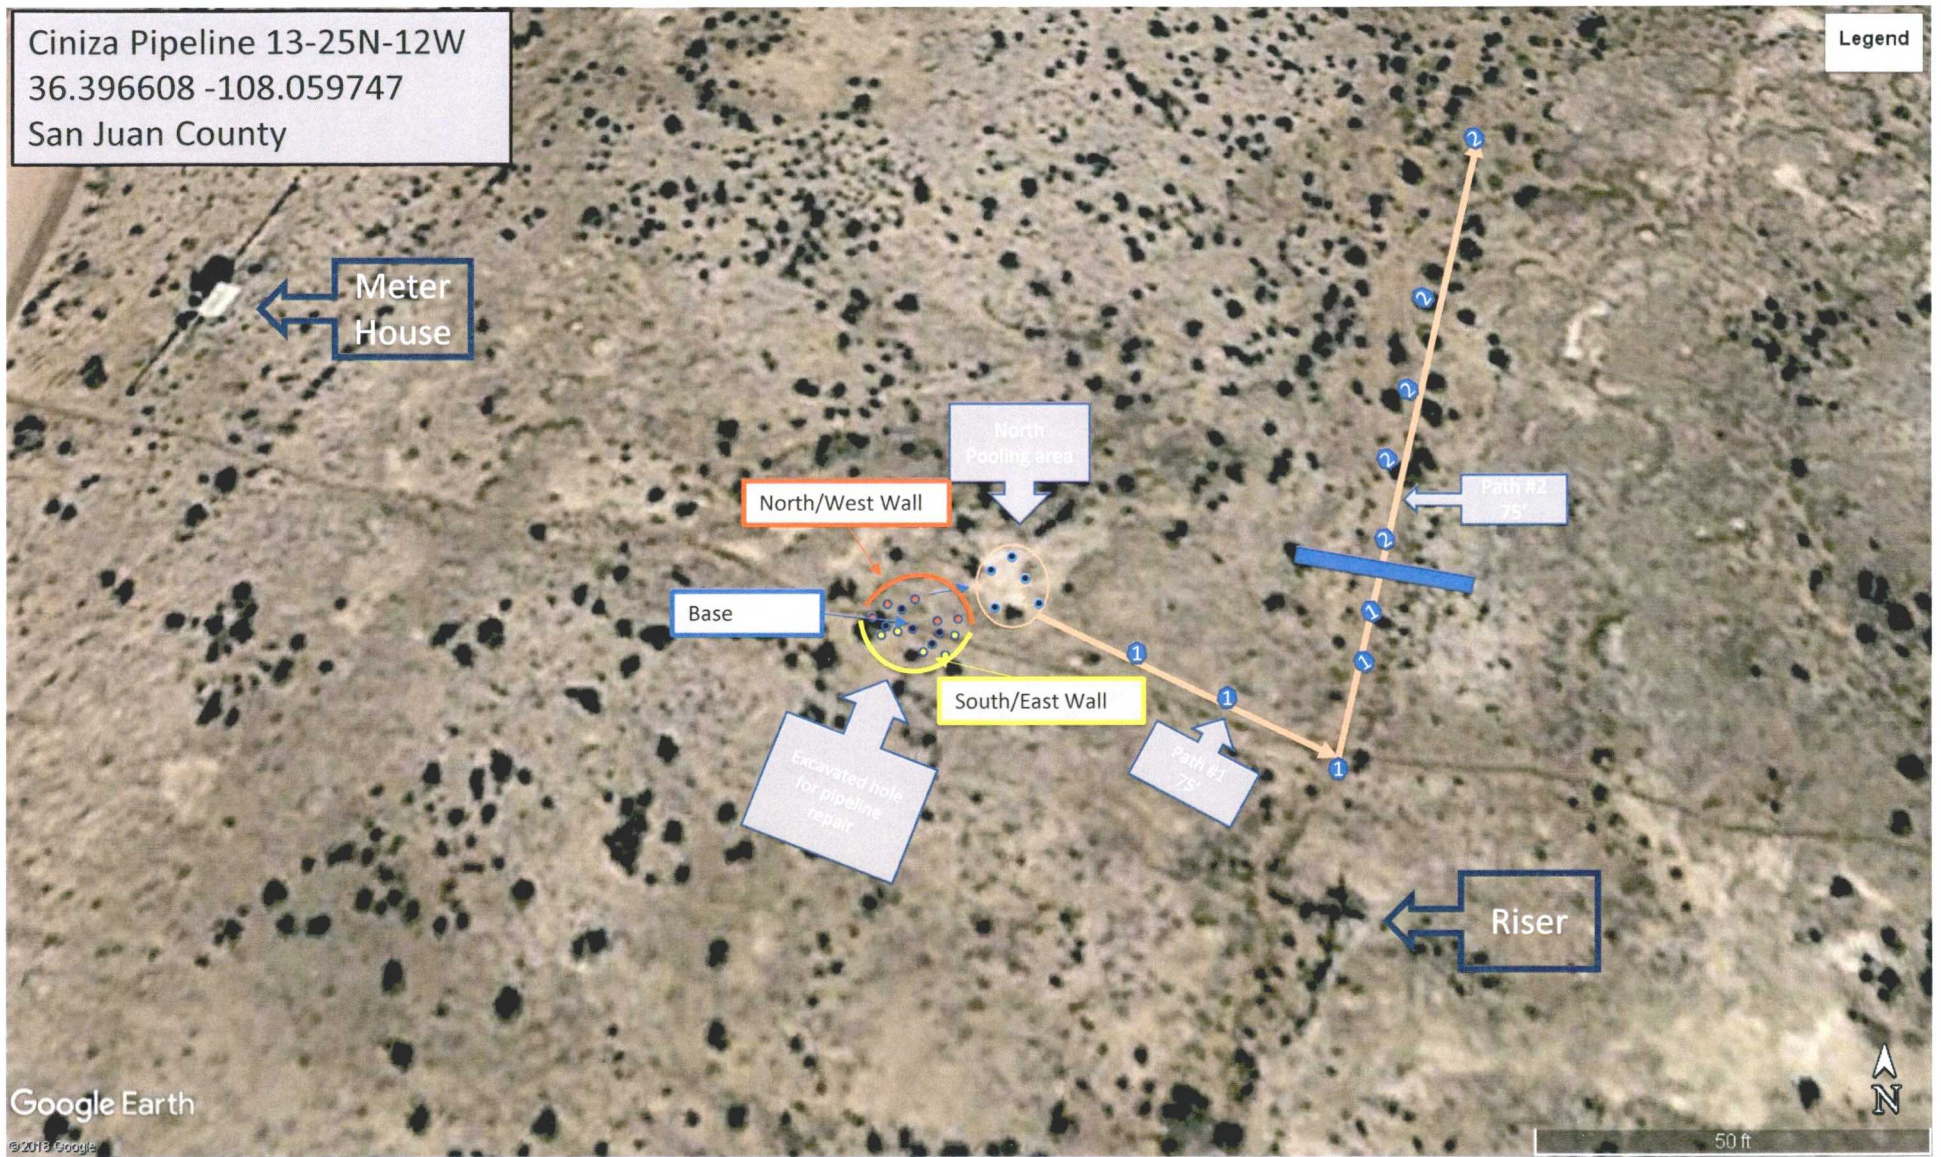
Ciniza Pipeline 13-25N-12W  
36.396608 -108.059747  
San Juan County

Excavated hole for pipeline repair
