Release Notification and Corrective Action

Name of Company	Southern Union Gas Services, Ltd.	Contact	Tony Savoie
Address	P.O. Box 1226 Jal, N.M. 88252	Telephone No.	505-395-2116
Facility Name	Lea County Field Dept.	Facility Type	Natural Gas Gathering

Wantz Compressor Station

#2006-056

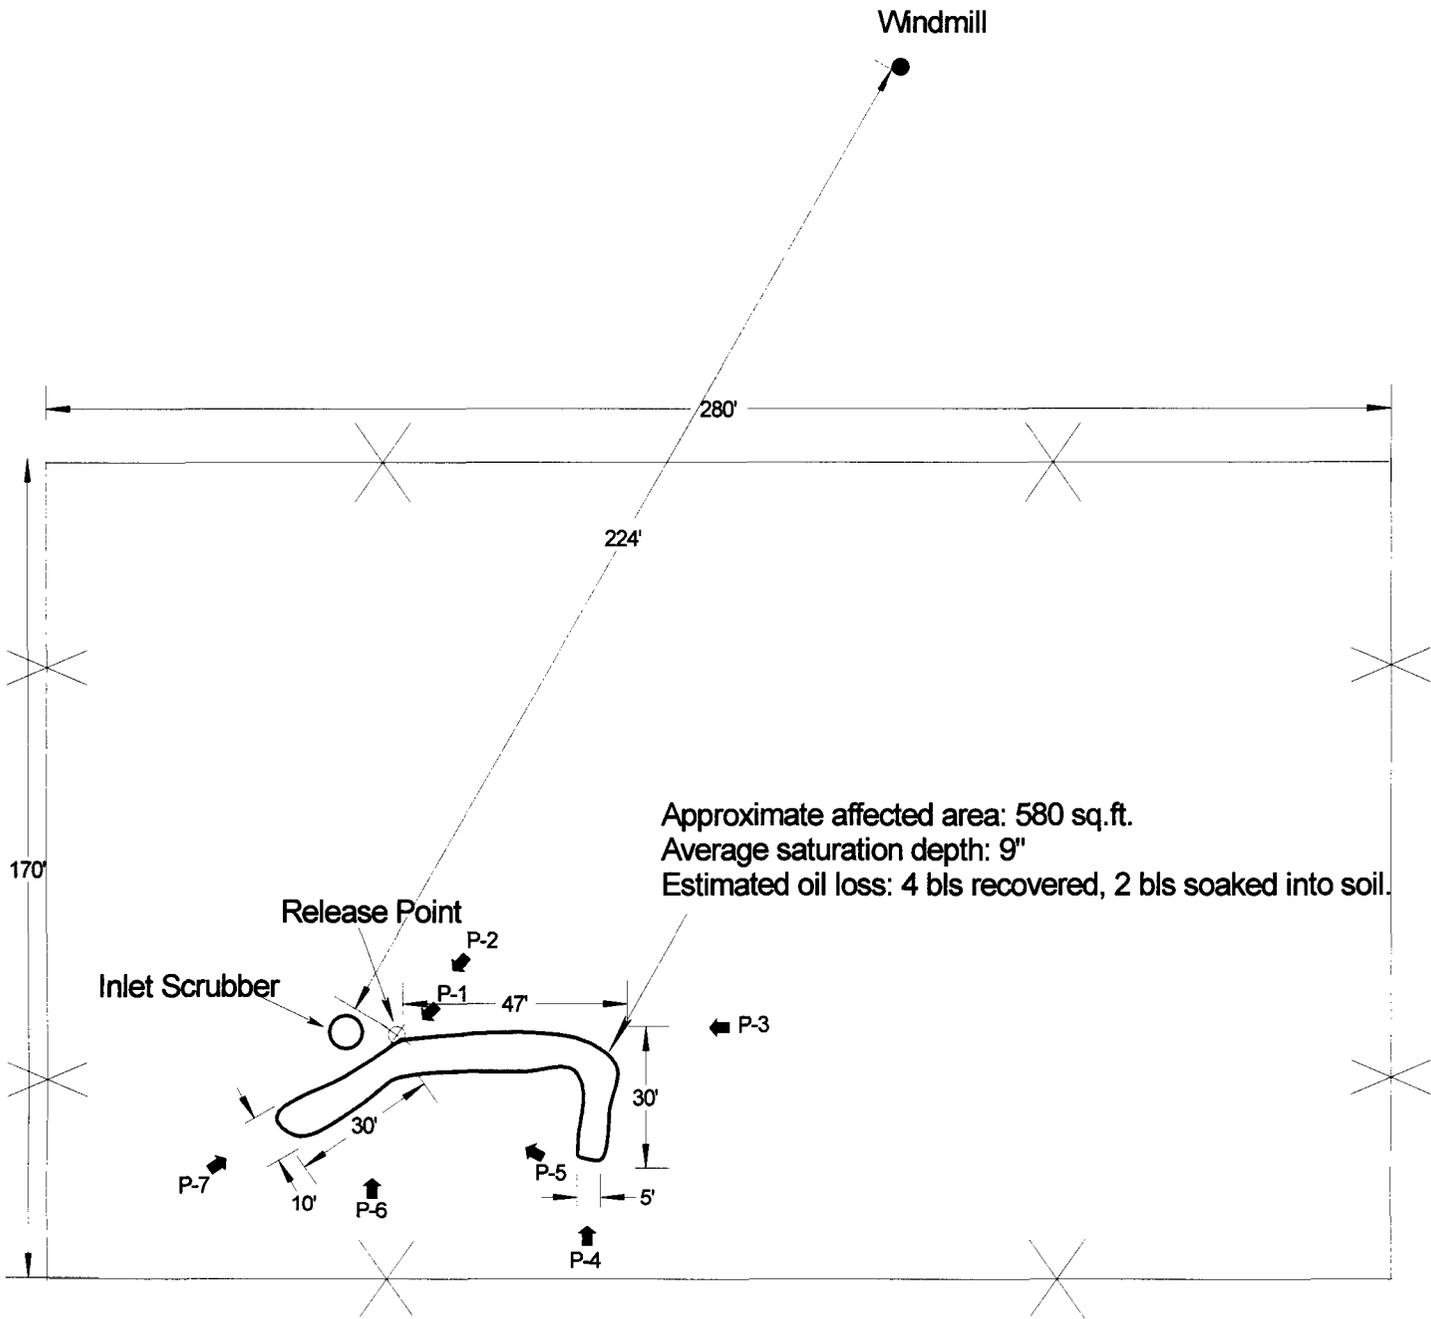
Figure 1

SITE PLAN: Wantz Compressor Station

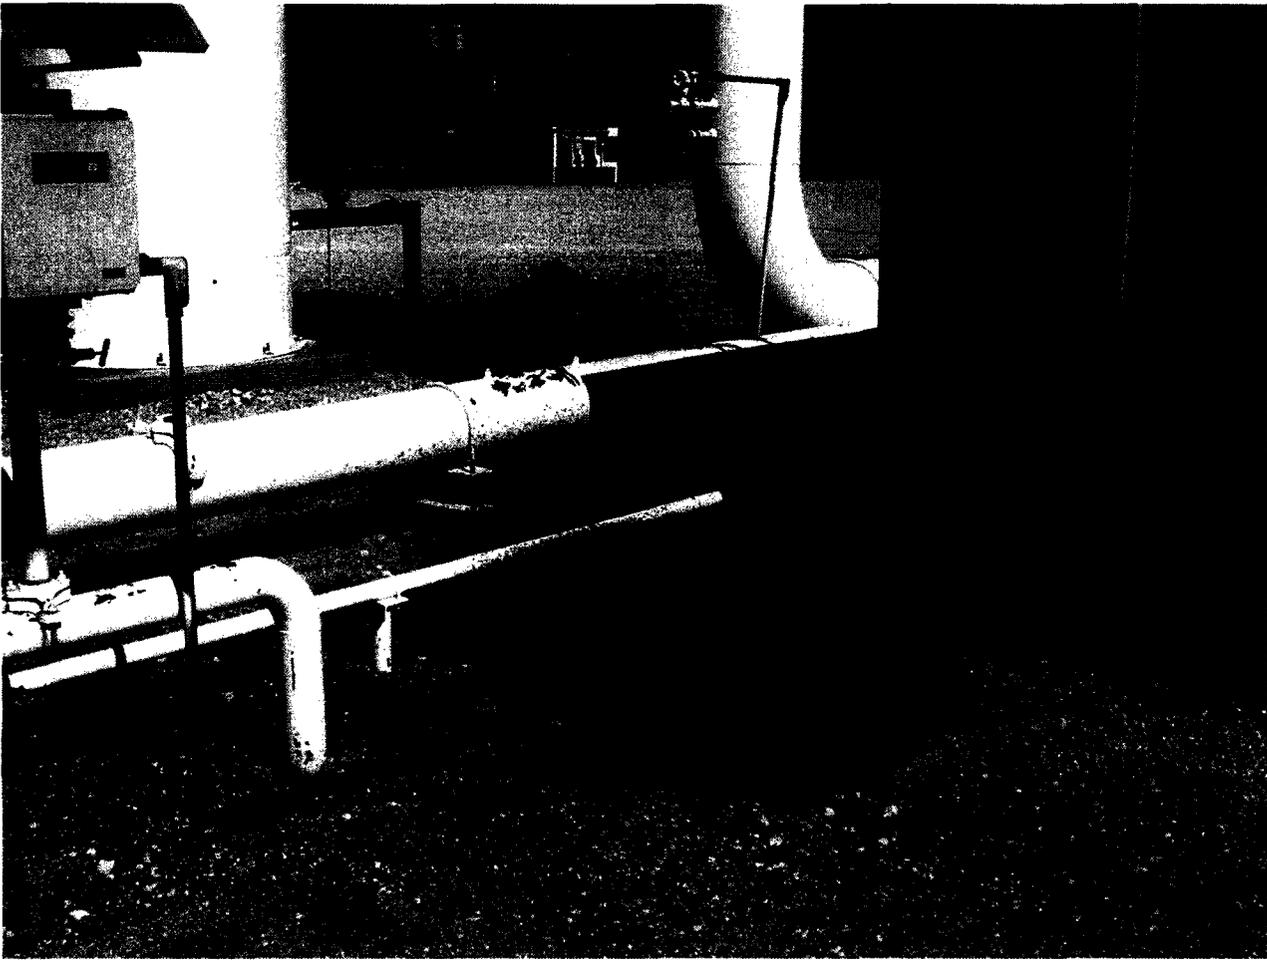
Photo 7

Southern Union Gas Services Site: Wantz Compressor
Job #2006-056 Before Remediation 11/15/06
