Release Notification and Corrective Action

Name of Company	Southern Union Gas Services, Ltd.	Contact	Tony Savoie
Address	P.O. Box 1226 Jal, N.M. 88252	Telephone No.	505-395-2116
Facility Name	Lea County Field Dept.	Facility Type	Natural Gas Gathering

RP# 1063

Site Plan-2C 8"

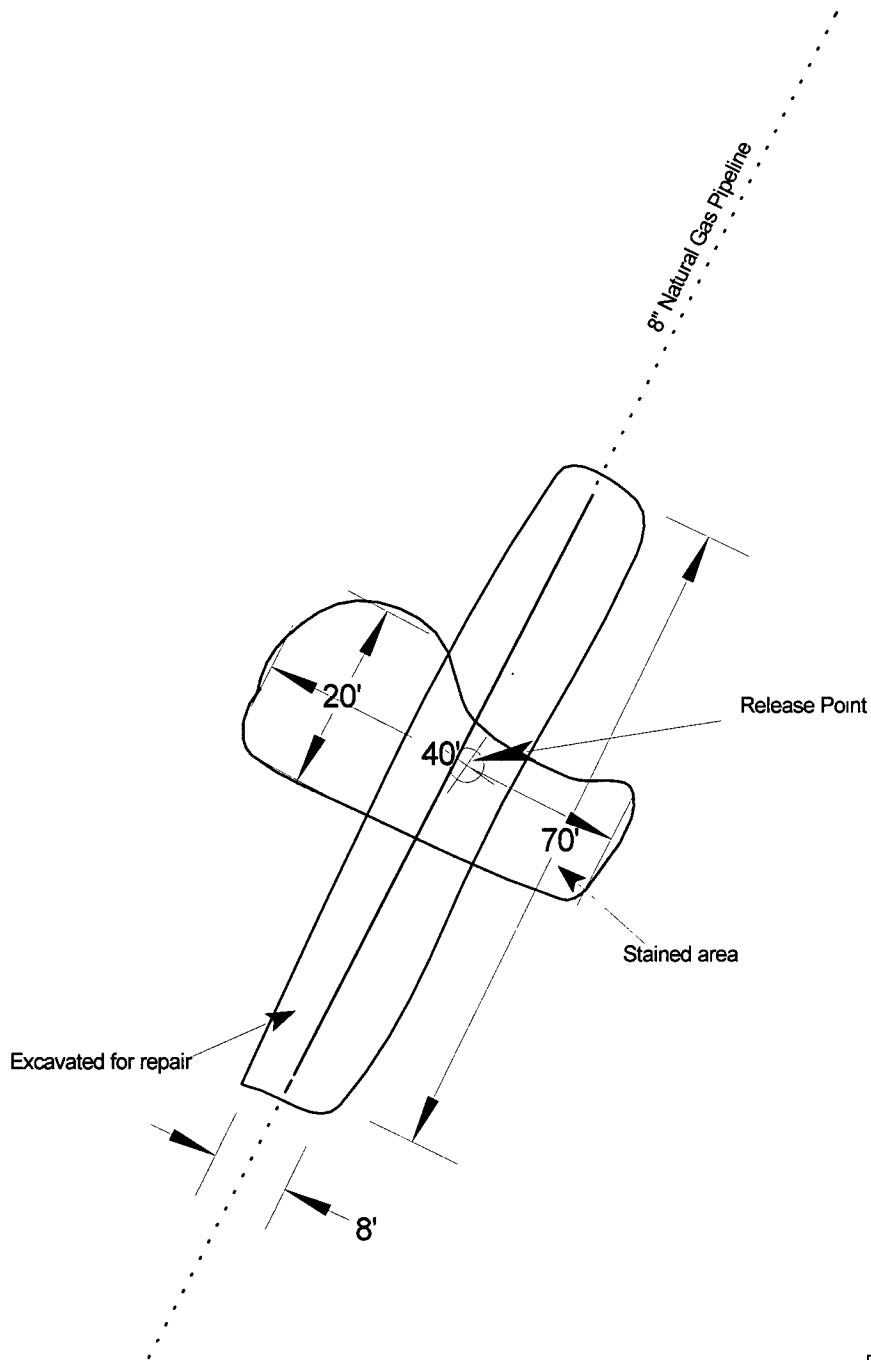
Figure 1

The 8" steel gathering pipeline, operating at 25 psi developed a leak, the line was excavated and the affected area was replaced with approximately 45 ft. of 8" poly pipe. Approximately 40 bbls of pipeline liquids were recovered at the time of the response and repair operations. Normal operating pressure on the line is 20-psi to 30-psi, with a potential H2S content of 4000-ppm.

Describe Area Affected and Cleanup Action Taken. The affected area is pasture. An area covering approximately 800 sq. ft. was affected by the release and response activities. Remediation activities will start after the landowner has approved the remediation plan. All remediation activities will follow the NMOCD Recommended Guidelines For The Remediation of Leaks and Spills.

Remediation Plan:
All affected soil will be excavated and sampled for the presence of Hydrocarbons EPA method (8015M)
Soil with TPH values greater than 100 mg/kg with will be transported to the Southern Union Gas
Landfarm or remediated on site following the NMOCD guidelines for the remediation of leaks and spills.
Soil samples will be collected from the excavation and analyzed for Hydrocarbons EPA method (8015M)
All samples will be field screened with a "PID" The soil sample with the highest PID reading will be
analyzed separately and tested for BTEX.
