SITE CLOSURE REPORT (FINAL)

DK #5 TANK BATTERY

NMOCD REF: #1RP-1485

EPI REF: #160264

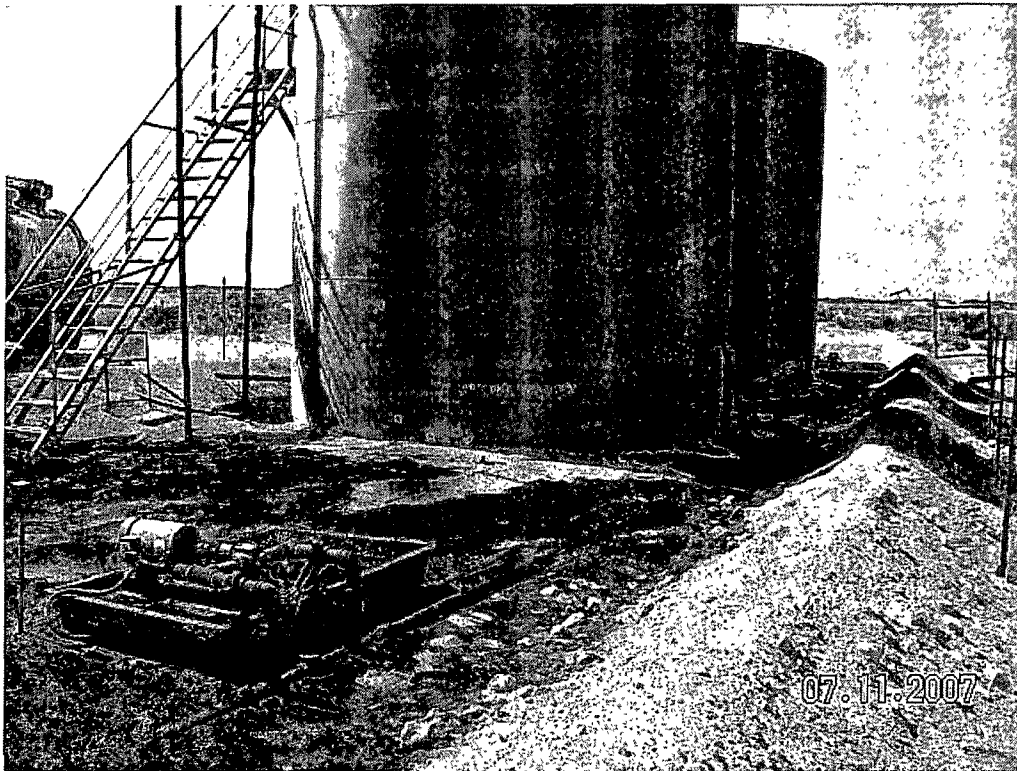
Photograph #2 – Looking southerly across release area contained within the tank battery confines.

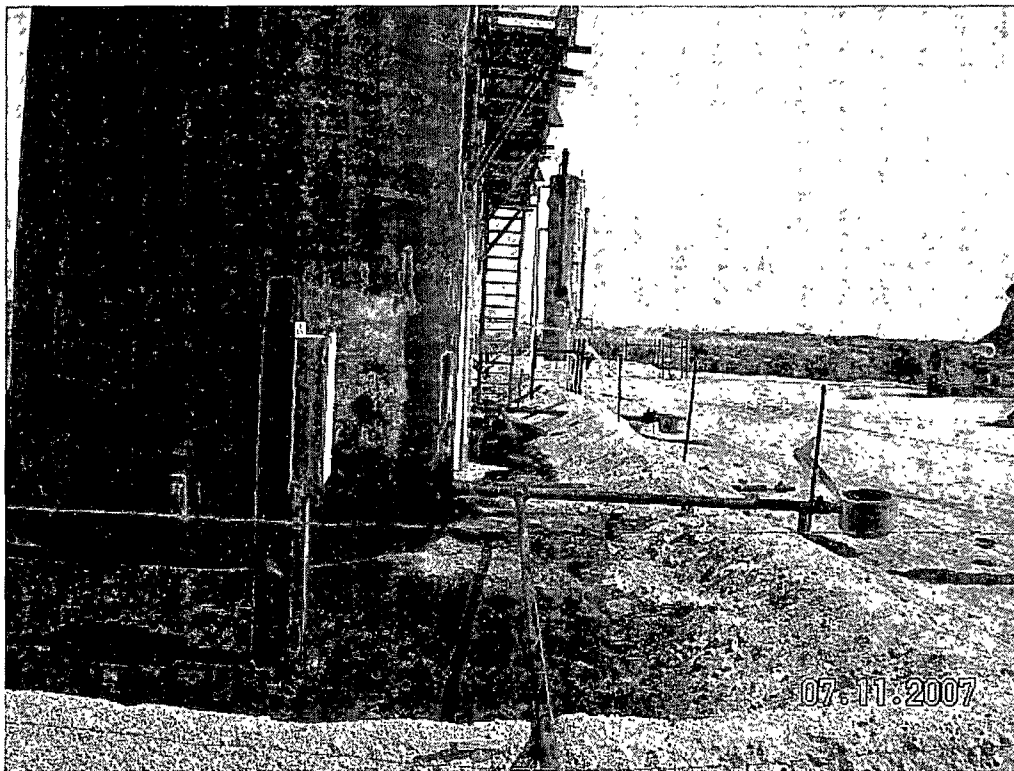
Photograph #3 – Looking northerly across release area contained within the tank battery confines.

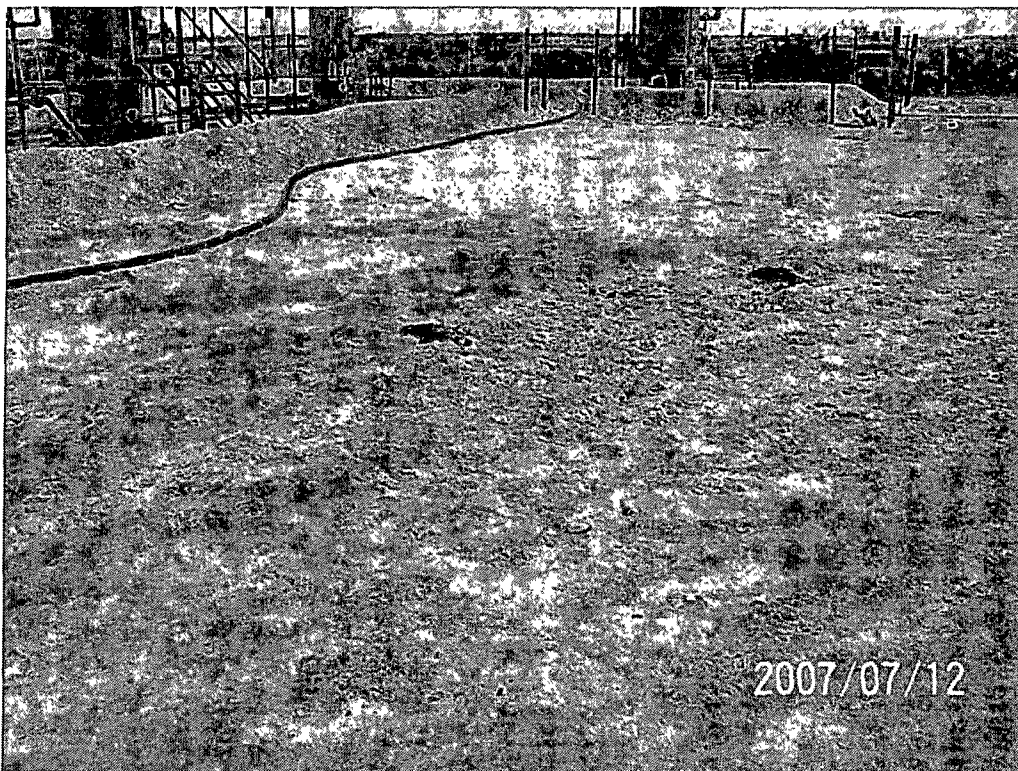
Photograph #4 – Looking westerly across release area outside the tank battery confines. Dark soil indicates contamination.

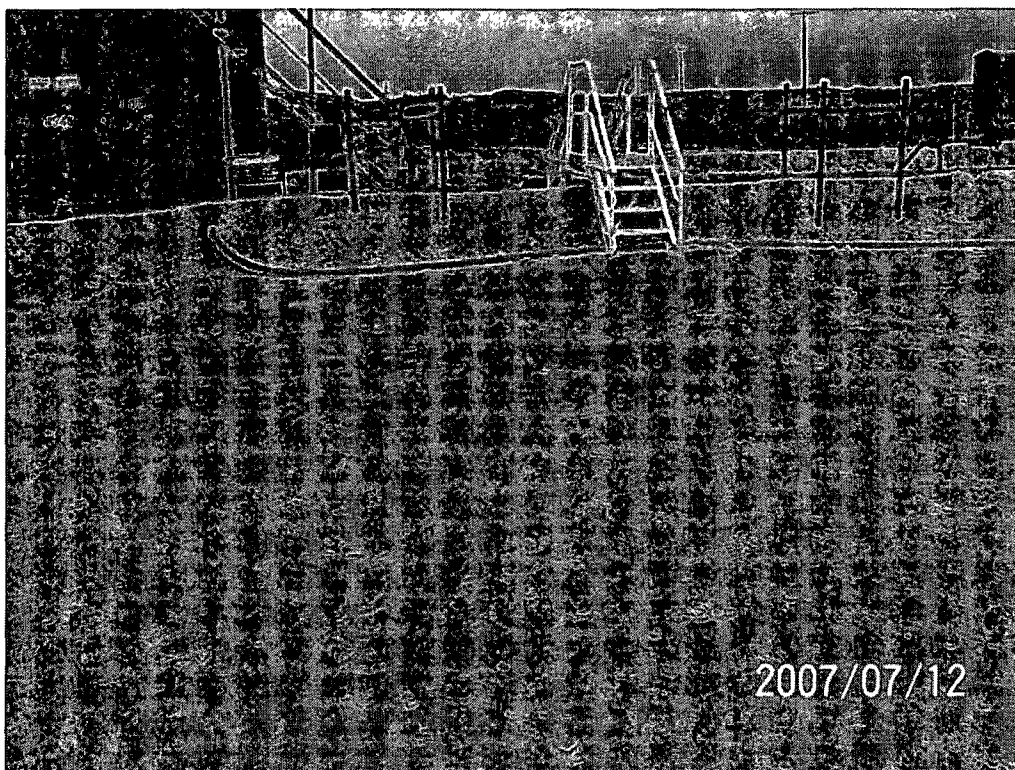
Photograph #5 – Looking westerly across release area outside the tank battery confines. Dark soil indicates contamination.

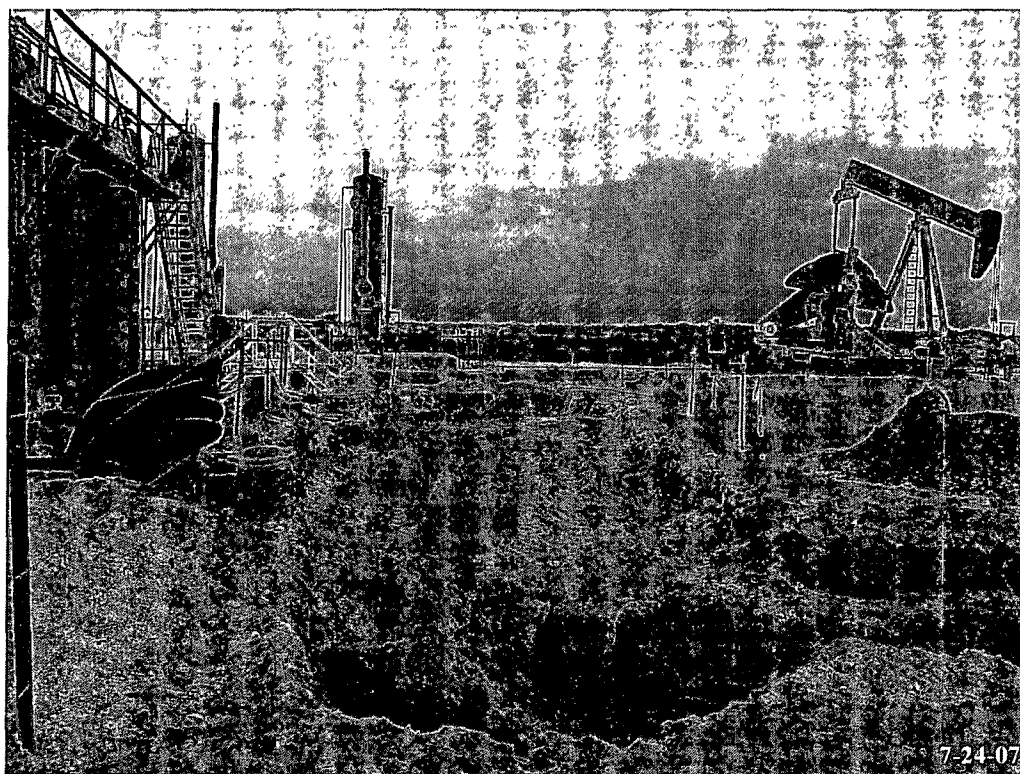
Photograph #6 – Looking north across caliche pad excavation.

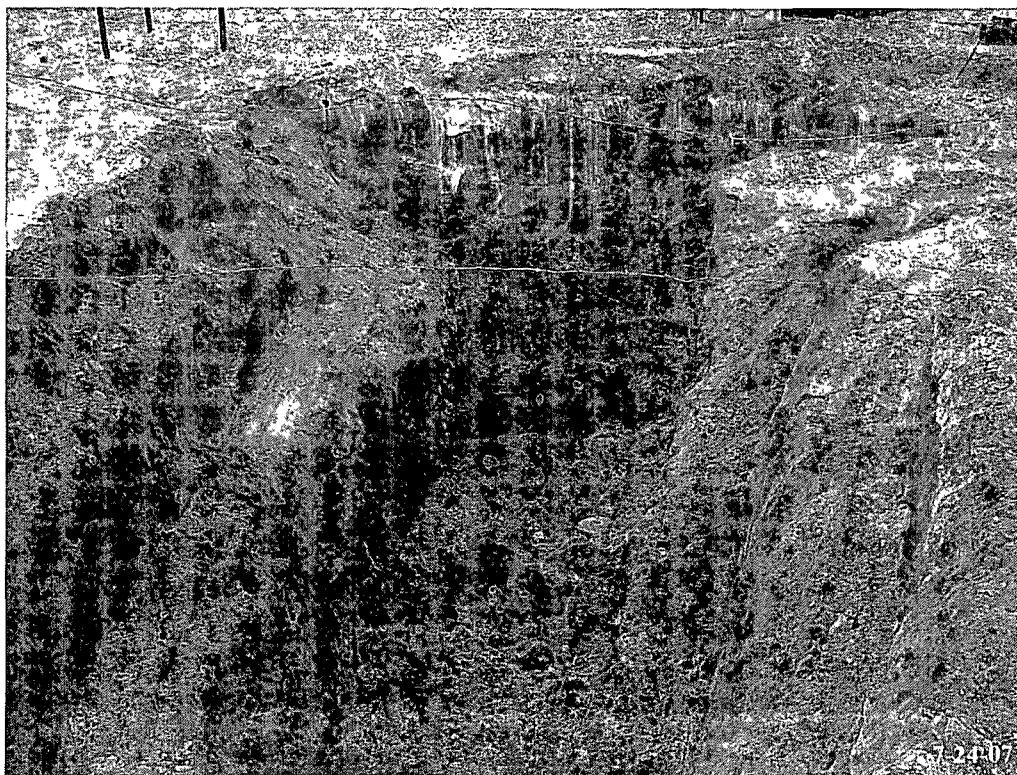
Photograph #7 – Looking westerly across caliche pad excavation.

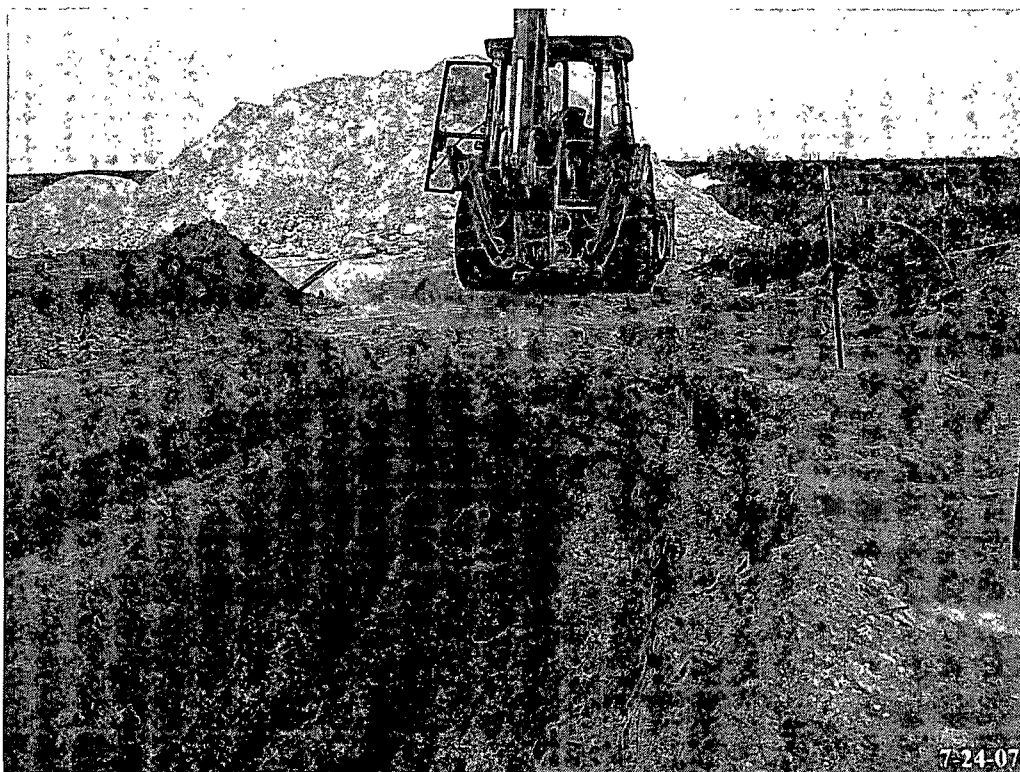
Photograph #8 – Looking east across caliche pad excavation.

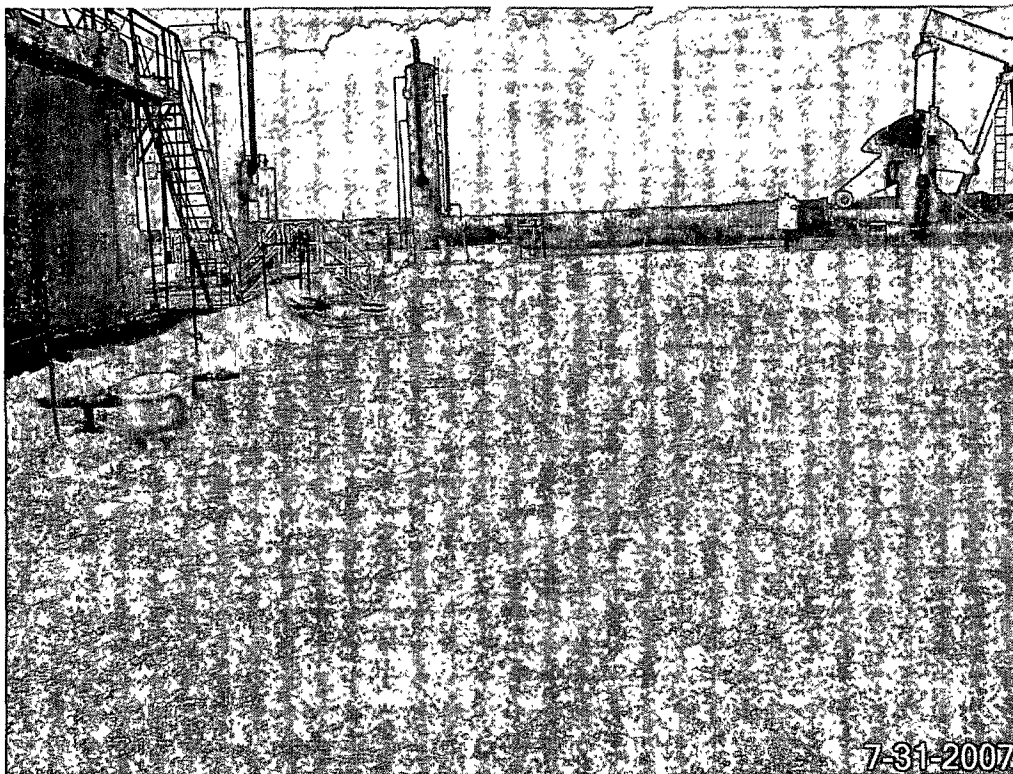
Photograph #9 – Looking north across remedial site.

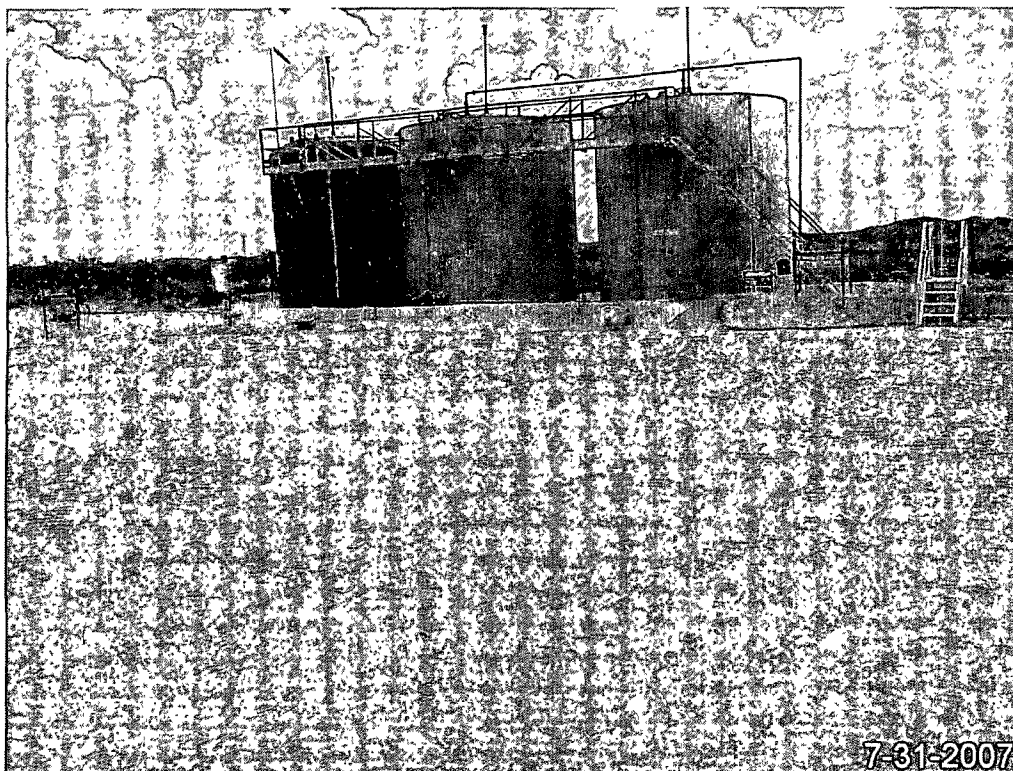
Photograph #10 - Looking west across remedial site.

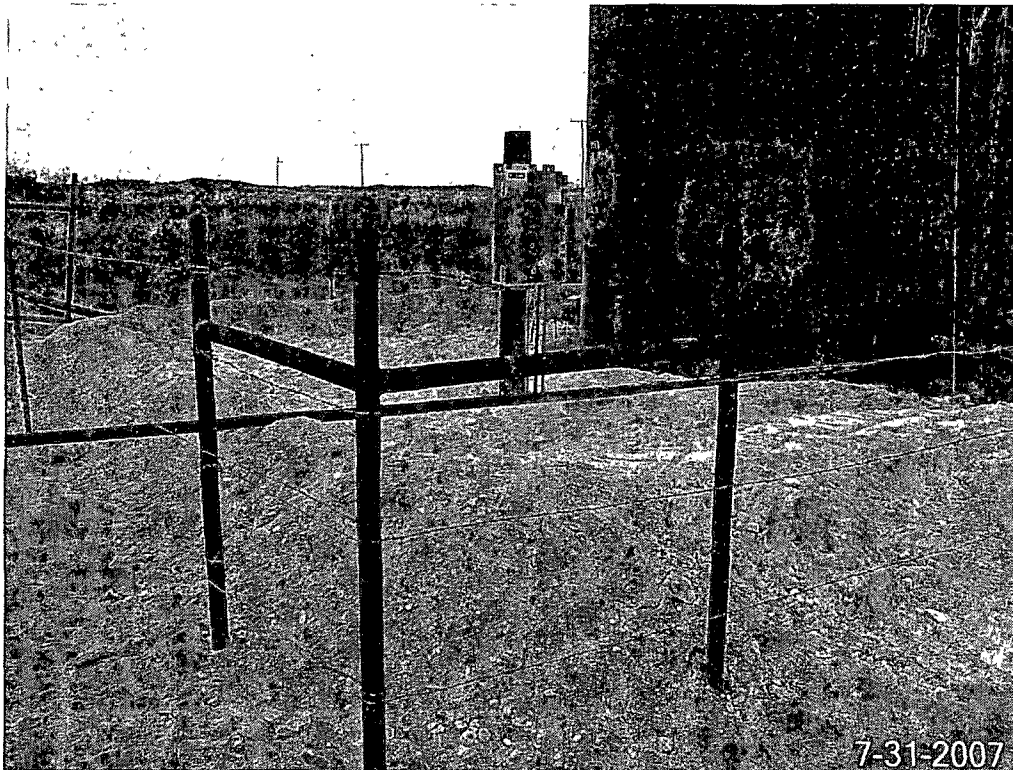
Photograph #11 – Looking northeast across remedial area within the tank battery confines
