Release Notification and Corrective Action

**Fasken Oil and Ranch, LTD.
Denton SWD #5
Delineation Report/Work Plan
Unit N, Section 2, Township 15S, Range 37E
Lea County, New Mexico**

September 12, 2007

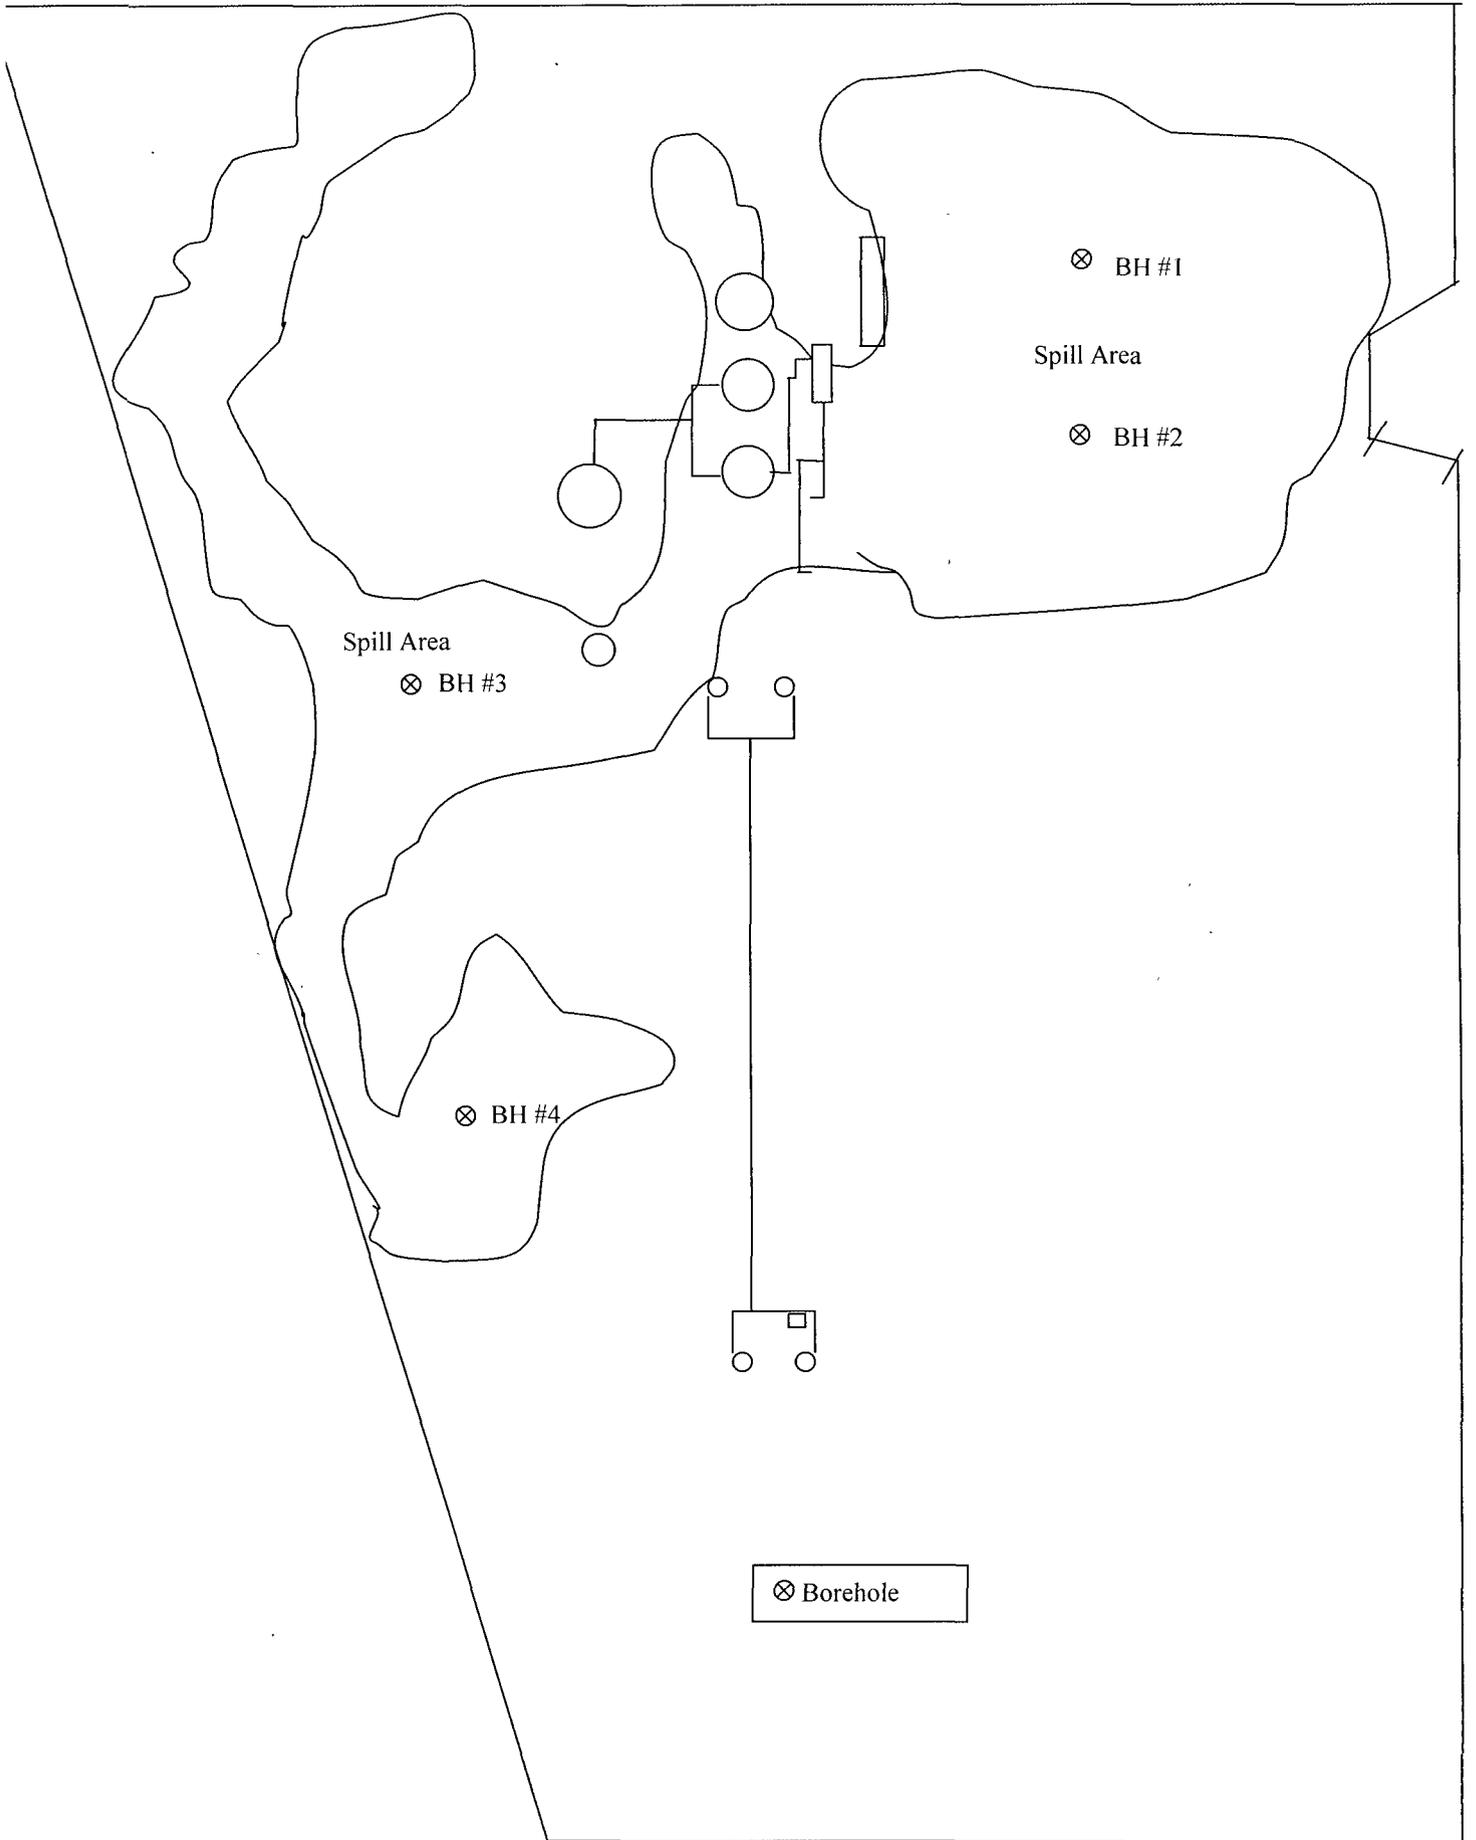
**Figure 2
Site Plan**

On August 29, 2007 SESI installed four (4) soil borings inside the spill area to determine the vertical extent of contamination. Borehole #1 was drilled to a depth of 20', Borehole #2 was drilled to a depth of 15' and Boreholes #3 and #4 were drilled to a depth of 10'. Samples were retrieved in 5' intervals from all boreholes. All samples were properly preserved and transported under Chain of Custody to Argon Laboratories of Hobbs, New Mexico for analysis. The samples were analyzed for Total Petroleum Hydrocarbons (EPA Method 418.1), BTEX (EPA Method SW-846-8260), and Chlorides (EPA Method 4500-Cl⁻B).

It is proposed that a cosmetic cleanup, consisting of the removal of the top 12"-15" inches of soil, be performed around the tank battery. The remaining spill area will be excavated for the removal of the most highly contaminated and/or saturated material. The excavated soils will be transported to an NMOCD approved facility for disposal. The excavations will then be backfilled with clean soils.
