Release Notification and Corrective Action

Name of Company Occidental Permian Limited Partnership	Contact Steven M. Bishop
Address 1017 West Stanolind Road, Hobbs, N.M. 88240	Telephone No. (505) 397-8251
Facility Name South Hobbs Unit Injection System	Facility Type Production

RE: Remediation Plan
South Hobbs Unit 8" Injection Trunk line
from Central T/B to Injection Building #1
UL 'K', Sec. 4, T-19-S, R-38-E

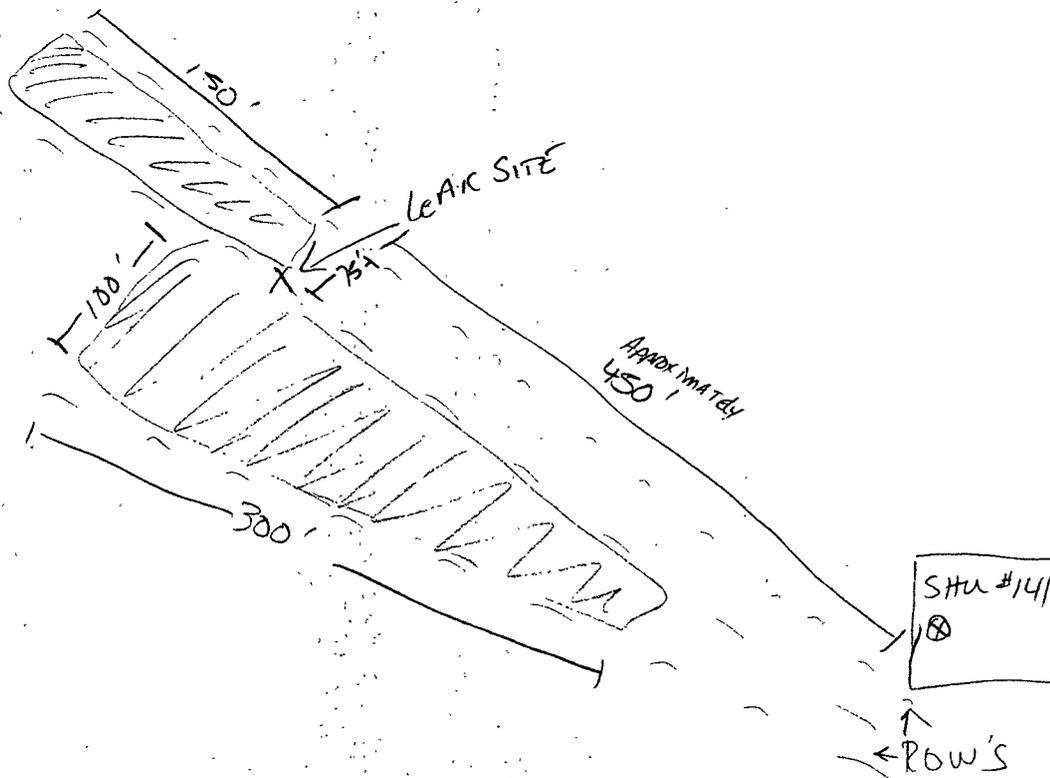
SPILL MAP

SOUTH HOBBS UNIT INJECTION TRUNKLINE
8" Cement lined pipe
10/03/2007 2:30 PM
estimate 2 BOX 250 BW
Ø Recovered
150yds NW OF SHU # 141

SHU
SATELLITE
#5
