GW - 156

Re: Response to Inspection Report, GW-156
Key Energy Services facility, 5651 US Highway 64
San Juan County, New Mexico

**Re: Inspection Report, GW-156
Key Energy Service facility, 5651 U.S. highway 64
San Juan County, New Mexico**

OCD Inspection Key Energy 5651 U.S. Hwy., GW - 156

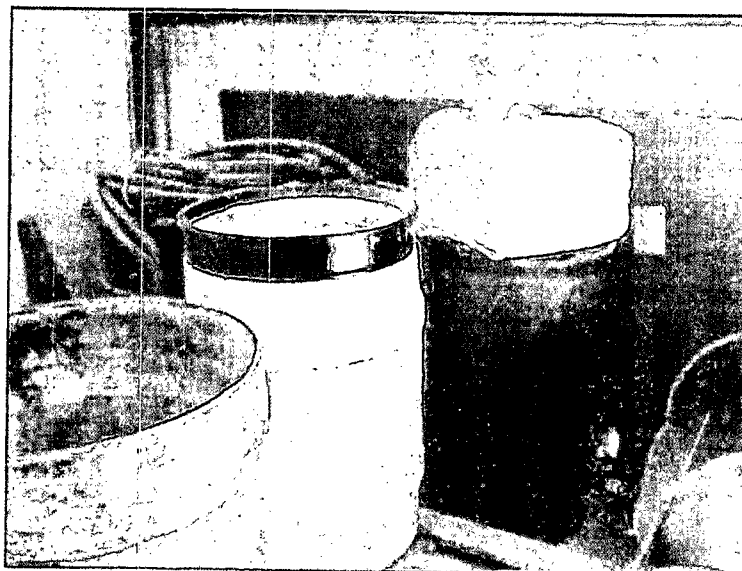
OCD Photo 1: Unlabeled barrels.

1. Photo 1 - 3: All containers should be identified for their specific contents. If containers are empty they shall be noted as so.
2. Photo 5: Drain/sump needs to be cleaned and inspected. It is unclear where this sump drains to. Key Energy needs to identify the engineering of this sump and submit its schematic to the OCD. All underground lines shall be identified on schematic.

1. Containers identified for their specific contents or labeled "empty" by June 17, 2008. See Photos K1 and K2.
2. Drain/sump cleaned and inspected. Sumps cleaned and inspected June 17, 2008. See Photos K4 and K5. Lines were located June 19, and identified on a schematic (Figure 2). Documentation and additional photos may be found in Sump Test Record (Attachment A).

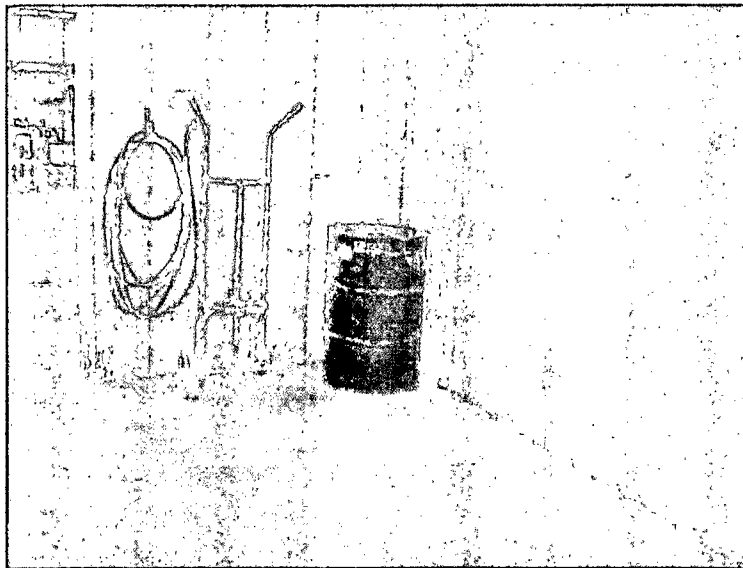
Photo K2: Trash Containers labeled

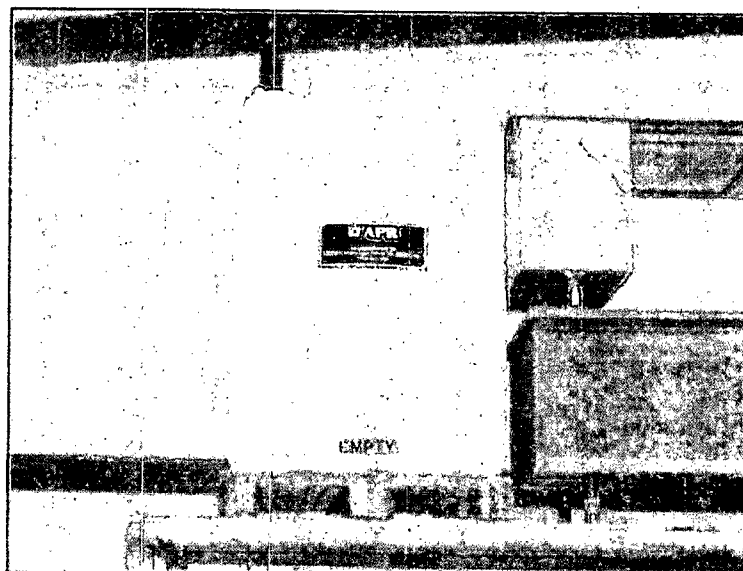
Photo K3: Empty container labeled "Empty".

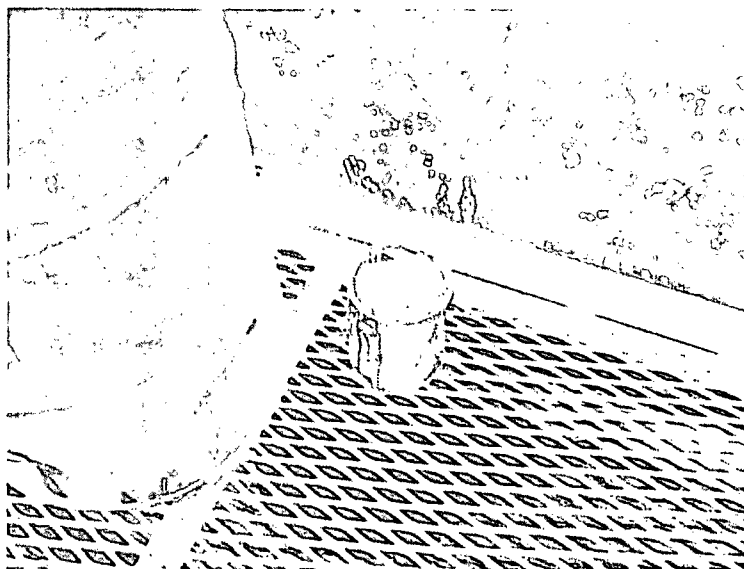
Photo 6: Unidentified substance in lube oil containment area.

3. Photo 6: All sumps without a leak detection system must be cleaned and inspected annually. Sumps with a leak detection system are to be inspected monthly. Sumps that have the potential to hold less than 500 gallons are exempt from these requirements if fluids are removed within 72 hours.

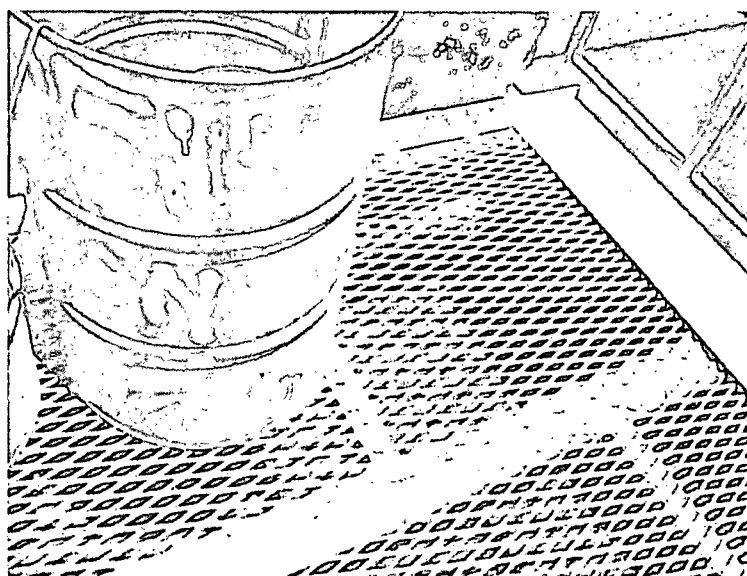
Photo K6: Dried can of paint removed.

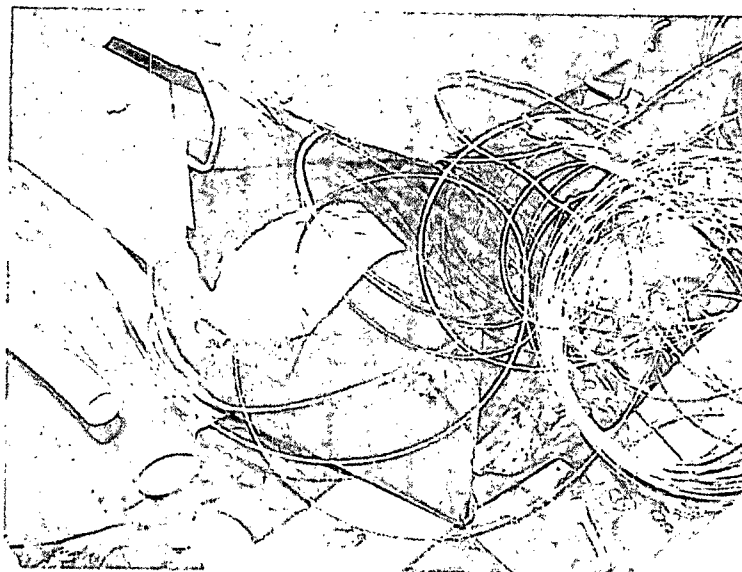
OCD Photo 7: Ensure disposed barrels are EPA cleaned before disposing.

4. Photo 7: Barrels to be disposed of at solid waste landfills and NOT an OCD landfill are to be verified EPA clean. This is only a reminder and OCD did not assume or attempt to verify these disposed barrels. All barrels/containers should be identified.

4. Key's policy is to return drums to vendors for recycling, if drum is damaged or otherwise unreturnable, the empty drum is visually verified to be RCRA clean prior to placing in a scrap bin.

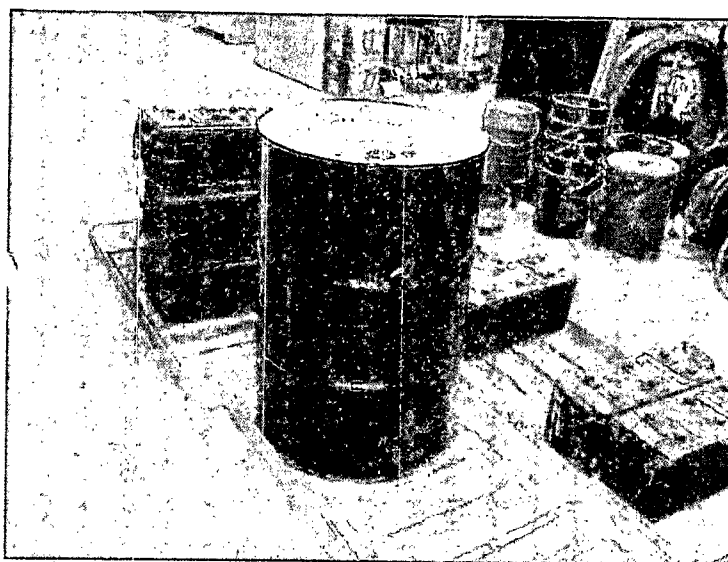
Photo K7: Undamaged barrels are returned to supply vendor for recycling.
Damaged barrels scrapped EPA RCRA clean.

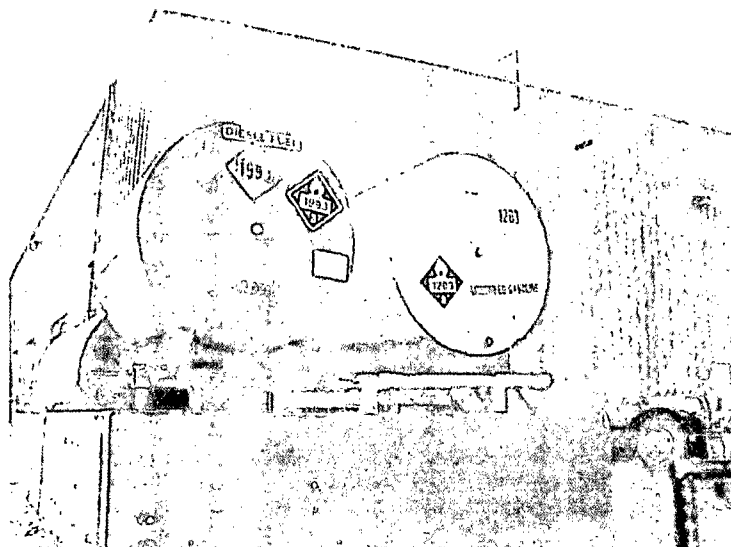
Photo K8: Tanks emptied, labeled "Empty", outlets plugged.

5. The fuel saddle tanks (500-gallon unleaded gasoline and 500-gallon diesel) were emptied, plugged, labeled "empty" and removed from service on June 25, 2008. See Photo K8.

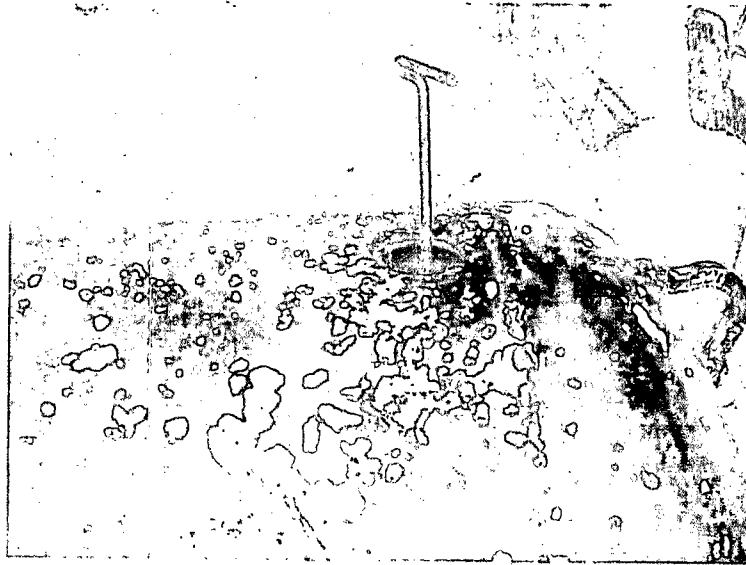
Photo 11: Used oil tank appears to be full to capacity.

6. Photo 9 - 10: Small sumps/depressions shall not hold fluids more than 72 hours.
7. Photo 11: Used oil tank appears to be full to capacity. A secondary containment is used for prevention of discharge on to the ground and not part of the primary tanks purpose of holding fluids. A secondary containment should not have any leaks. Key Energy needs to maintain a unauthorized discharge facility.

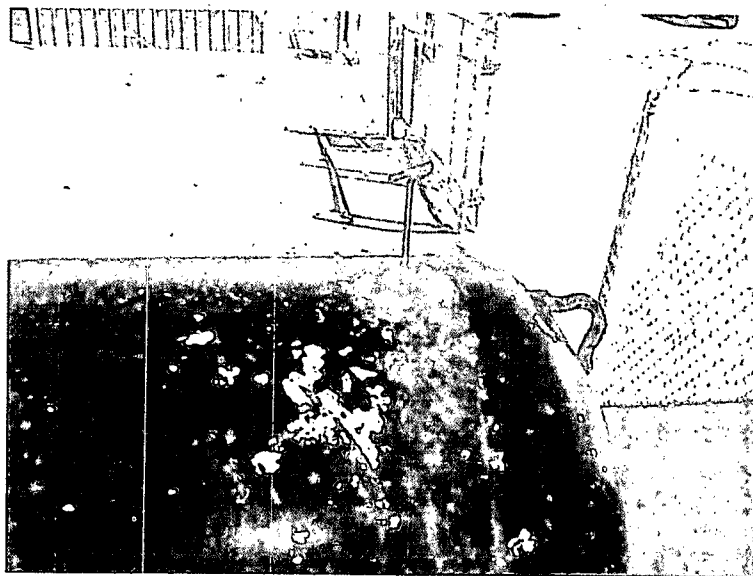
Photo K11: Safety-kleen removed oil for recycling as normally scheduled.

6. Rainwater removed. See Photo K9.
7. Used oil drained from tank for recycling by Safety-Kleen as normally scheduled. See Safety-Kleen manifest (Attachment B). Rainwater in low point shown in OCD Photo 9 removed. See Photo K9.

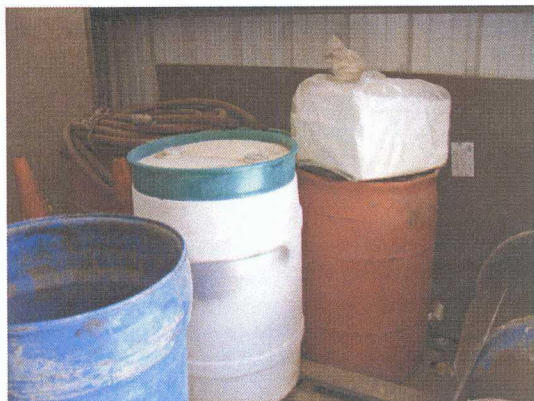
Photo 1: Unlabeled barrels.

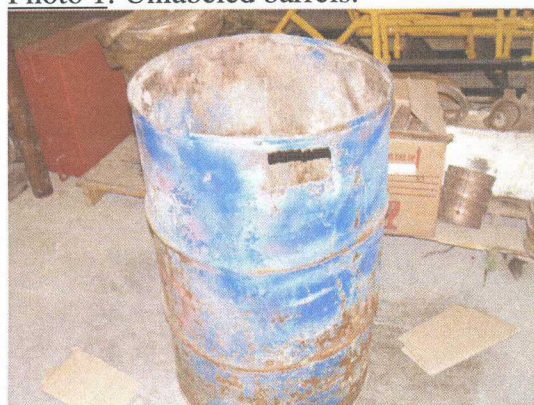
Photo 2: Unlabeled container.

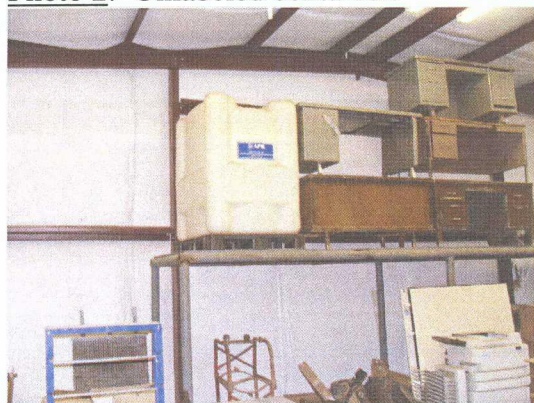
Photo 3: Unlabeled container. Annotate if empty.

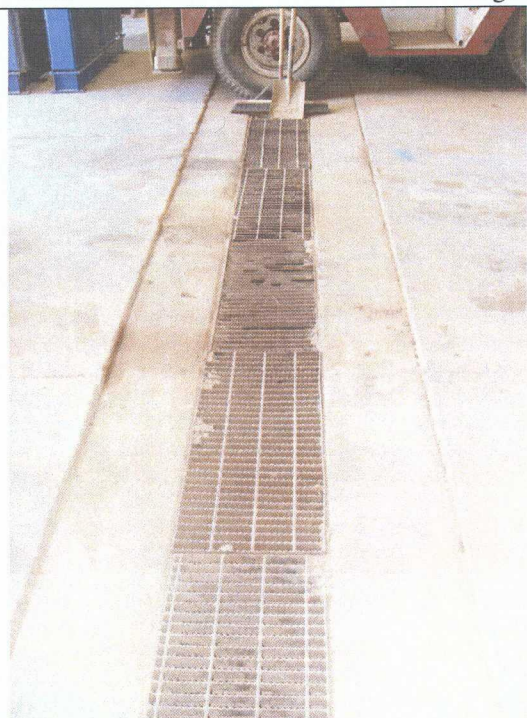
Photo 4: Drain pan area in first building supposedly drains in to a BGT. Not known. Needs to be kept cleaned and inspected.

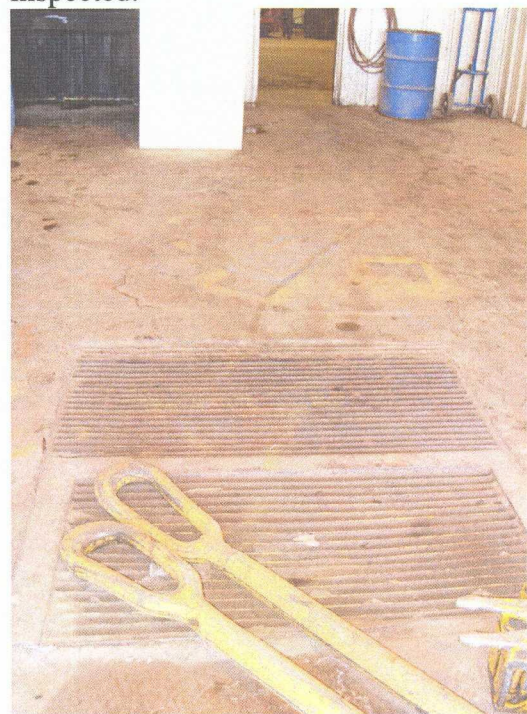
Photo 5: Sump with skimmer needs to be tested and inspected annually.

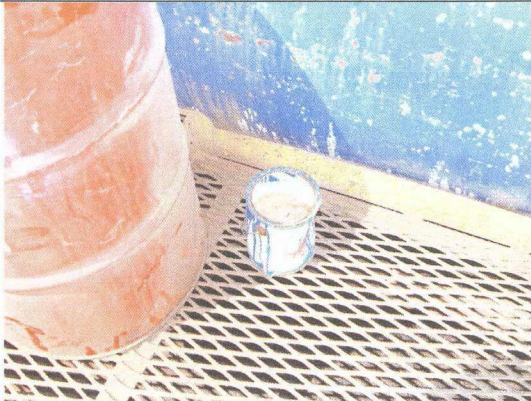
Photo 6: Unidentified substance in lube oil containment area.

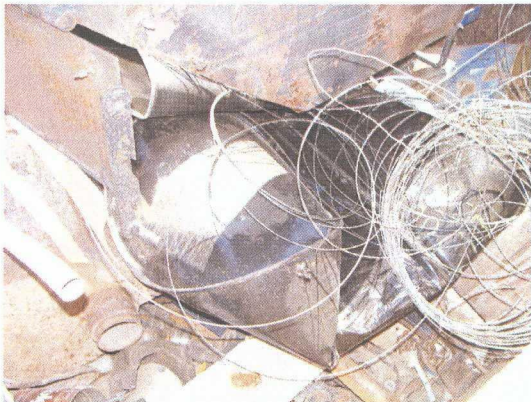
Photo 7: Ensure disposed barrels are EPA cleaned before disposing.

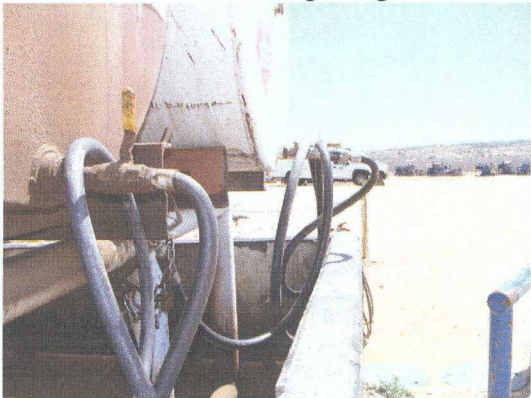
Photo 8: Saddle tank outlets need to be moved away from edge of secondary containment.

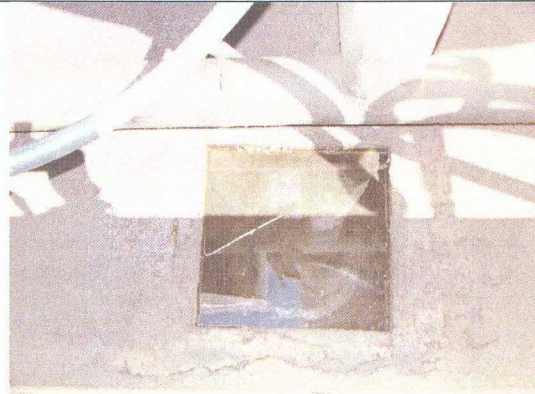
Photo 9: Low point in saddle tank area needs to be inspected and cleaned.

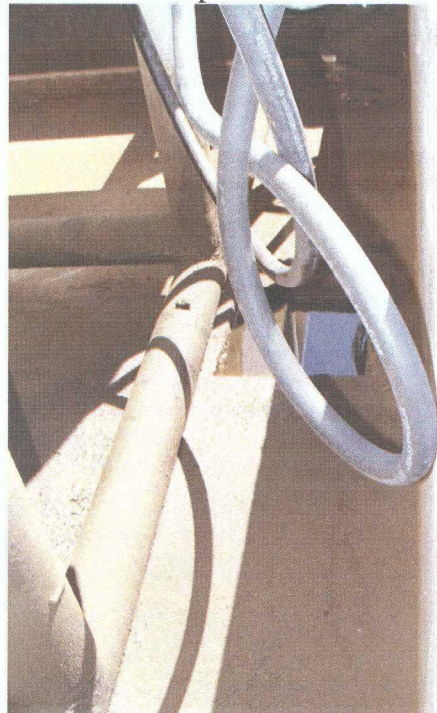
Photo 10: Liquids are not allowed to left in condition for more than 72 hours. Could be considered a "pond".

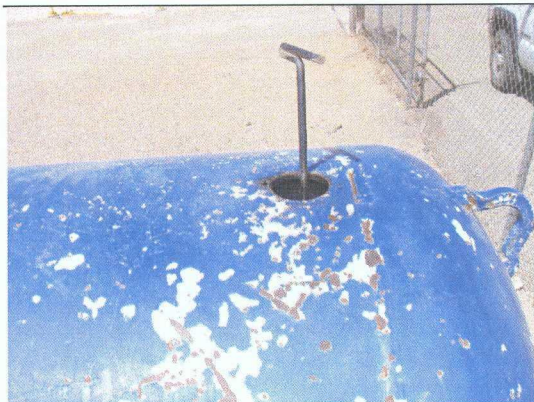
Photo 11: Used oil tank appears to be full to capacity.
