Release Notification and Corrective Action

**Americo Energy Resources
East Shugart Unit #75
Closure Report
Unit A, Section 35, Township 18S, Range 31E
Eddy County, New Mexico**

August 6, 2008

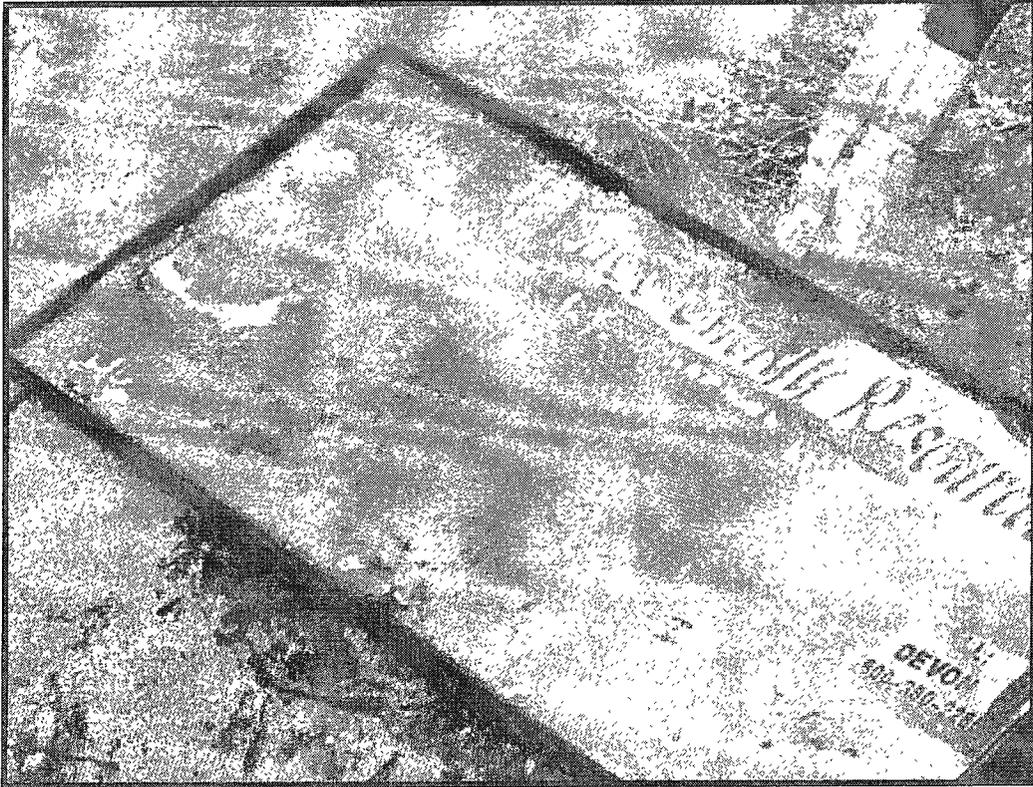
Well sign

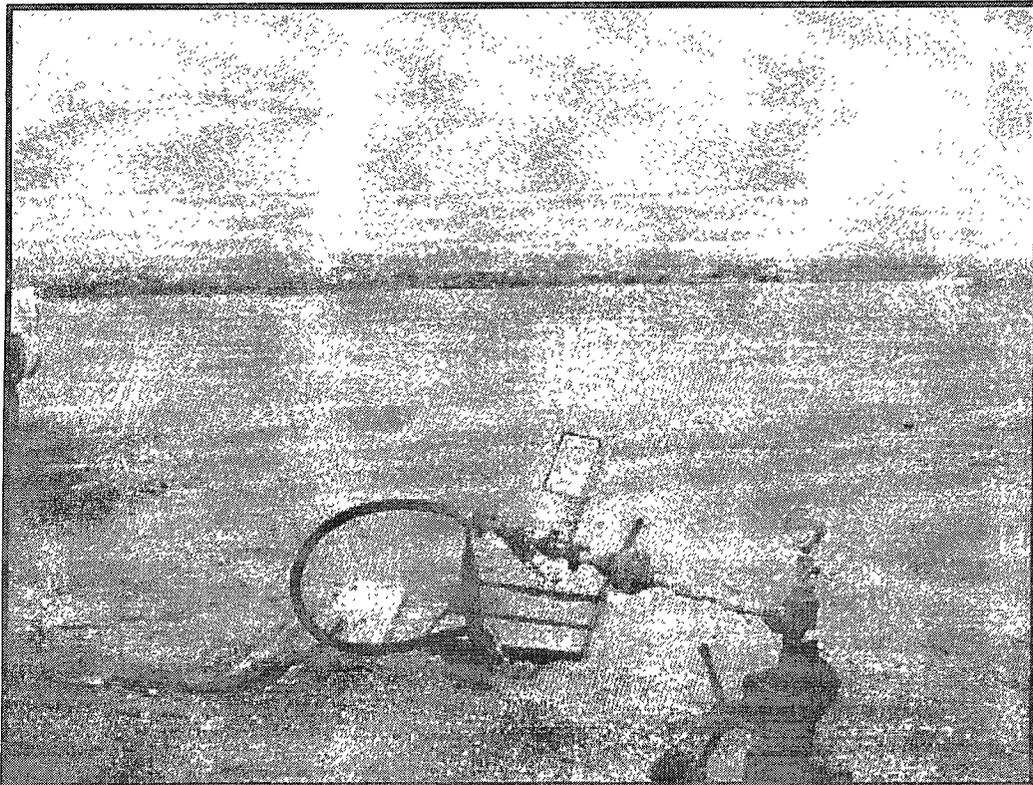
Injector well facing South

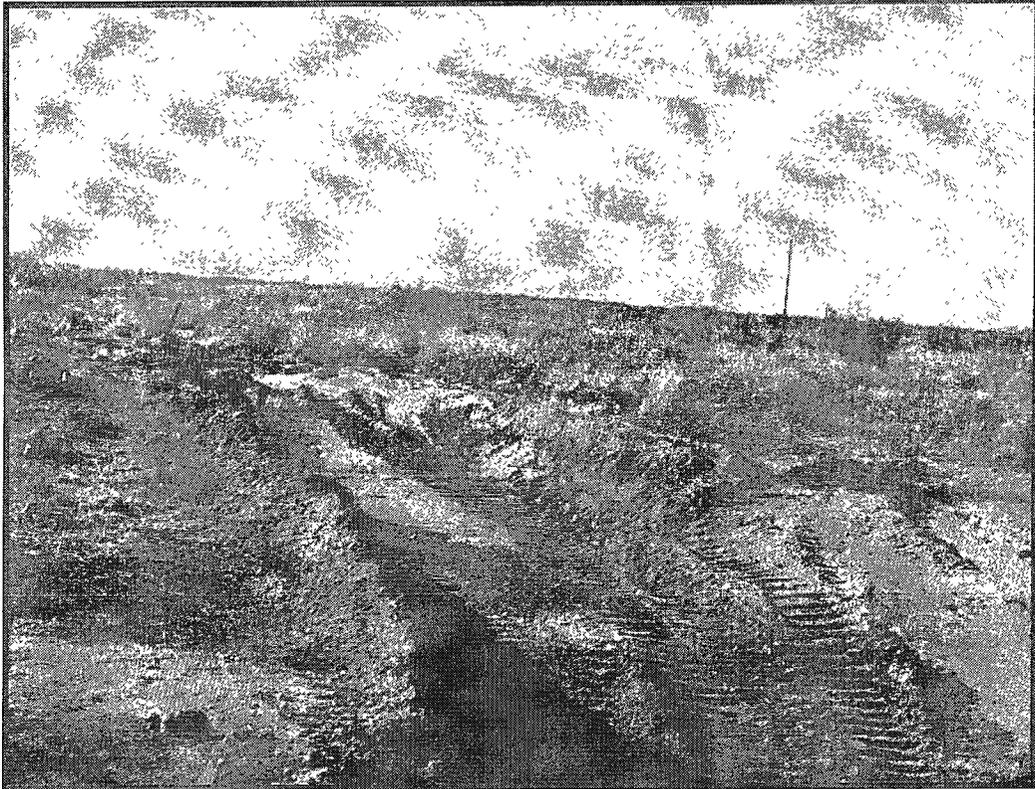
Area 2 excavated facing east

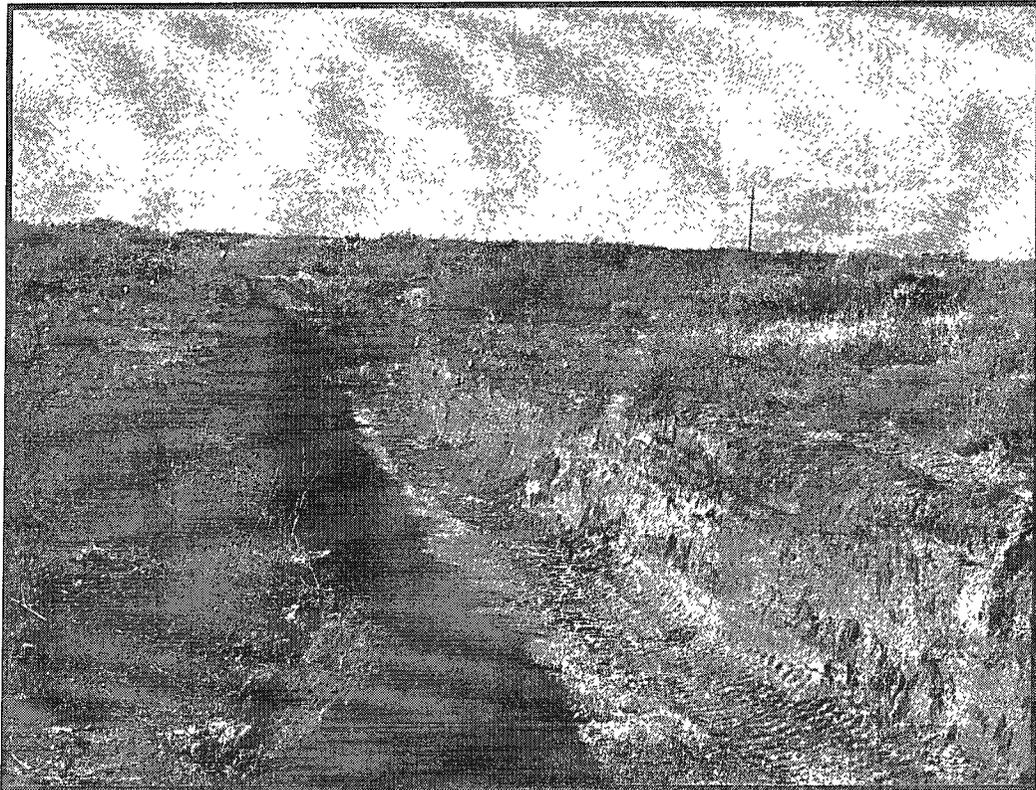
Area 2 excavated facing east

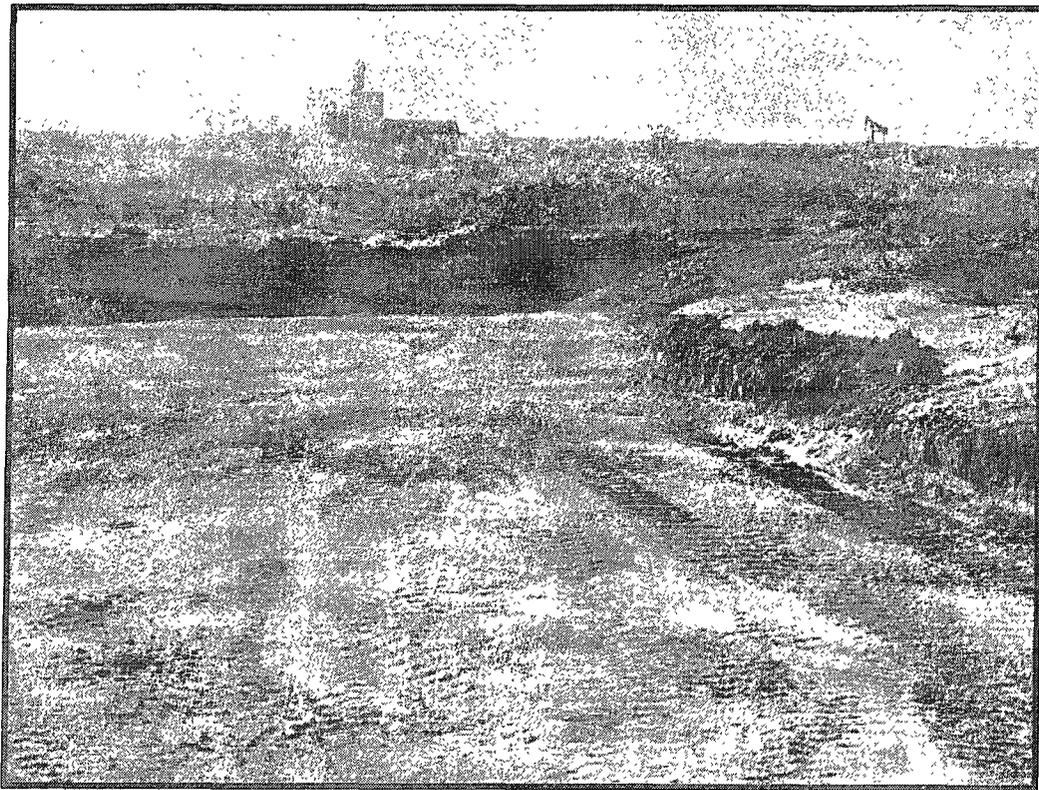
Area 1 excavated facing southeast

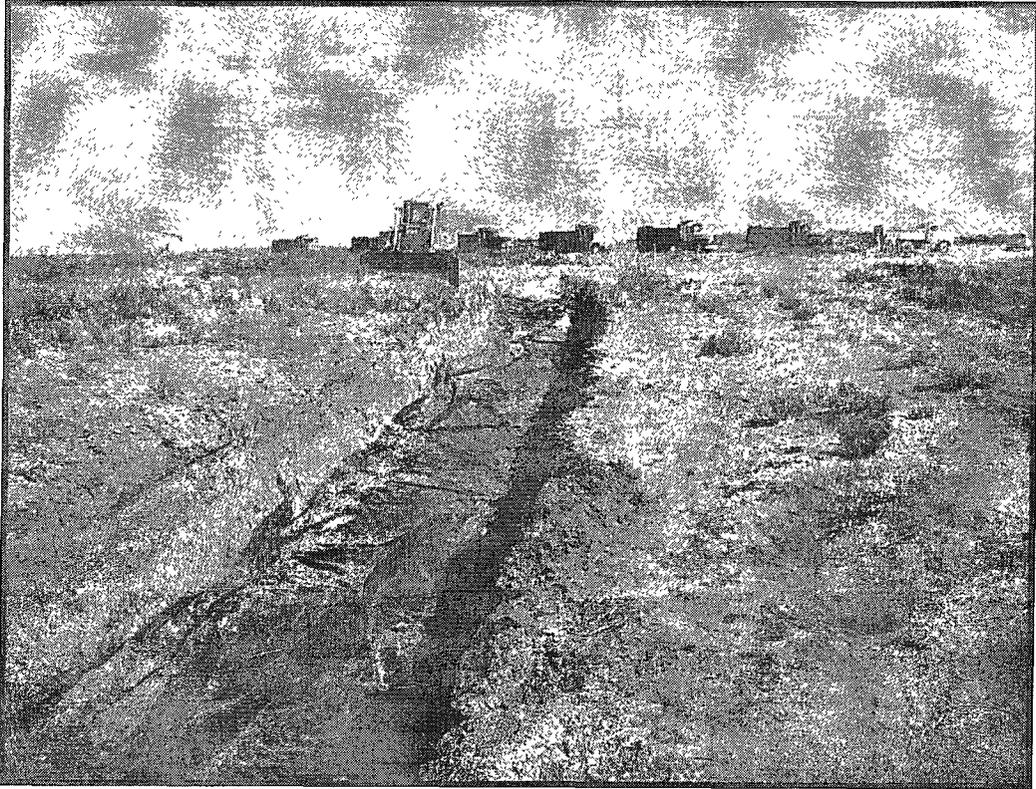
Area 2 lined facing west

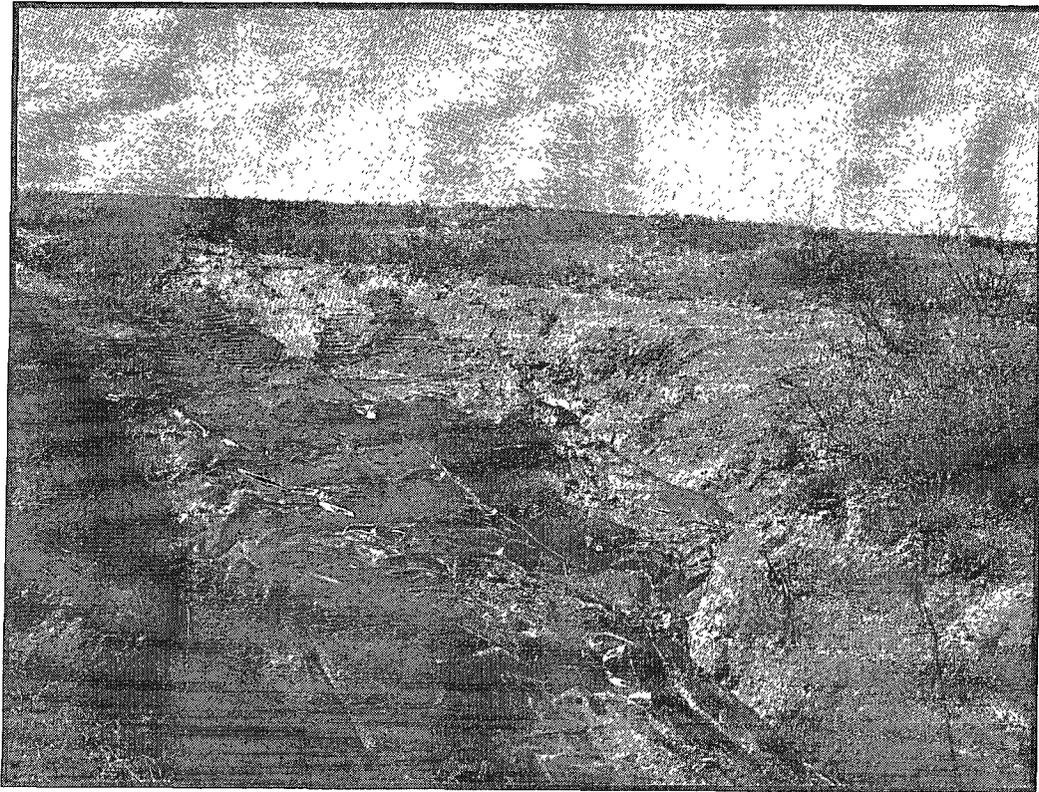
Area 2 lined facing south

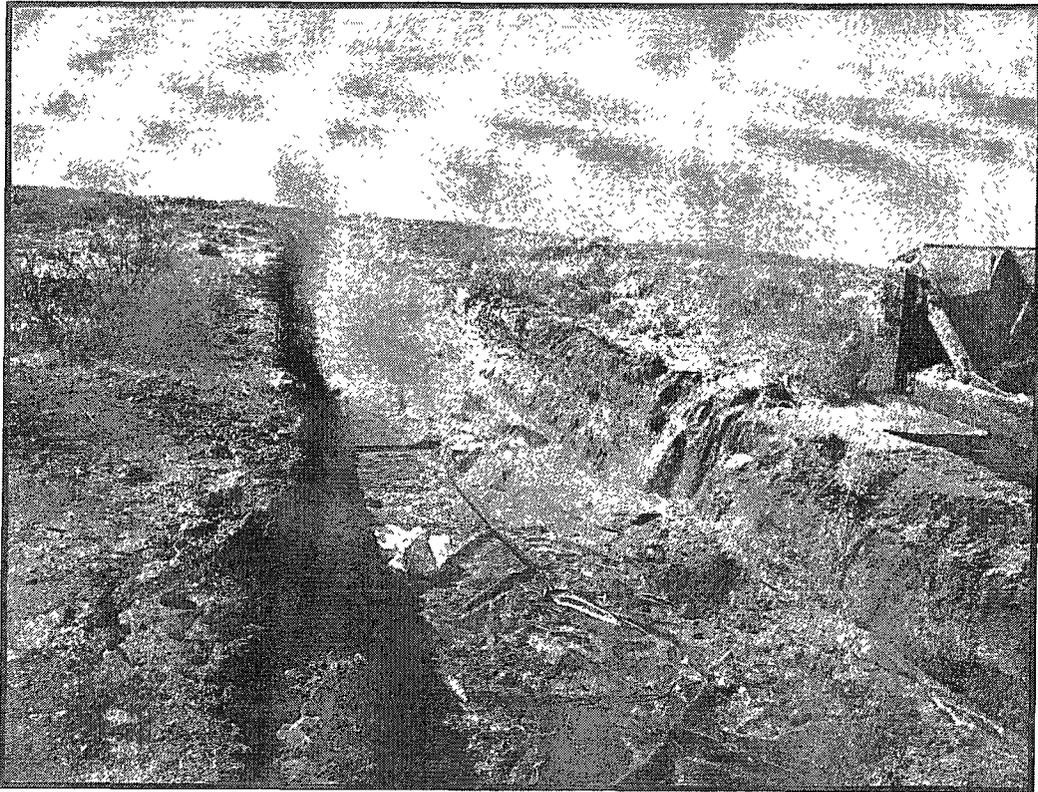
Area 2 lined facing east

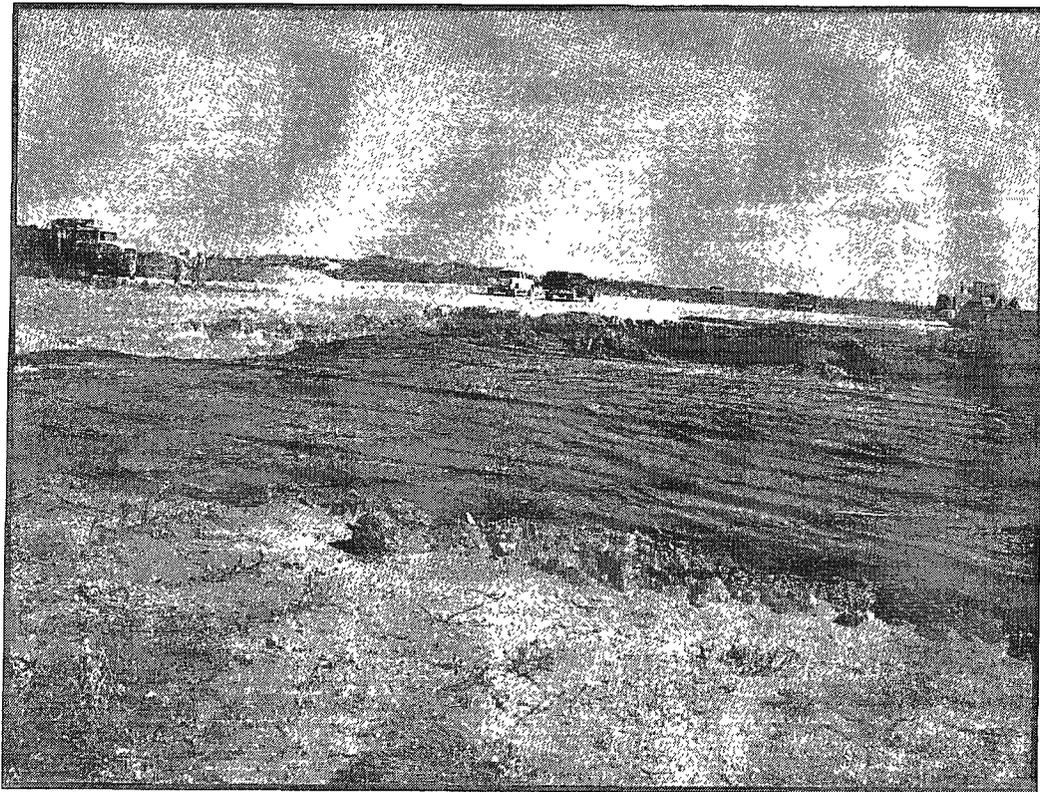
Area 1 lined facing north

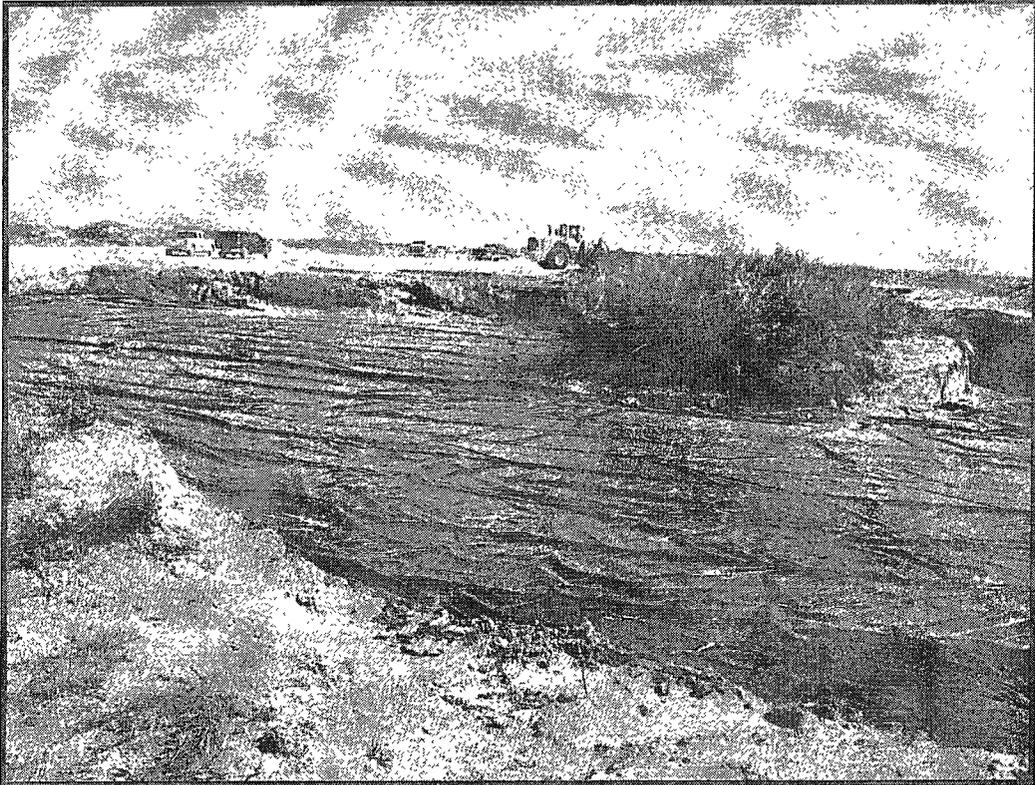
Area 1 lined facing north

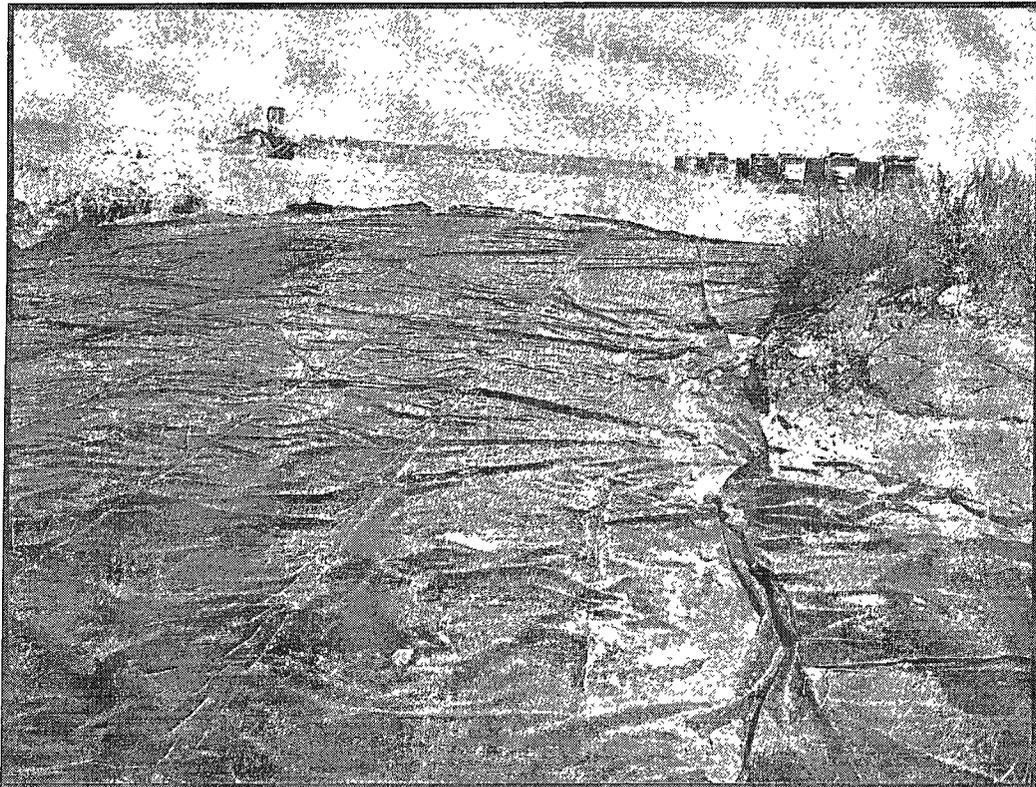
Area 1 lined facing west

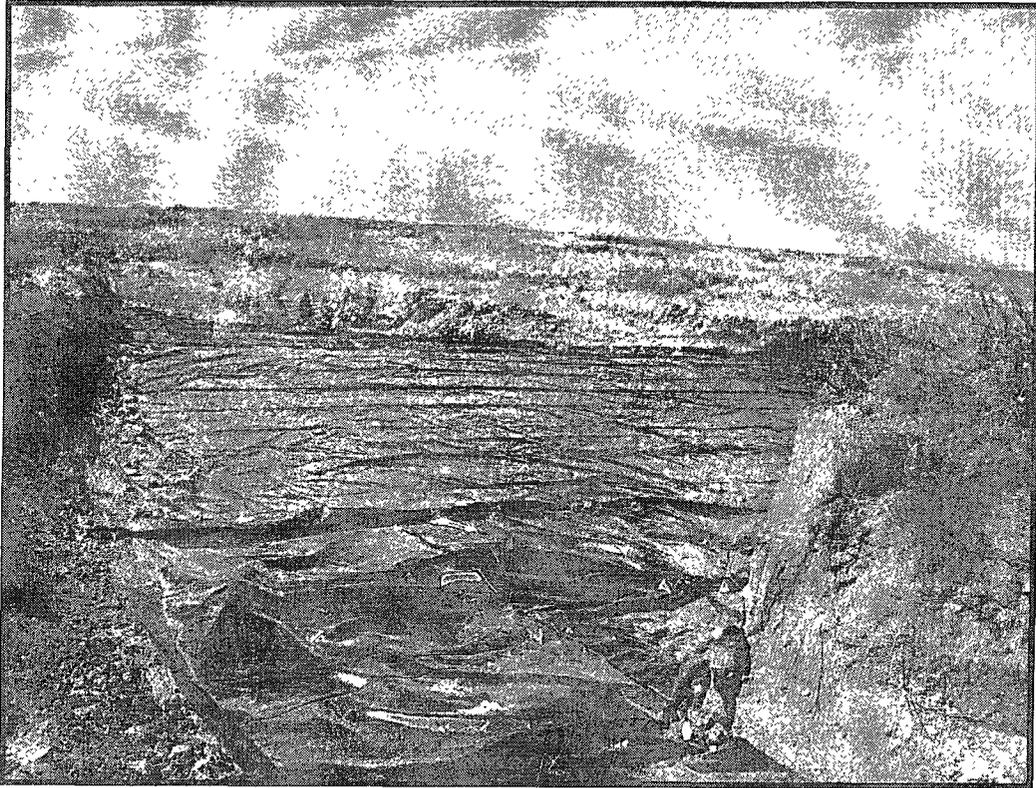
Area 1 lined facing south

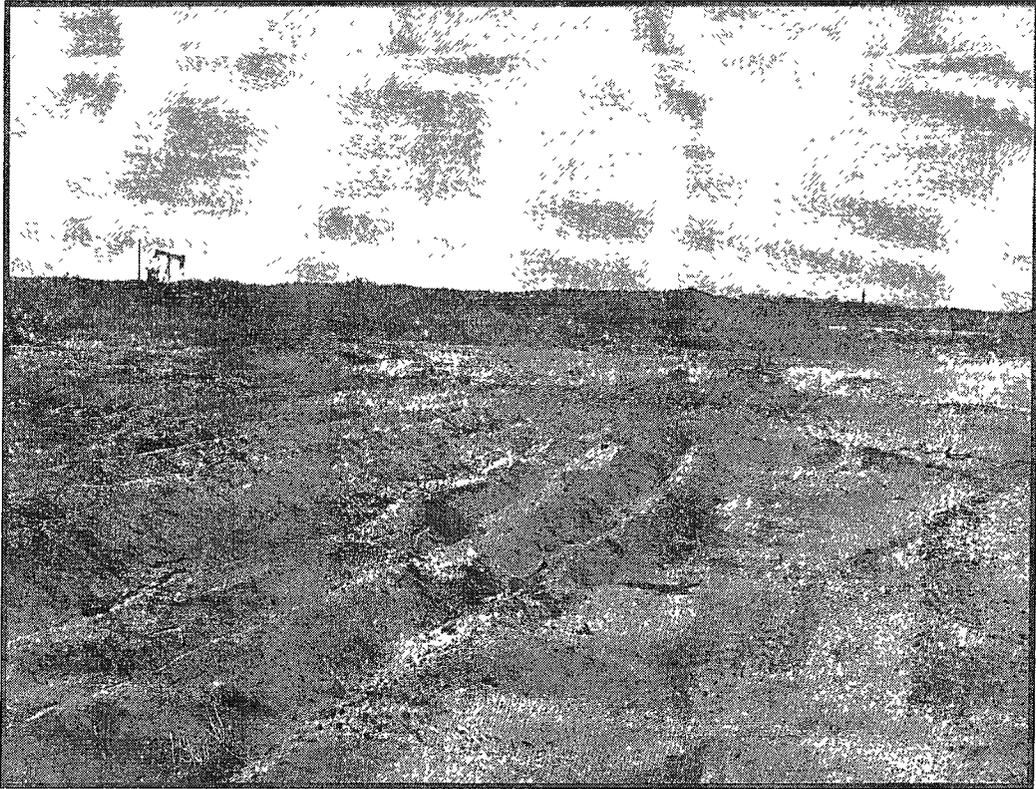
Area 2 backfilled facing west
